## Condition

| Model(s) | Year(s) | VIN Range | Vehicle Specific Equipment |
|---|---|---|---|
| Q4 e-tron, and Q4 Sportback e-tron | 2024 – 2026 | All | PR Code:<br>V7A |

The following TSB describes the specific flashing procedure that must be used on the vehicle.

All part and service references provided in this TSB (**2082957**) are subject to change and/or removal. Always check with your Parts Department and/or ETKA for the latest information and parts bulletins. Please check the Repair Manual for fasteners, bolts, nuts, and screws that require replacement during the repair.

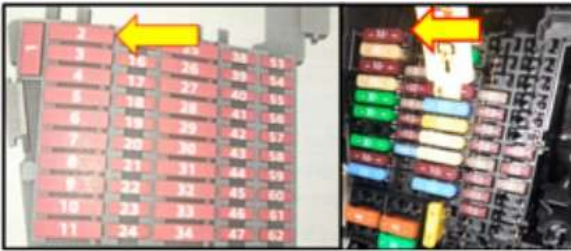
- Insert the USB stick specified by the diagnostic tester.
  - If the instructions to remove the fuse (7.5 A, brown) for airbag control unit J234 are shown, follow the instructions on the tester. Refer to the image to see the fuse location (-2-).
