## Condition

| Model(s) | Year(s) | VIN Range | Vehicle Specific Equipment |
|---|---|---|---|
| Q4 e-tron, and Q4 Sportback e-tron | 2024 – 2026 | All | PR Code:<br>V7C |

The following TSB describes the specific flashing procedure that must be used on the vehicle.

- Moving images are not played while the vehicle is moving.

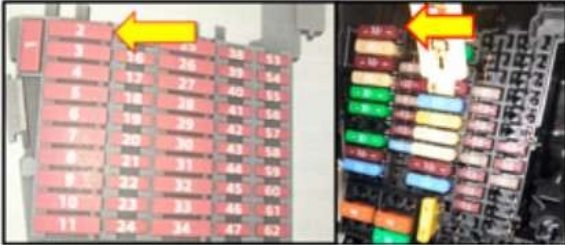
- Insert the USB stick specified by the diagnostic tester.
  - If the instructions to remove the fuse (7.5 A, brown) for airbag control unit J234 are shown, follow the instructions on the tester. Refer to the image to see the fuse location (-2-).
