## Technical Service Bulletin

Transaction No.: **2082961/1**

00 Combined software update ID.S 5.6.3 for Audi Q4 - V7G without S7E

Release date: Aug 26, 2026

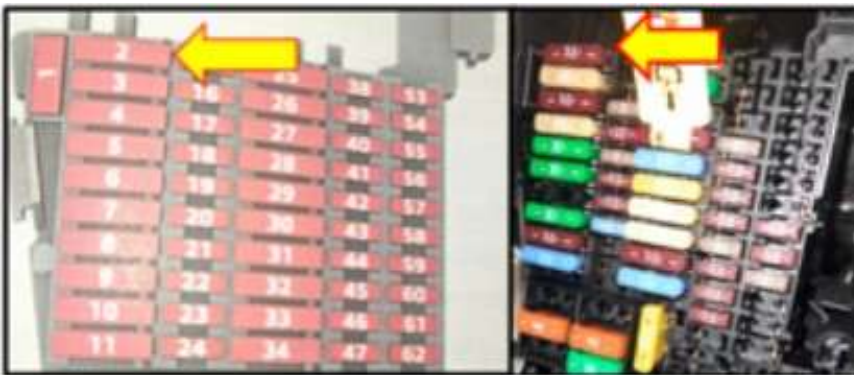
- Insert the USB stick specified by the diagnostic tester.
  - If the instructions to remove the fuse (7.5 A, brown) for airbag control unit J234 are shown, follow the instructions on the tester. Refer to the image to see the fuse location (-2-).
