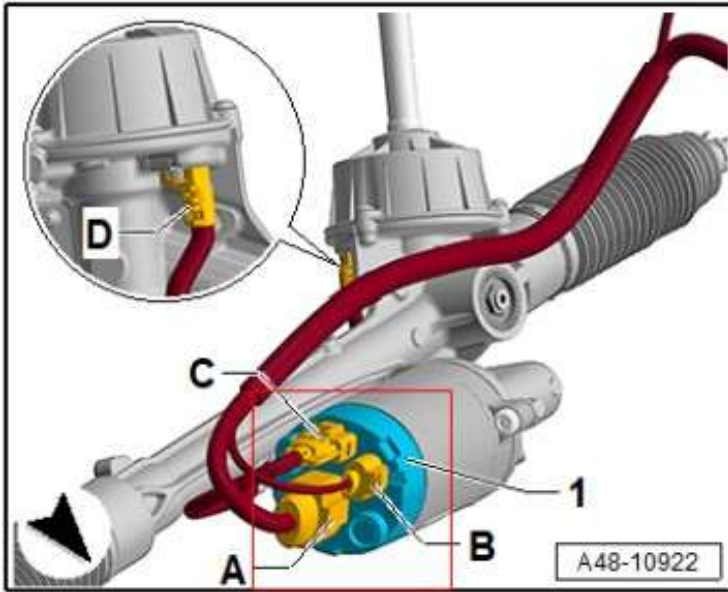
This can be done either by disconnecting the 12V battery or unplugging the main connector (+/- connector "A", refer to photo) from the steering (J500).

Please perform a terminal 30 reset for power steering control unit J500 (at least 5 minutes).

Then perform virtual replacement of J500 (without actually replacing any hardware) and then reactivate it.
