## Technical Service Bulletin

Transaction No.: **2083116/1**

97 Parking aid fault when combustion engine is running, event memory entry in DA0009 about parking aid sensor

Release date: Aug 26, 2026

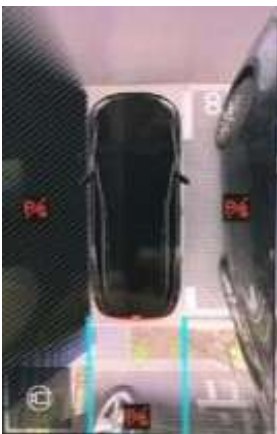
Corresponding symbols in the center display indicate that the parking aid function is restricted (refer to Figure 1).

**Figure 1.** Symbols in the center display.

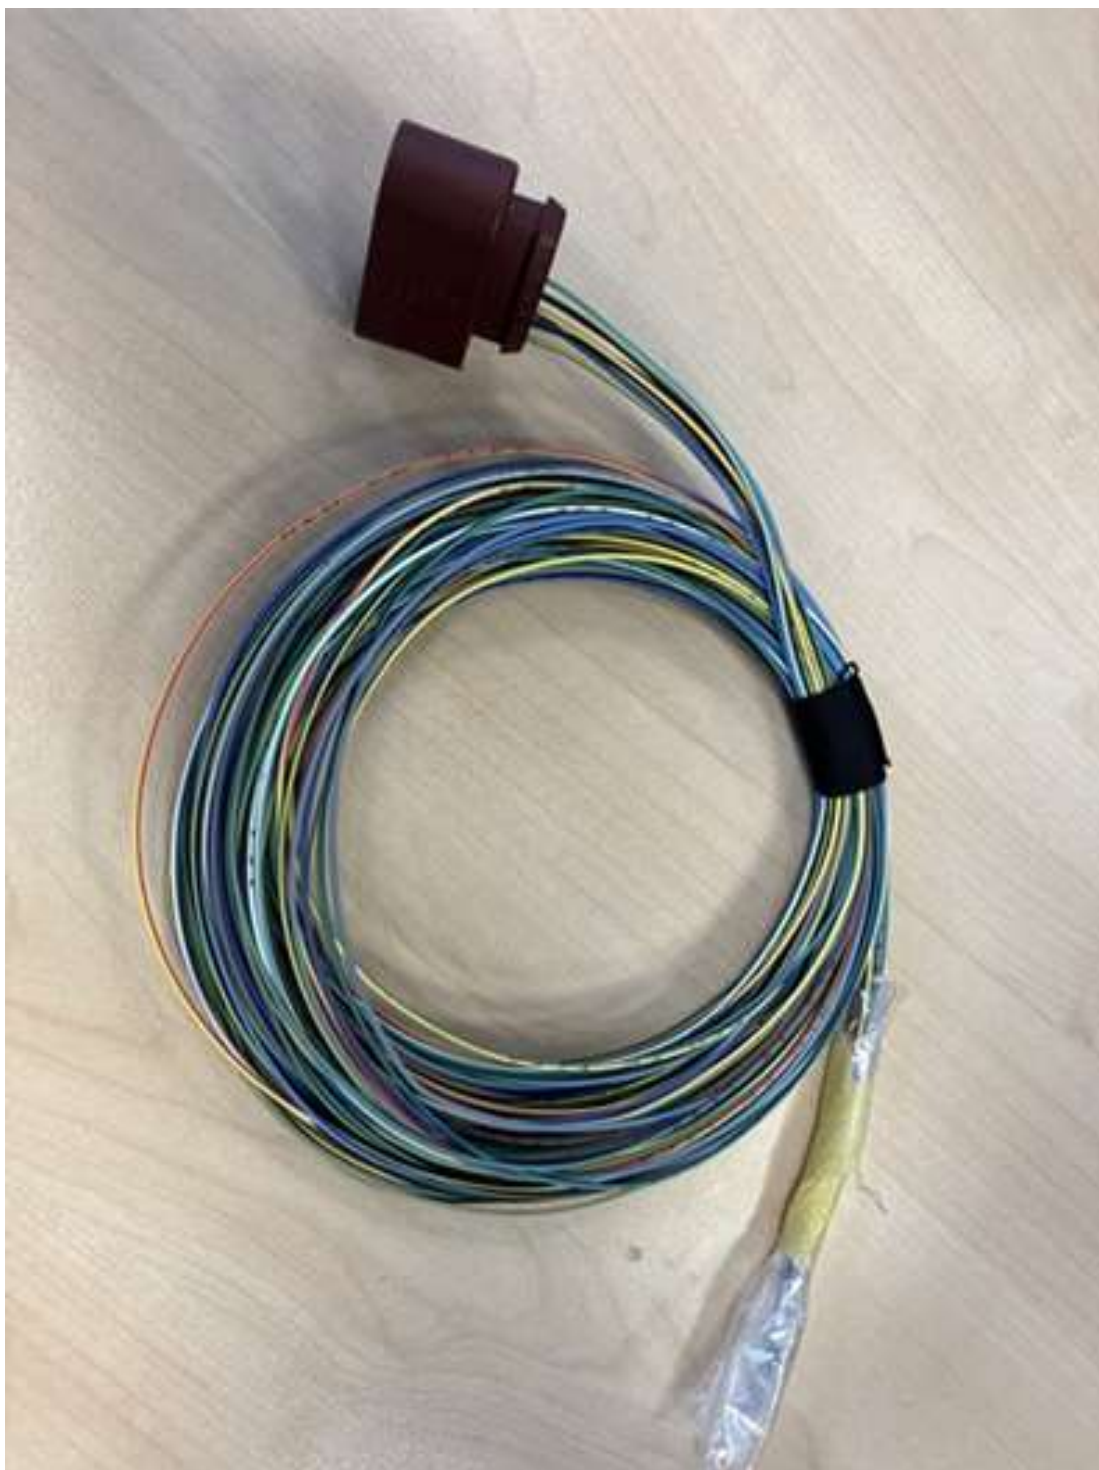
**Figure 2.** Wiring harness with part number 4P0971065 for Audi A5 (FU) and Audi A6 (FN)

The wiring harness with part number 4P0971065 is required for the Audi A5 (FU) and the Audi A6 (FN) (refer to Figure 2).

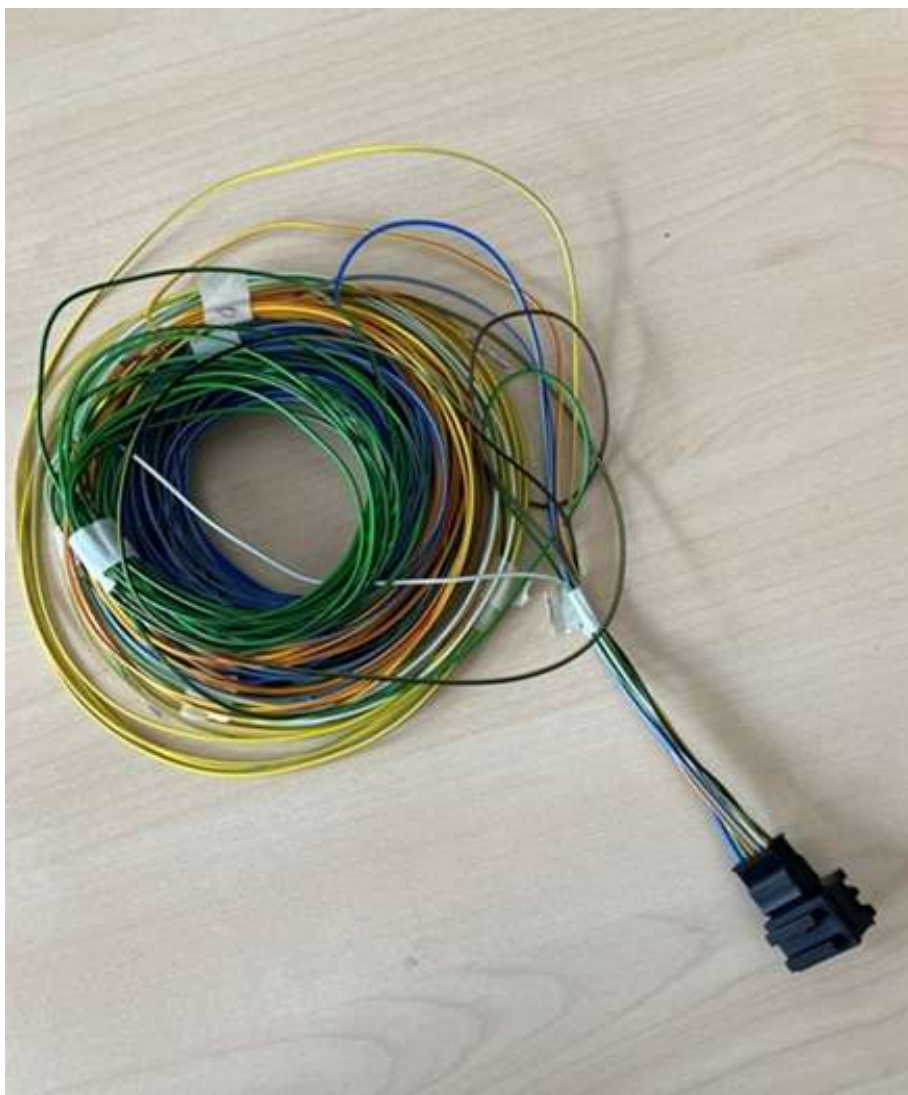
**Figure 3.** Wiring harness with part number 8MA971065 for Audi Q5 (GU).

The wiring harness with part number 8MA971065 is required for the Audi Q5 (GU) (refer to Figure 3).

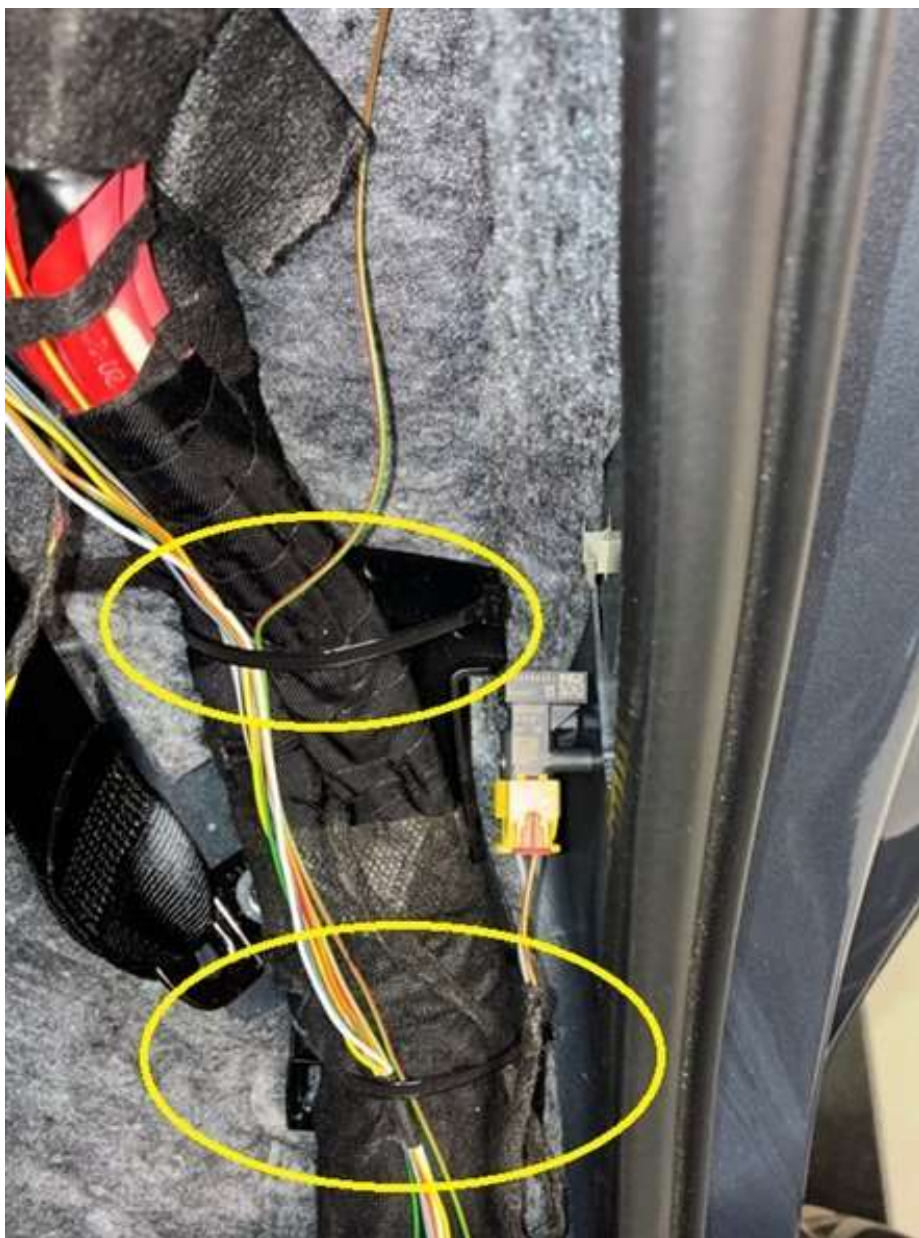
**Figure 4.** Route the wiring as shown.

Route the wiring harness with the open side (without a connector) loosely from the luggage compartment towards control unit J519. Where possible, guide it through existing cable ties, brackets and cable guides (refer to Figure 4).
