## Technical product information

| <b>Topic</b> | Water evident on the A-Post pillar seam - Water dripping behind the door seal - Sunroof specified vehicles only |
| <b>Transaction No.</b> | 2070638/3 |

### New Continental GT and New Flying Spur

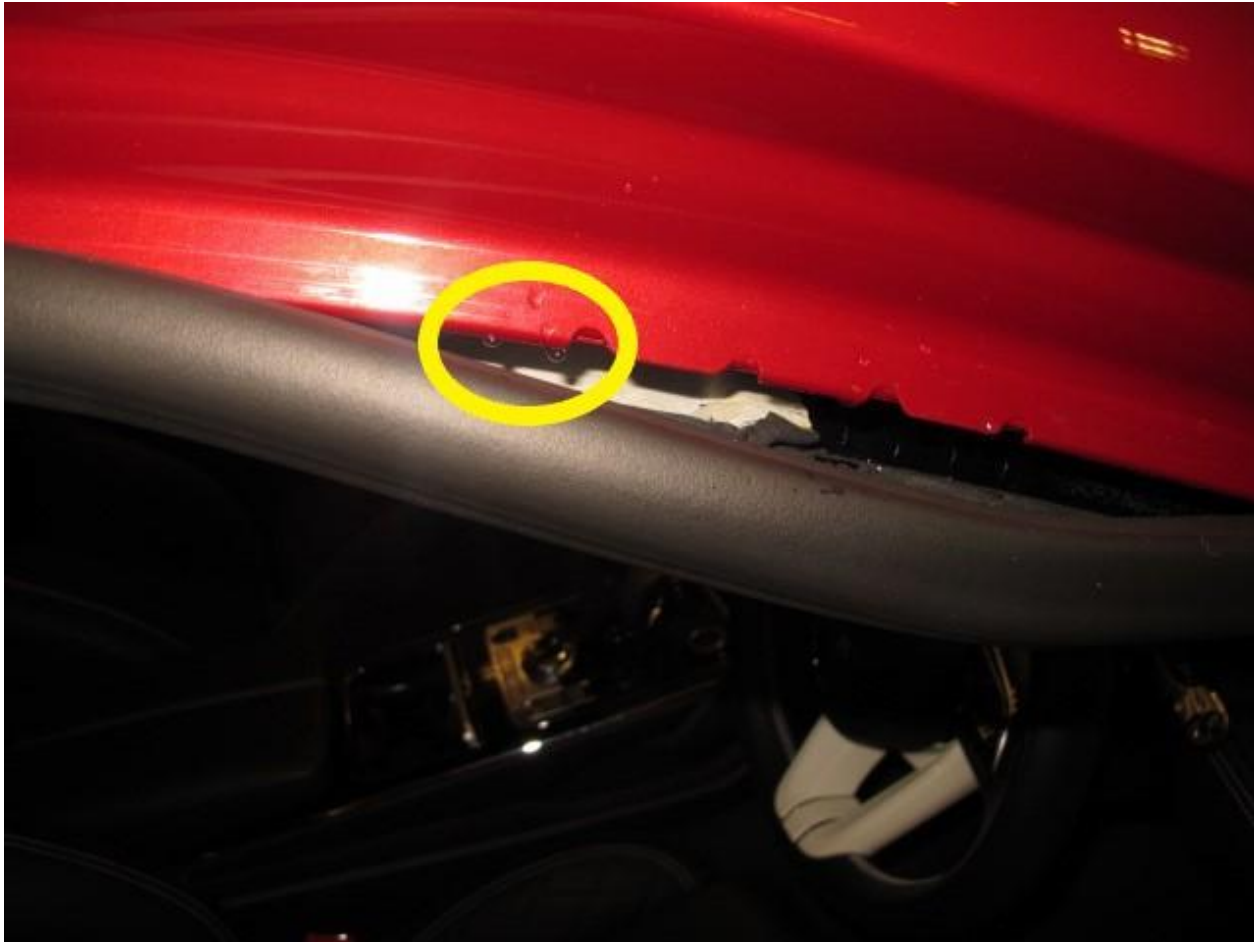
- Water evident on the A-Post pillar seam - Water dripping behind the door seal (Figure 1)

After conducting TPI 2062622/- water is found to be leaking from the location shown in Figure1

The issue described is only evident on vehicles with a sunroof, in the event the issue is evident and the vehicle is not specified with a sunroof please raise a DISS query and await feedback before conducting any further work

1) Has TPI 2075699/- been conducted?

**No** - Please conduct 2075699/- to completion

**Yes** - 2075699/- has been completed and the leak is still evident from the location shown in Figure 1 In the event the leak is still evident the operative should request assistance via a new or existing DISS query
