# Service Alert

**FUEL DOOR STUCK CLOSED OR ALLEGEDLY FELL OFF BY ITSELF (PHEV)**

**Service Alert No.: SA-056/26**

2025-2026 CX-70 (PHEV ONLY)

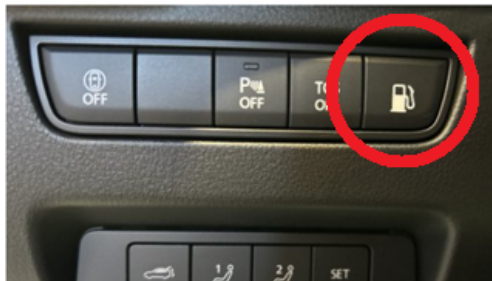
1. Press the fuel filler lid switch on the dash.
