# McLaren 750S Door Pocket Rework

**Topic:** McLaren 750S Door Pocket Rework

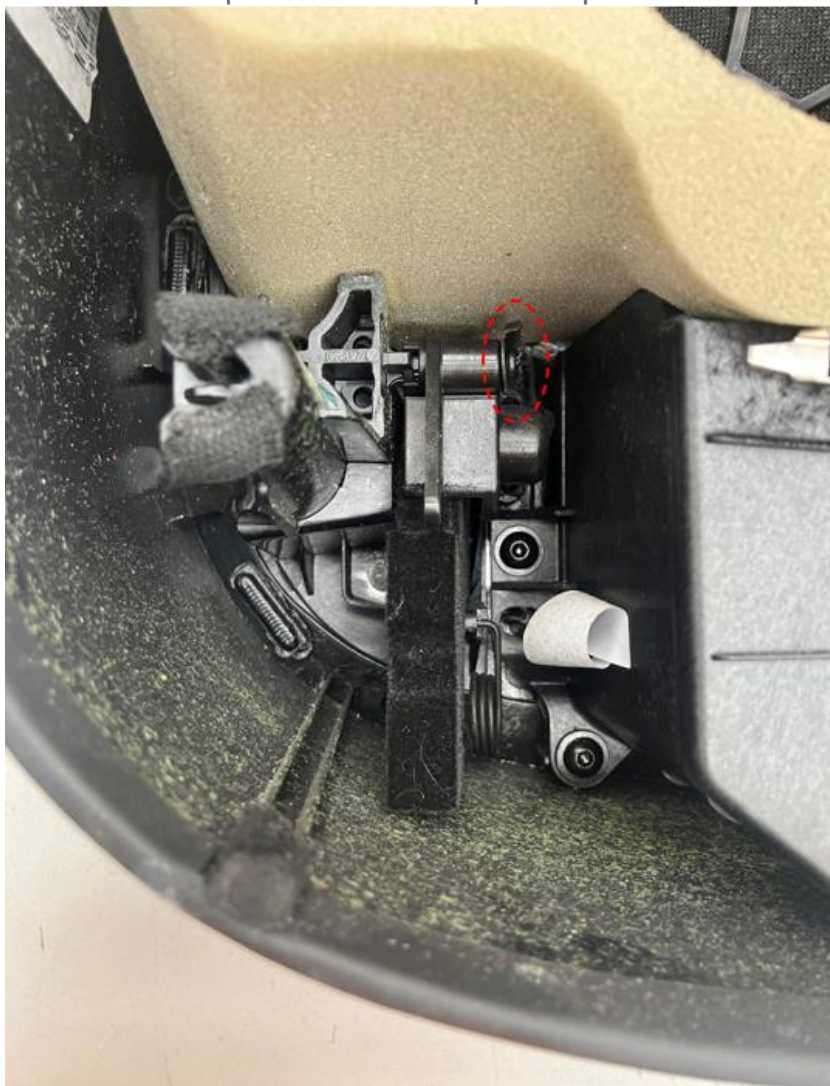
If the door pocket is reported an inoperative, please perform the below steps on the door pocket pendulum C-clip.

2. Remove the clip from the door pocket pendulum:
