# McLaren Artura Transmission Oil Leak Diagnosis Guide

**Location:** Powertrain / Hybrid

**Topic:** McLaren Artura Transmission Oil Leak Diagnosis Guide

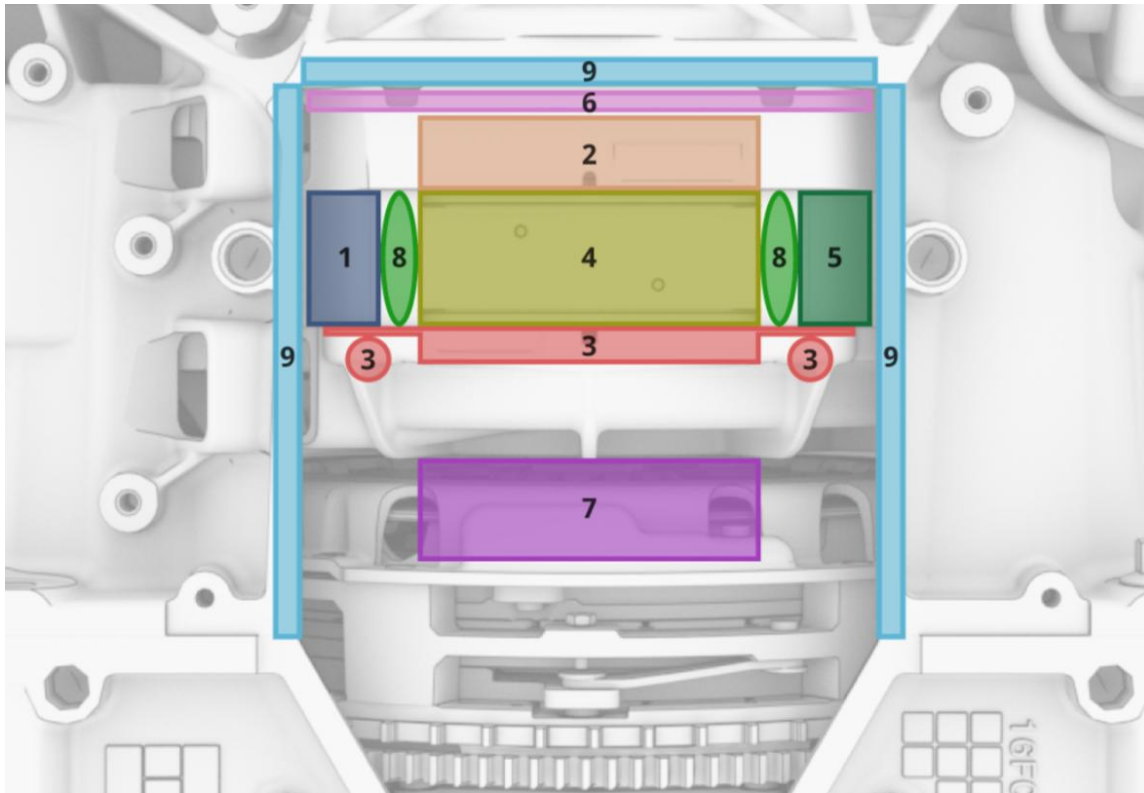
14. If leak continues post cycle 2 please fill in table in accordance with the leak path map below. Complete transmission health check, then check dielectric oil level when vehicle has cooled down and attach table, dielectric oil level and all images to a TR
