**Creaking Noise from the Front End of the Vehicle (SY 63/26)**

Vehicle Type: **911 GT3 (992)/911 GT3 with Touring Package (992)/911 GT3 RS (992)/911 S/T (992)**

Concerns: **Upper trailing arm**

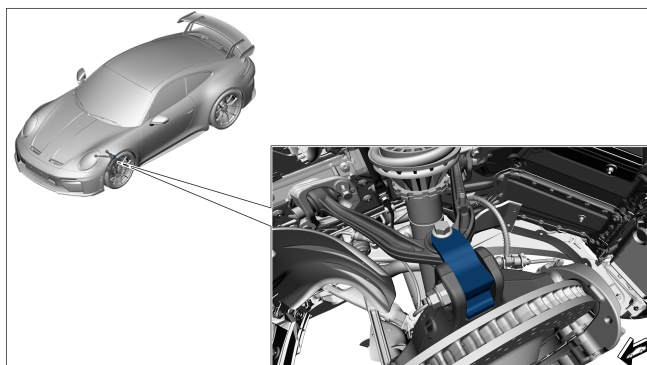
Reason: In rare cases, dirt on the contact surfaces between the camber console of the upper trailing arm and the mounting of the wheel bearing housing can cause a creaking noise.

Installation position of camber console for upper trailing arm

Remedial Action: If the customer complaint can be clearly limited to the area of the camber console connection point (top of axle control arm) for mounting the wheel bearing housing, clean the contact surfaces of the camber console and wheel bearing housing on the affected side of the vehicle.
