## Various White Messages Regarding Driver Assistance Systems/Fault Memory Entry "C12D5FA" in the ZFAS Control Unit (75/25)

Model Line: **911 (992)**

Model Year: **from 2020**

Concerns: **Control unit for driver assistance systems (ZFAS)**

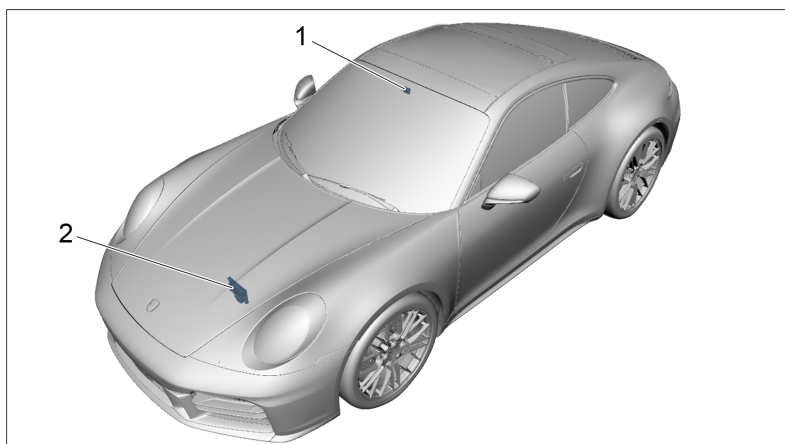
Installation Position:

- 1 Front camera for driver assistance systems
- 2 Control unit for driver assistance systems (ZFAS)

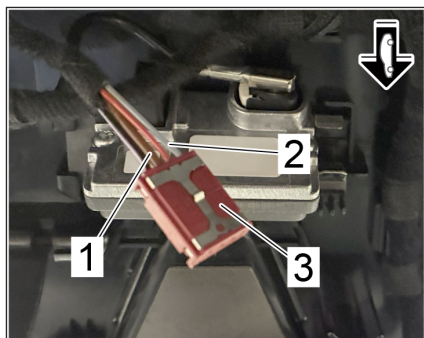
Bypassing ground loop

Reason: If the fault memory entry is **passive**, there is a possibility that electromagnetic incompatibility/influences on the video line may lead to the above-mentioned complaints.

- 4.1 Unpin electric line (**brown**) -1- from **chamber 2** of the connector housing -3-.
  - 4.2 Unpin electric line (**grey**) -2- from **chamber 4** of the connector housing -3-.

- 4.3 Disconnect plug contacts on the electric lines (brown and grey) -1 and 2-.
  - 4.4 Crimp electric lines (brown and grey) -1 and 2- with each other.  
Work procedure, see: **9797INA1 Information on electric crimp/splice connections**
