Windshield Water Ingress in the Area of the Front Overhead Console (34/26)

Model Year: **As of 2024 up to 2026**

Model Line: **Macan (XAB)**

Concerns: **Windshield**

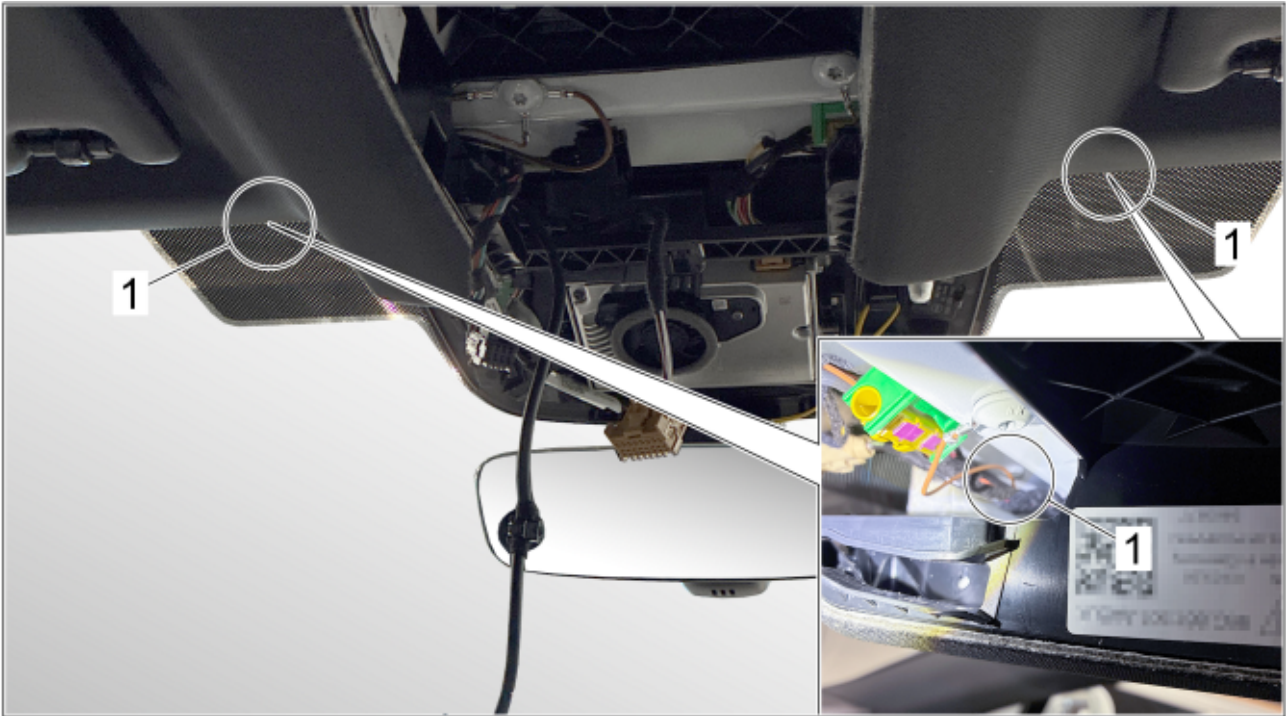
Bonding test area

| Assessment | | Action |
|---|---|---|
| (✓) | There ⇒ <i>Bonding test area -1-</i> is <b>no</b> fog or water ingress in the area of the riveting points on both sides. | Windshield bonding is OK. <ul style="list-style-type: none"><li>▪ Install windshield trim frame at the left and right.</li><li>▪ Install cover, top</li><li>▪ Install front overhead console</li><li>▪ Remove workshop vacuum cleaner hose from rear door window and remove adhesive residues</li></ul> Continue troubleshooting elsewhere.<br><b>End of action.</b> |
| (x) | Fog or water ingress ⇒ <i>Bonding test area -1-</i> is detected in the area of the riveting points.<br>⇒ <i>Fog or water ingress on bonding</i> | Windshield <b>bonding is not OK.</b><br>Continue with: |

- 4 Check and evaluate bonding at the rivet points ⇒ *Bonding test area -1-* in the front overhead console area.  
The test takes place through the opening of the overhead console. Lift roof trim panels **slightly** in the windshield area if necessary.

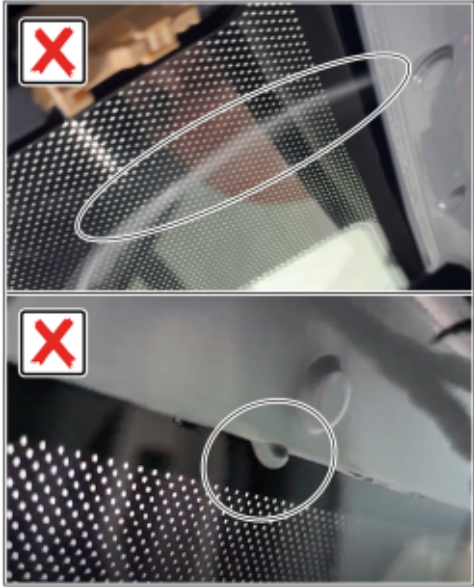
| | <p data-bbox="553 953 889 985"><i>Fog or water ingress on bonding</i></p> | <p data-bbox="1003 346 1360 410">⇒ Technical Information '666119<br/>Reworking windscreen bonding'</p> |

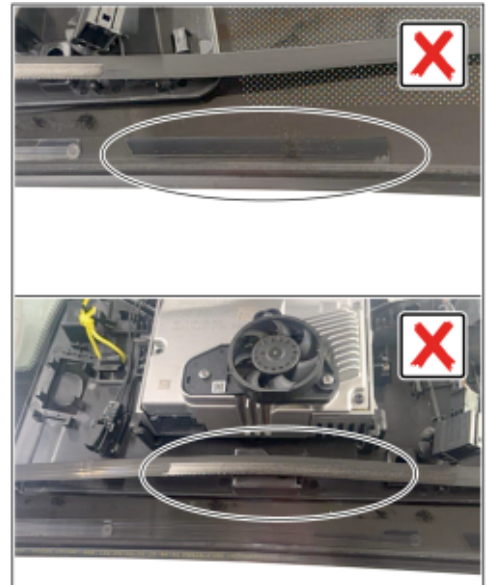
Windshield adhesion is not OK

- Work Procedure:
- 1 Remove windshield, but do not cut back residual adhesive material yet.  
⇒ Workshop Manual '641219 Removing and installing windscreen'
  - 2 Check residual adhesive material on the windshield and body and ensure that there is full-surface adhesion to the windshield and body.  
If this is not the case, remove loose residual adhesive material in accordance with the repair instructions.

It must be ensured that there is a full bond between the residual adhesive material and the windshield or body.

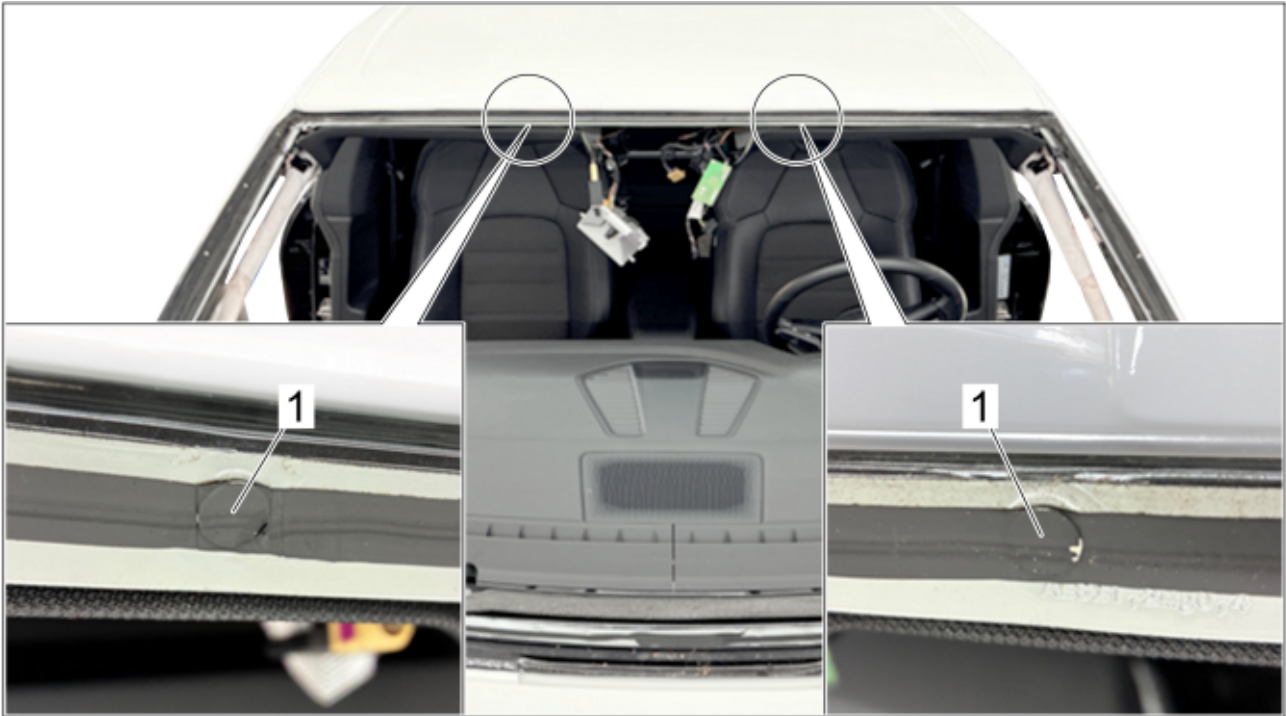
Cause: In rare cases, a leak can occur due to faulty bonding of the windshield in the overhead console area.

**Apply a slightly increased amount of window adhesive in the area of the two rivets ⇒ Affected rivets in front overhead console area -1-** if they have not already been pre-treated with window adhesive.
