# Technical Information

69/26

## High-Frequency Squealing During Fast or Jerky Steering Movements (69/26)

Model Line: **Taycan (Y1A/Y1B/Y1C)**

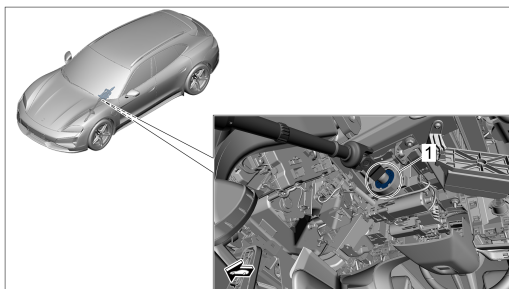
Information: **The customer complains that a high-frequency squeaking noise can be heard from the steering column module and/or steering column area during fast or jerky steering movements.**

Installation position of steering column bearing point

1 Affected bearing point

Action: If there is a customer complaint, rework the bearing point of the steering column.  
**Replacing the center steering column is not required for this complaint.**

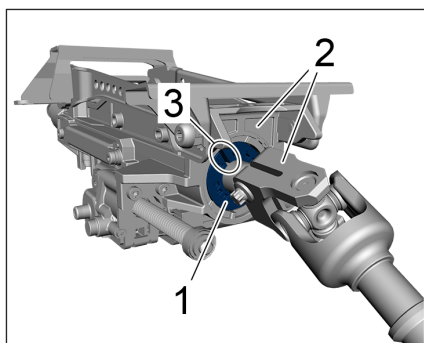
Rework the bearing point (shown on electrically adjustable steering column)

- 3.1 Clean steering column from dirt -2- in the area of the bearing point -1- with suitable means (e.g. microfiber cloth).
- 3.2 Coat bearing point -1- over the slot in the inner ring -3- with Krytox special lubricant.
- 3.3 Remove excess special lubricant using a dry, dust-free cloth.
- 4 Install footwell blower, front.  
**805519A3 Removing and installing footwell blower, front**
- 5 Install knee airbag on driver's side.  
**697819A1 Removing and installing knee airbag on driver's side**
