## Porsche Mobile Charger NEMA Supply Cable Initialization Failure

### Condition

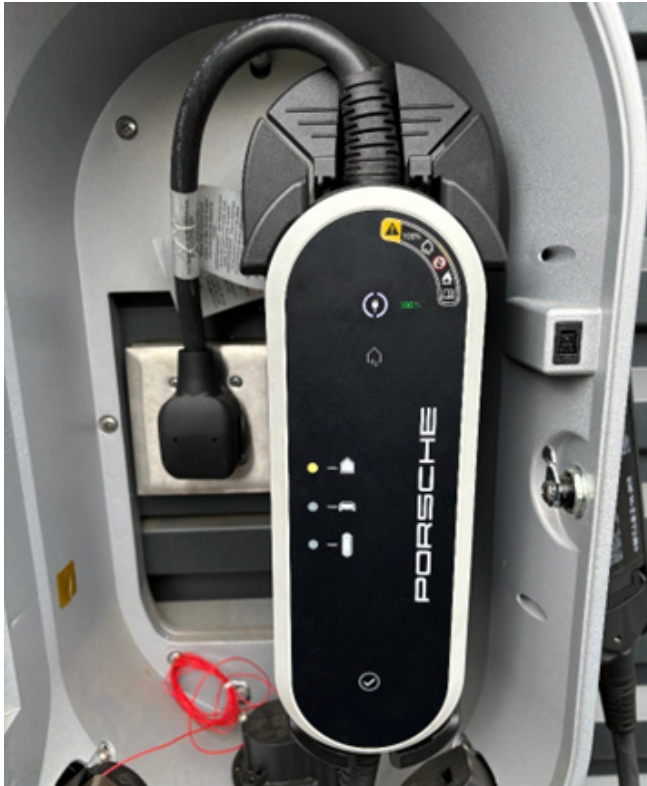
Figure 1

Phase 1: (~20 seconds)

The uppermost Charge Status LED illuminates solid white, while the top "House" LED will illuminate solid yellow for a few seconds as shown in figure 1.

While the Operating Instructions recommend removing and reinserting the power plug, this does not always remedy the condition. There is currently no known correlation of this condition to supply cable production date. If a charger exhibits the described behavior with a particular supply cable, normal operation cannot be guaranteed with a power supply cable of later production date. Each cable must be physically tested with the customer's charger at the Porsche Center to confirm functionality before returning the updated charger and new supply cable to the customer.

This condition is not directly a fault of the temperature-sensing supply cable. New cables that do not work on the affected PMC+/PMCC devices demonstrating this condition can work normally on PMC Basic part number variants with updated software. If the customer PMC+/PMCC continues to display this behavior with at least 5 replacement supply cables after multiple outlet plug-in cycles, it should be replaced. **Please test 5 different supply cables before replacing the PMC+ or PMCC.**

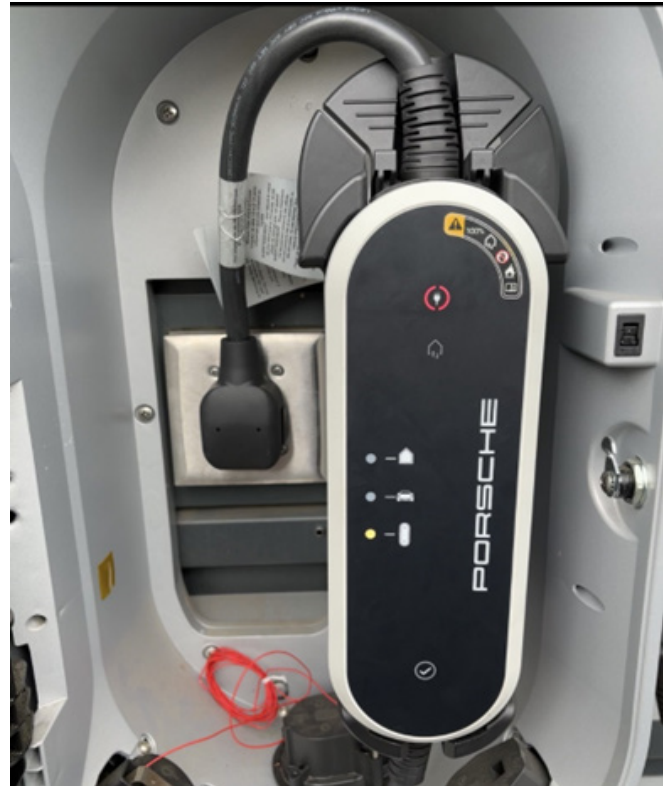
Figure 2

Phase 2: (indefinite)

The uppermost Charge Status LED illuminates solid red, and the bottom "Charger" icon LED flashes yellow as shown in figure 2 as long the unit remains plugged into an outlet.

Fault codes are stored in the device fault memory when scanned for fault codes with the PIWIS Tester.

**B105000\_FF000A** Universal charging cable -function restriction due to overtemperature

**U10DA00\_FF000E** Electrical system connection cable – coding invalid

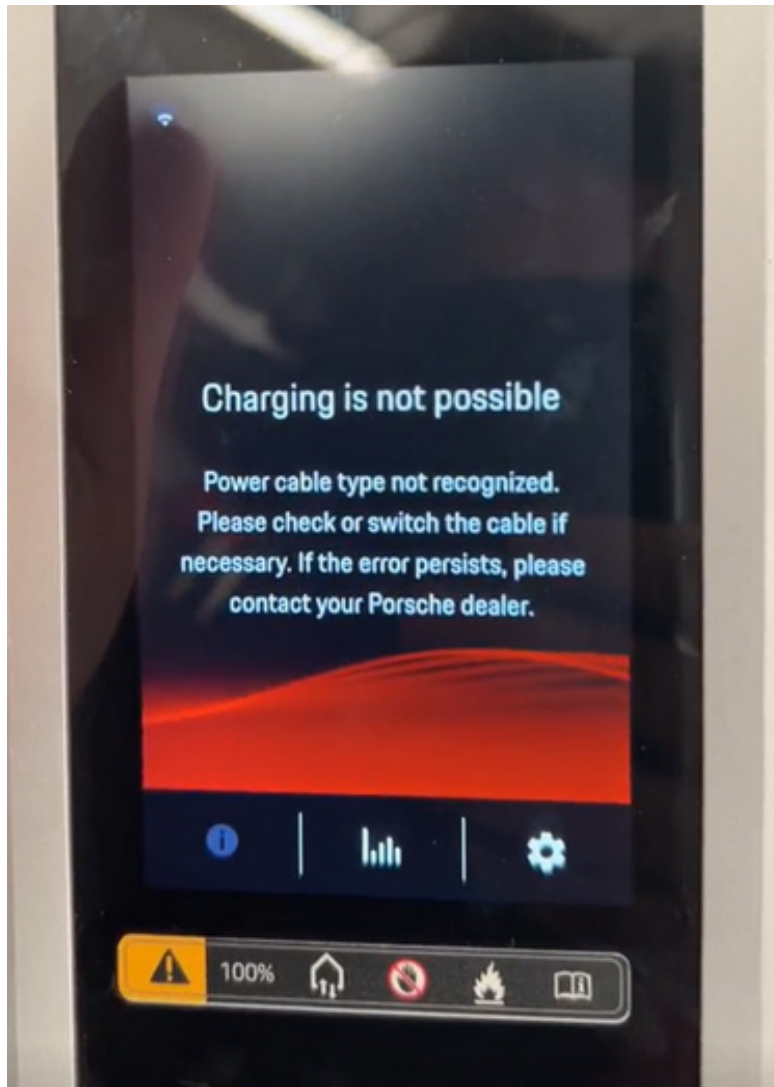
A similar fault occurrence can present in the PMCC variants on start-up. The lights will illuminate red after plugging into the power outlet, with the message in Figure 3 shown on screen.

For replacements of the PMCC, please continue to replace these with another PMCC unit due to the extended functionality that is available.

Please upload a screenshot of the Porsche Mobile Charger software version in the Extended Identifications menu of the PIWIS Tester to the PCSS job entry when claiming replacement parts for these situations. In cases with PMCC, please also provide a picture of the software update screen in the settings where the current Commboard software version is displayed. It should read 3031 or later before being considered for replacement.

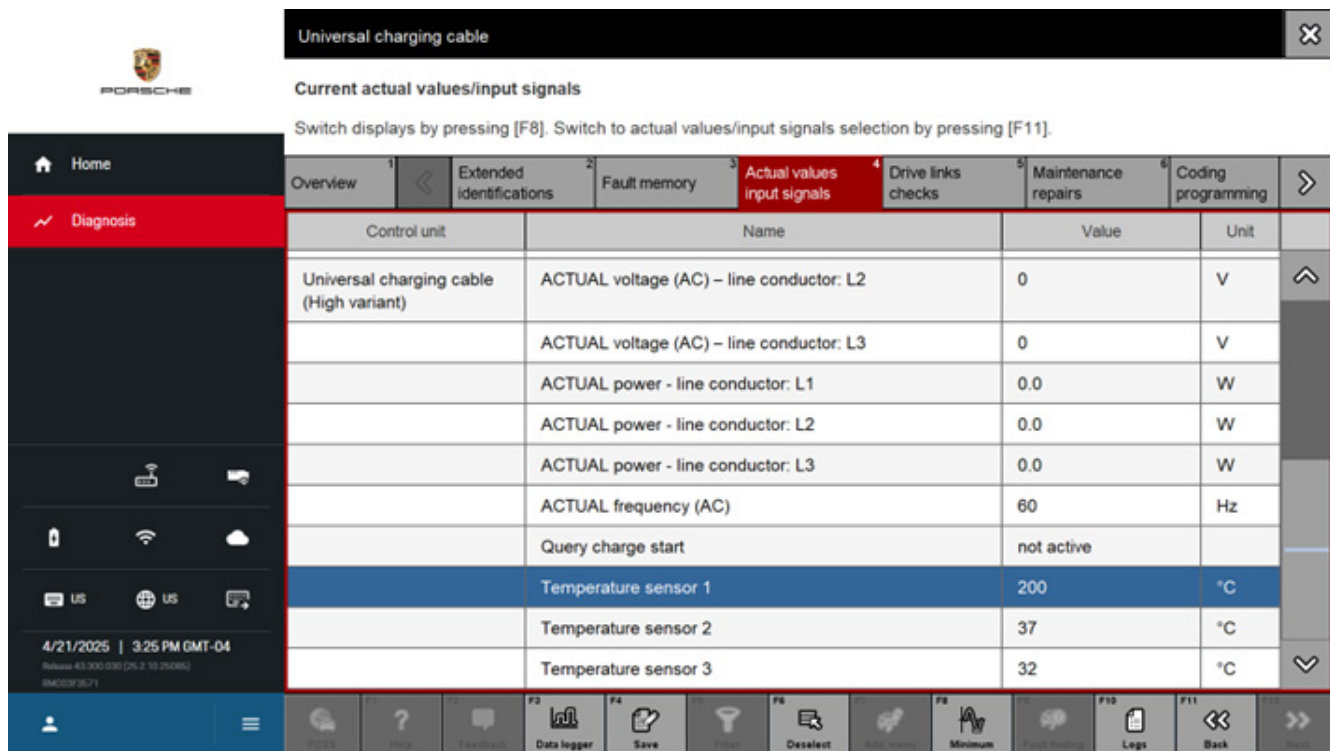
Figure 5

When connecting a Porsche Mobile Charger to the PIWIS tester for diagnostics, one of the temperature sensors in the Actual Values menu is always shown implausible at 200 °C as in Figure 5, regardless of which infrastructure cable is connected. This should NOT be used to diagnose a faulty infrastructure cable without the condition previously described in this case.
