| Topic | Subframe Mount Control Unit - Calibration Update Bentayga Series 26-27MY (SC26/16) |
| Campaign number | ED95 |

Subframe Mount Control Unit - Calibration Update | Bentayga Series | 26-27MY  
(SC26/16)

Release date: Aug 10,  
2026

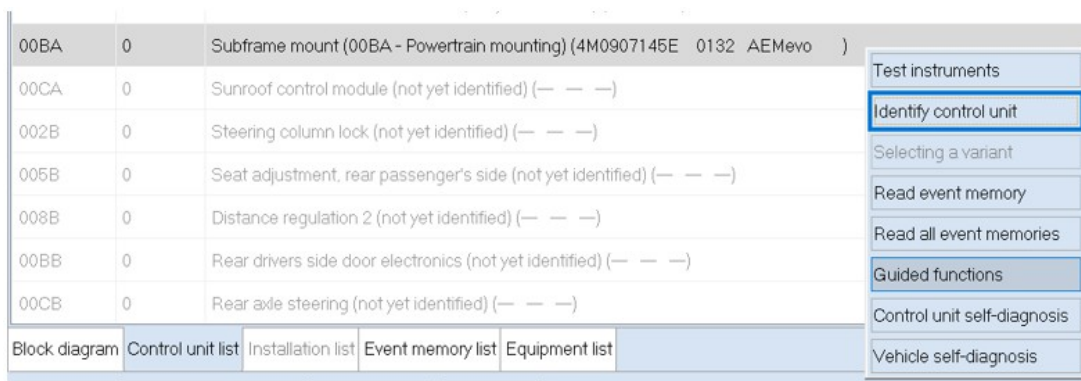
**Figure 1**

6. Right click and navigate to “Guided Functions.”

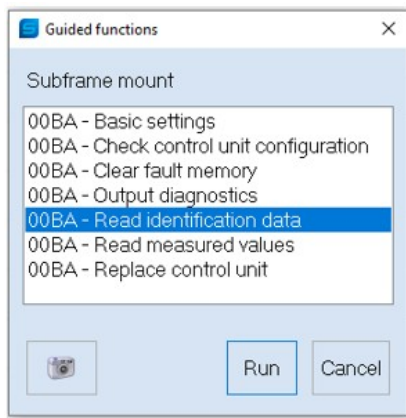
**Figure 2**

7. From the available functions, choose “Read Identification data.”

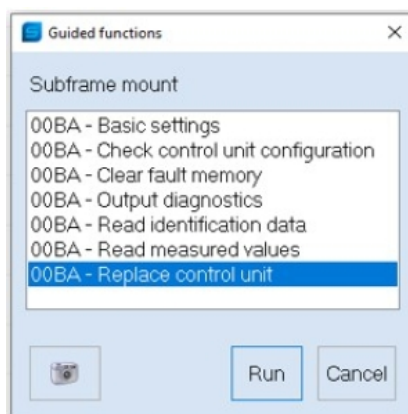
**Figure 3**

a. Navigate to Guided Functions > Replace Control Unit:

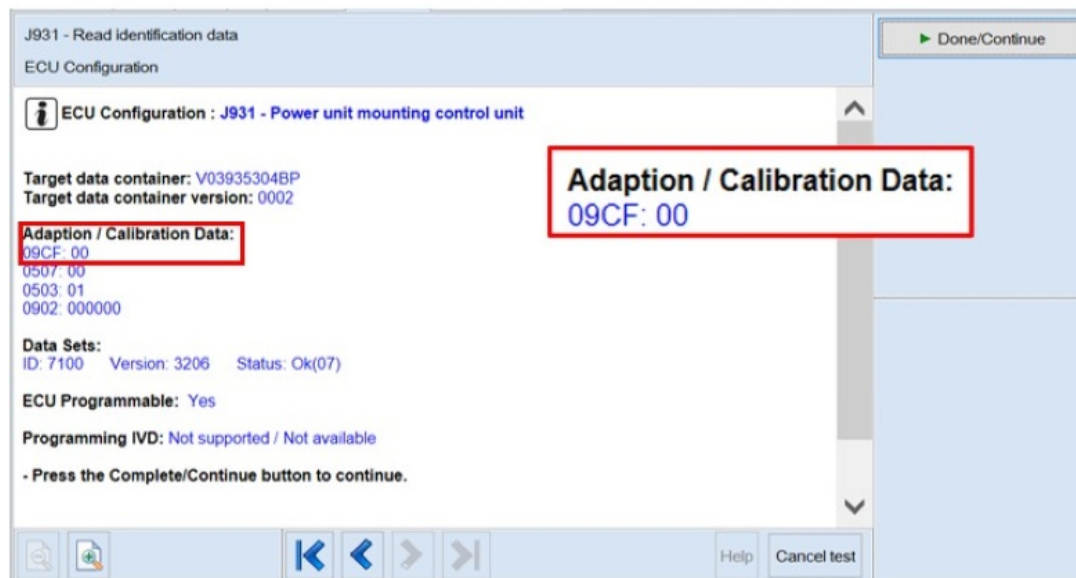
Figure 4

- Re-read control unit identification: TDC may still show same ID (this is acceptable).
- Check adaptation channel: 09CF must now be = 00 (previously 01).

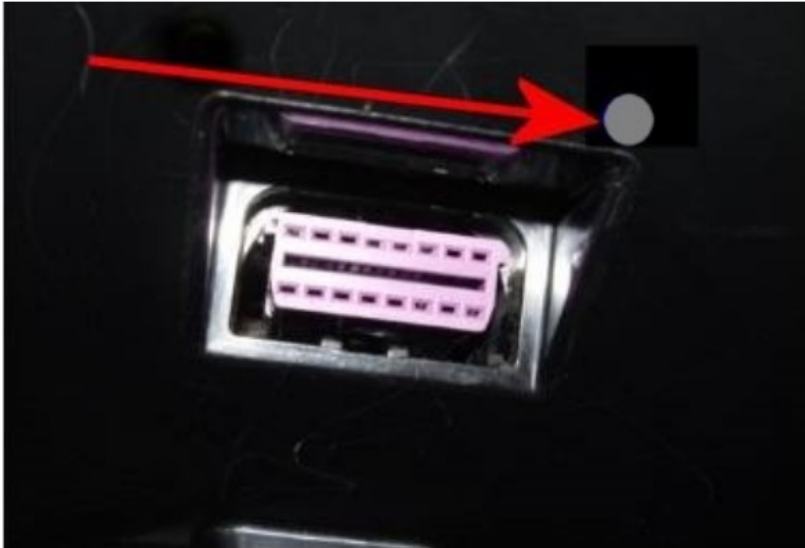
Figure 6

A silver campaign identification mark next to the OBD port confirms completion (Figure 6)
