# RCA-78-26-006-1: Reinforce or Replace Wheel Speed Sensor/Ride Height Sensor and Wheel Liner Harnesses

| Document Type | Customer Satisfaction Campaign Bulletin |
| Affected Model(s) | R2 |
| Rivian Reference Number | FSAM-1822 |

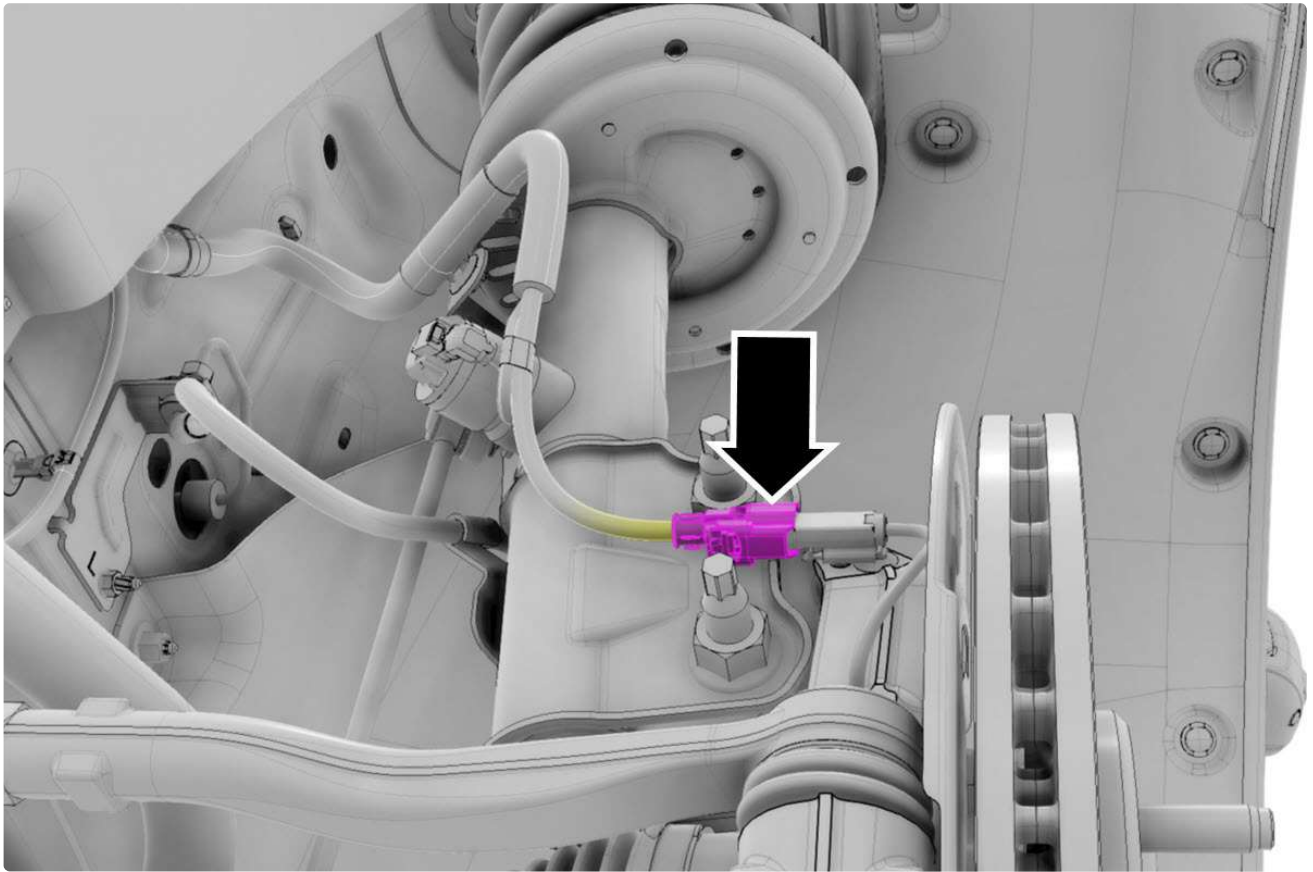
2. Working in the LH front wheelwell area:

**Note:**  
Front shown, rear similar.

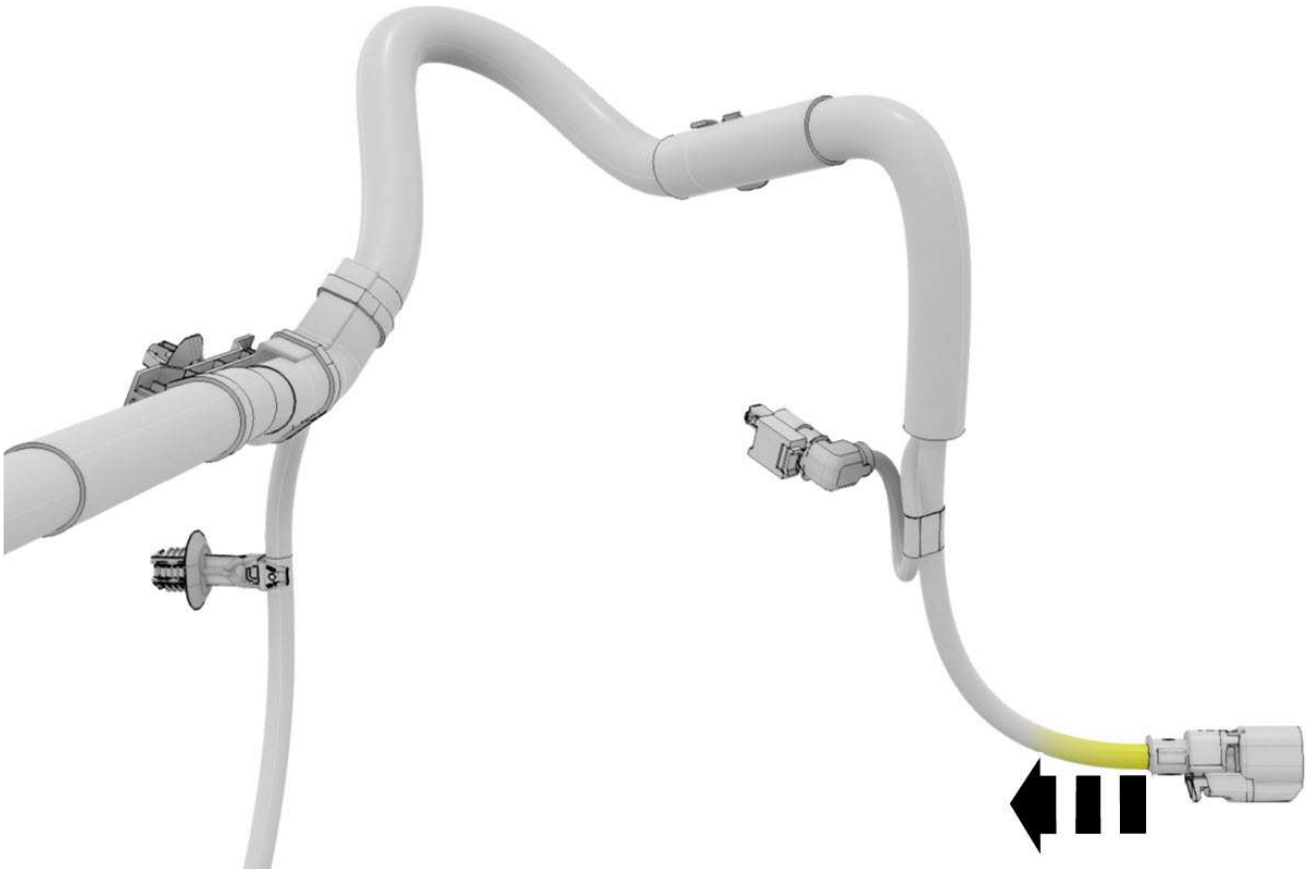
3. Pull in the highlighted areas.

- If the corrugated sleeve is loose:
  - Replace Harness, Wheel Speed Sensor/Ride Height Sensor, LH (refer to service manual procedure 787033510) or Harness, Wheel Liner, Rear, LH (refer to service manual procedure 787066010).
  - Skip to step [6](#).
- If the corrugated sleeve is not loose: Continue to the next step.
