| Topic | Rear Lid Latch Stud Inspection Continental GT 26MY (SC26/22) |
| Campaign number | EE02 |

Rear Lid Latch Stud Inspection | Continental GT | 26MY (SC26/22)

On affected vehicles, the rear lid latch stud mounting area may exhibit movement or damage within the rear lid structure. To ensure the continued integrity and durability of the rear lid latch assembly, an inspection of the latch stud mounting area must be carried out.

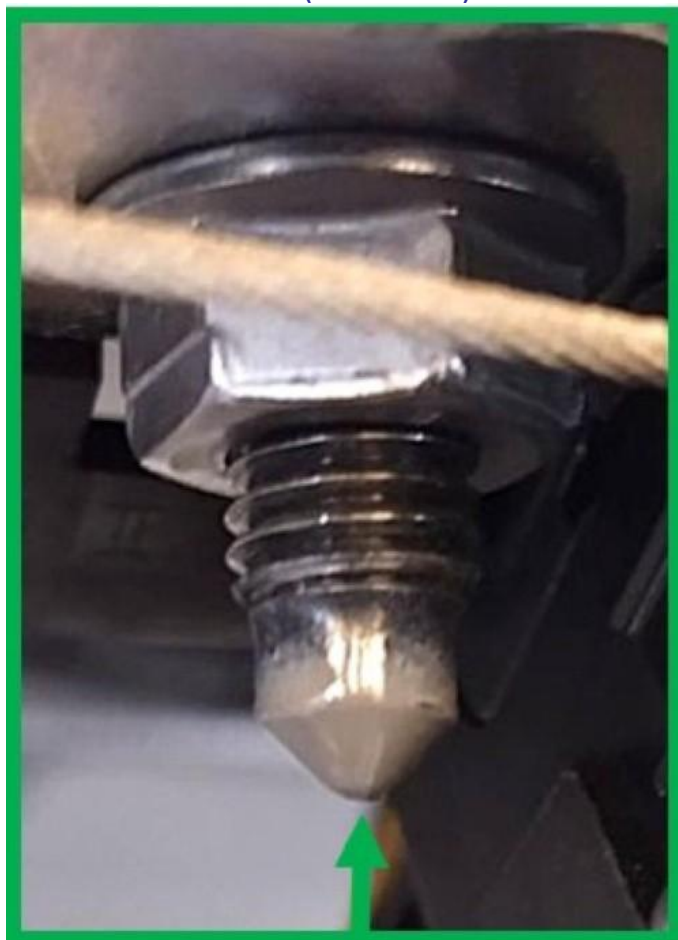
**Figure 1.** OK Stud Condition (Pointed End Stud)

#### OK– Pointed End Stud (Condition A)

If stud condition is OK, no further repair is required. Photograph the stud condition and upload the photograph to a non-technical DISS query. Reinstall all removed trim in accordance with ElsaPro. Apply the completion marks (See Identification section) and submit a Warranty claim via SAGA for a total of 60 Time units referencing condition A.

The original boot lid latch retaining nuts **MUST** be replaced. Tighten both new retaining nuts to 21 Nm.

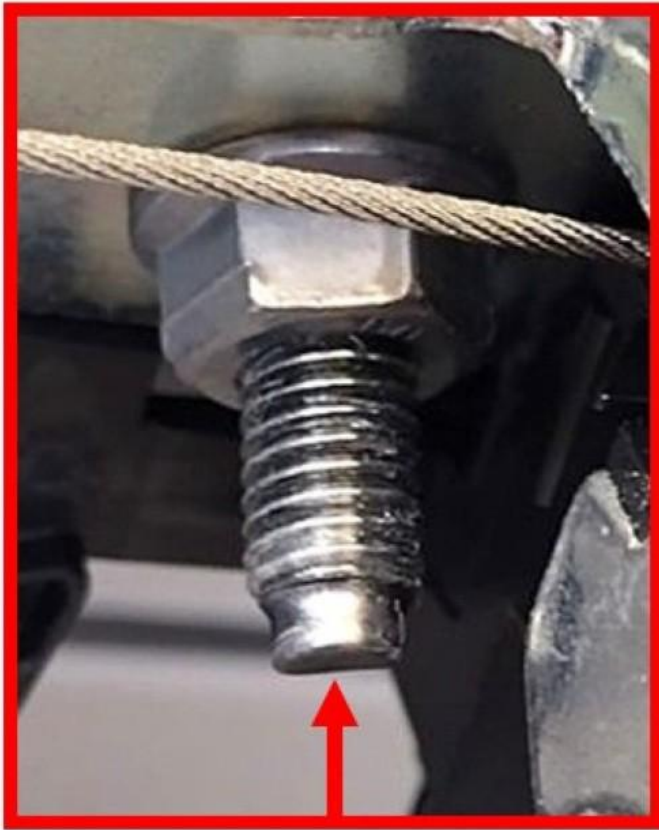
**Figure 2.** *Not OK (Flat End Stud)*

#### Not OK – Flat End Stud

**If one or both studs are identified as the flat end design as shown in figure 2, proceed to the onward instructions**

3. Remove the Rear lid central locking motor (V53) to expose the latch stud mounting area.

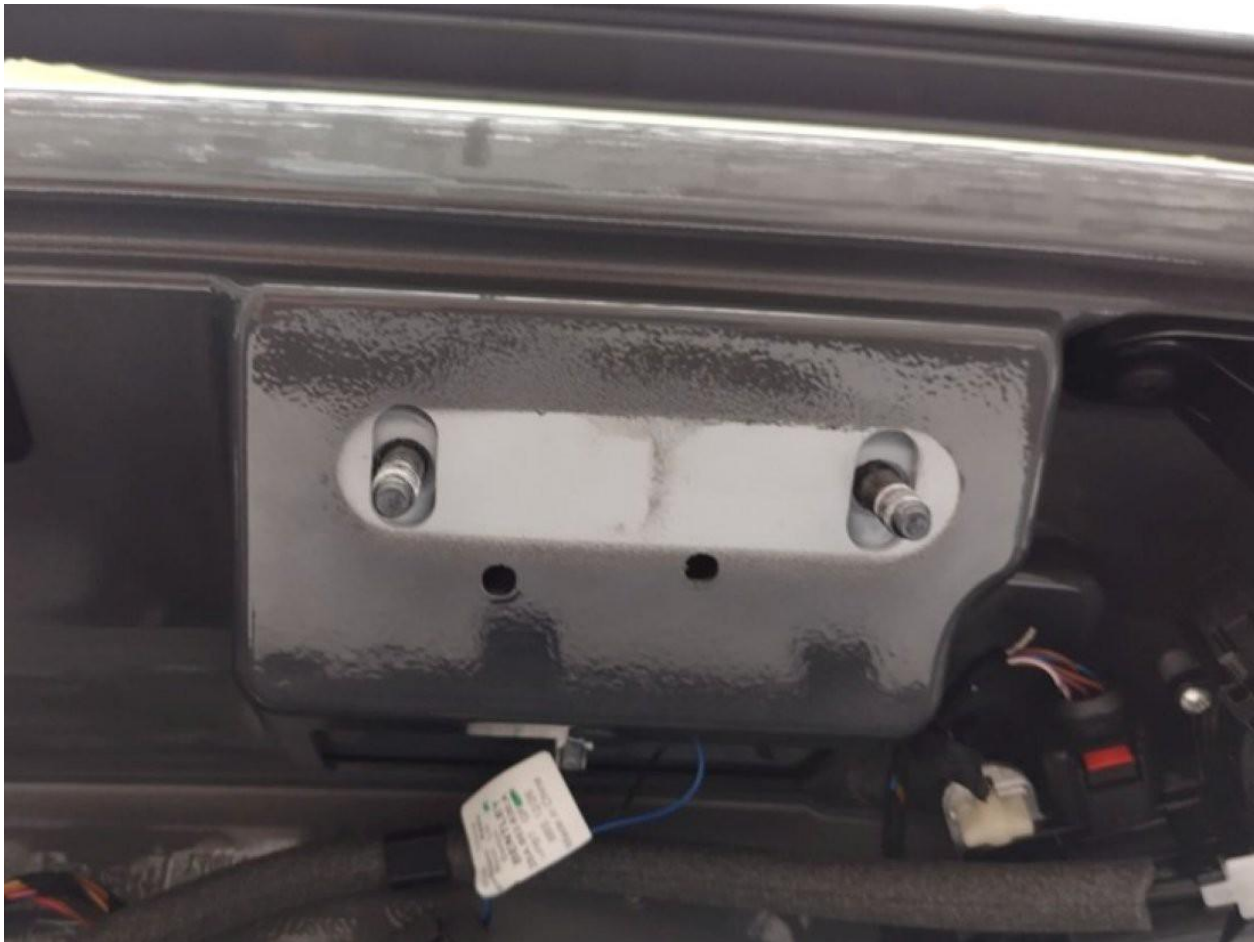
**Figure 3**

4. Inspect both latch studs and the surrounding reinforcement structure for any evidence of stud pull-through, detachment, cracking, movement, angle deviation, excess adhesive, or damage to the rear lid substrate.

5. If the stud remains structurally secure with no evidence of significant pull-through or structural damage  
Proceed to Section **Inspection Shim Assessment**

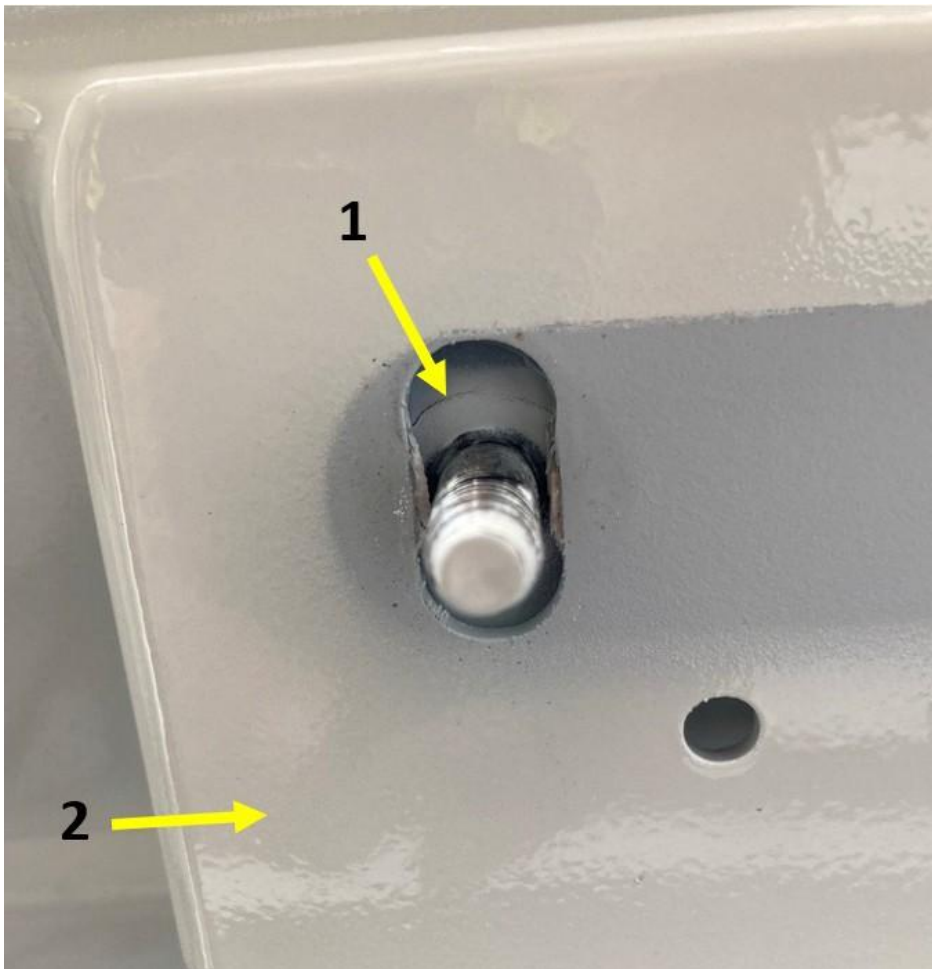
**Figure 4**

**Minor hairline cracks in the reinforcement plate -1- as shown in figure 4 are acceptable provided the stud remains correctly retained within the rear lid structure -2-.**

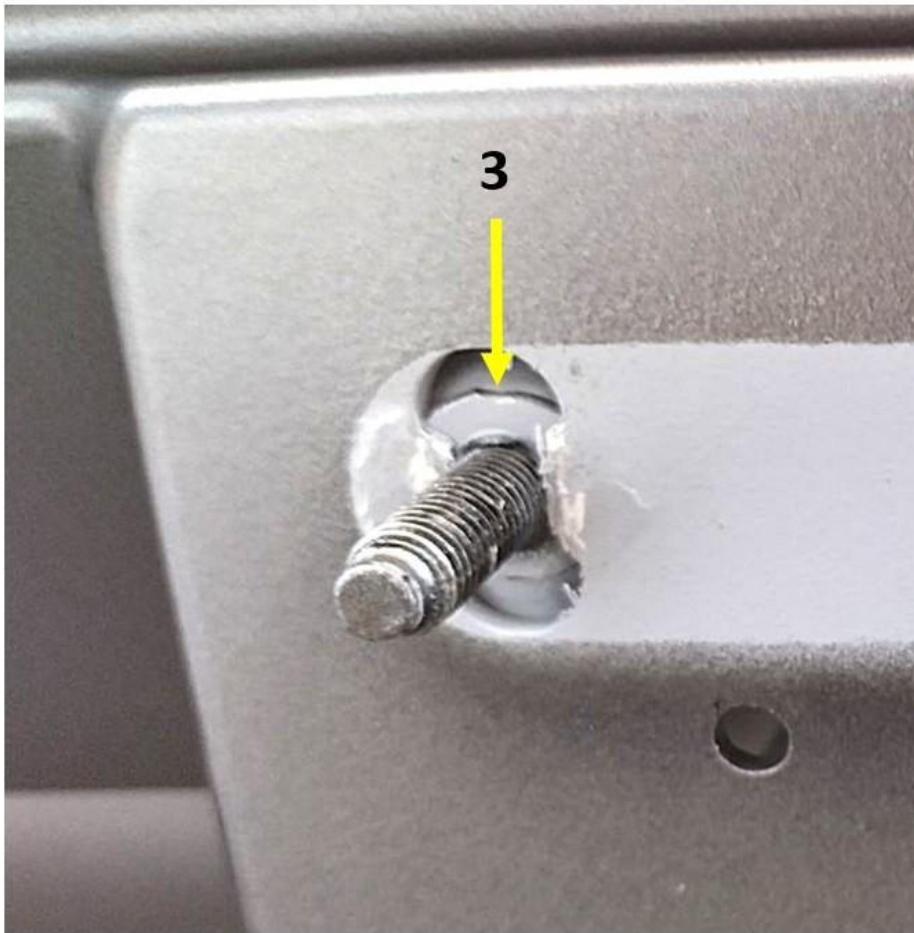
**Figure 5**

6. If the stud has pulled through the mounting structure -3- become detached or caused significant damage to the reinforcement plate or surrounding rear lid substrate as shown in figure 5, this condition is not suitable for a containment shim or resin filler repair.

**Do not apply resin filler or install a containment shim where significant structural damage is present as shown in figure 5.**

**Raise a full Technical DISS query with supporting photographic evidence and await further guidance before proceeding with any further work.**

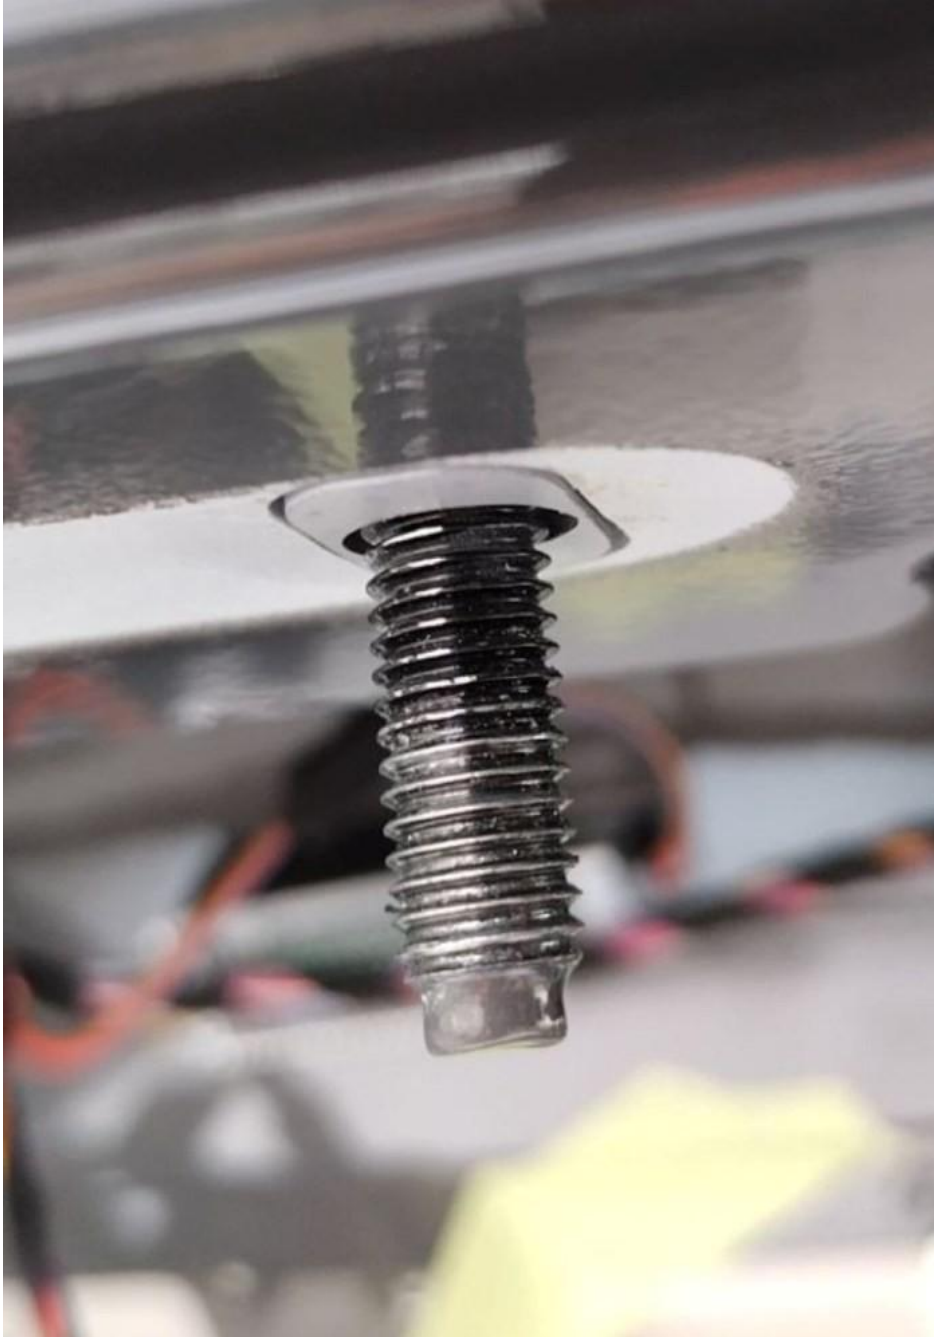
**Figure 7**

**Check whether the shim sits flush against the mounting surface as shown in Figure 7 and verify the shim does not rock or lift.**

If the Shim sits flat and no structural damage is present. Remove the inspection shim.

Apply **Loctite 454 adhesive** (source locally) to the mating face of the inspection shim.

Install the inspection shim into position around the stud as shown in figure 7.

Ensure the shim is fully seated and flush with the surrounding mounting surface.

Remove any excess adhesive and allow the adhesive to cure in accordance with the adhesive manufacturer's instructions.

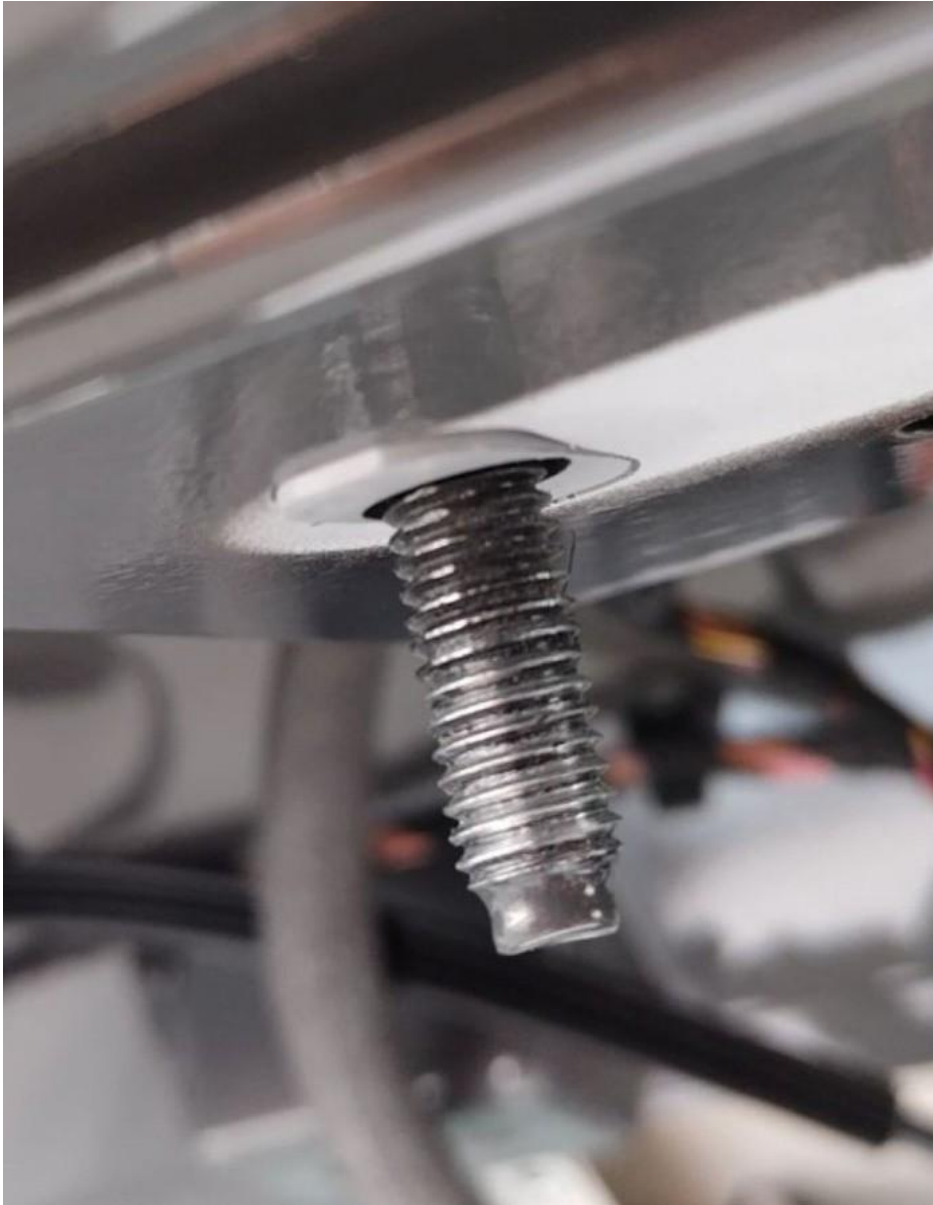
**Figure 8**

If the shim rocks or does not sit flush Carry out a structural assessment of reinforcement plate and studs.

- If no structural damage is present, as shown in Figure 4, proceed to Section: **Condition C - Resin Filler Repair.**
- If structural damage is identified, as shown in Figure 5, the vehicle should be classified as Condition D. Submit a comprehensive Technical DISS query and attach clear photographic evidence of the affected area. For rework instructions and further actions, await guidance from Product Support via DISS. **Refer to Condition D - Reinforcement Bracket Repair.**
