## Technical product information

| <b>Topic</b> | Engine Overheating - Warning in the DIP V8 Kovomo |
| <b>Brand</b> | Bentley |
| <b>Transaction No.</b> | 2061369/14 |

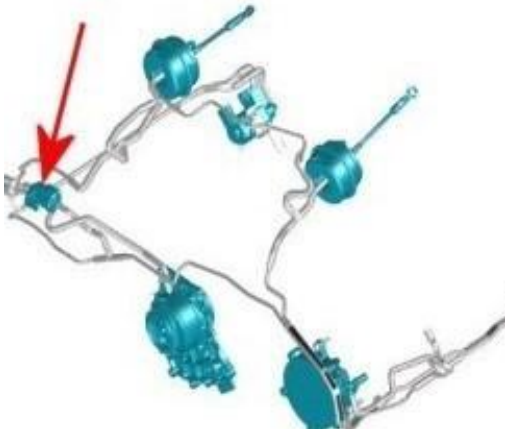
Figure 1

To allow the engine coolant to heat as quickly as possible (from cold start) coolant delivery from the mechanical coolant pump is interrupted by switch valve N649

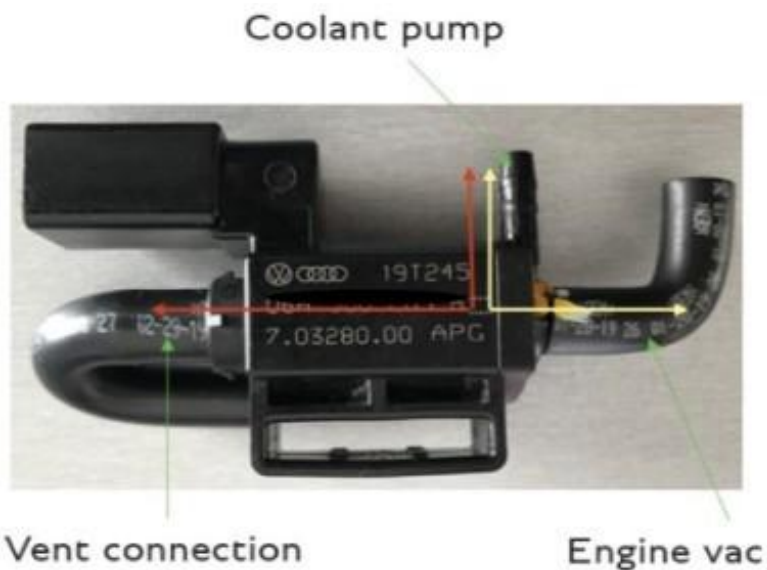
Figure 3

The correct operation of N649 (Figure 3) is as follows

Un-energised state (Ignition off) - Coolant pump connected to vent connection (red arrows)

Energised state (Ignition on) - Engine vacuum connection to coolant pump (yellow arrows)

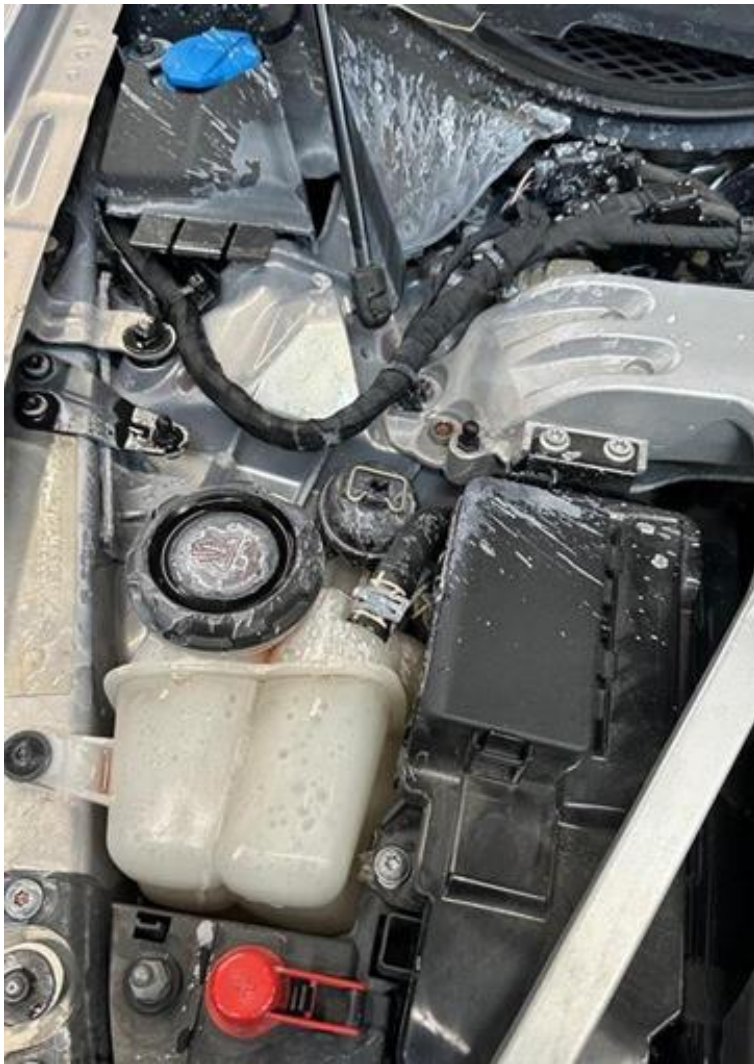
Figure 4

When inspecting the engine bay coolant residue can sometimes be seen around the reservoir when the engine has overheated (figure 4).

If this condition is found, the coolant may also be below the minimum level.

**If coolant residue is found in the engine bay, please raise a full technical DISS query and attach a photograph of the coolant residue. If the coolant level is below the minimum level please also attach photographic evidence of this.**
