| <br><b>MITSUBISHI<br/>MOTORS</b> | Mitsubishi Motors North America, Inc.<br><b>TECHNICAL SERVICE BULLETIN</b> | |
| SUBJECT:<br><br><b>Front Bumper Mislabeling Issue</b> | No: TSB-26-51-001 | Version: 1 |

MY 2025-26 Outlander / Outlander Plug-in Hybrid

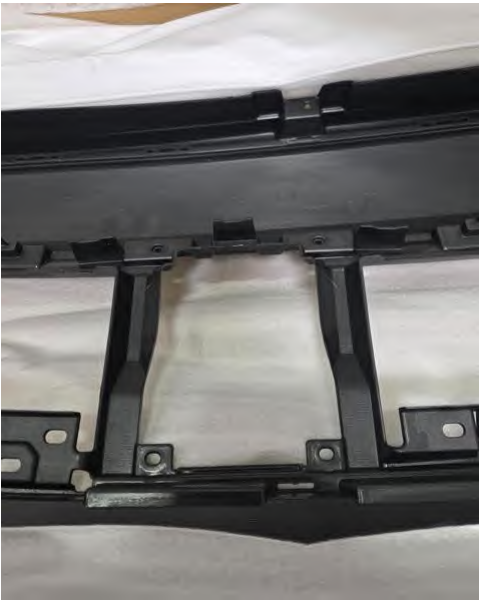
**Old design** (no FCM mounting holes) approved for 2025 MY ONLY. Do NOT install on a 2026 MY vehicle - there is no provision to secure the FCM module.

- Four mounting holes present → **NEW design** (Figure 2).
  - No mounting holes → **OLD design** (Figure 1).
3. **Check the variation of the replacement part.** Confirm the headlamp washer and/or parking sensor openings in the part match the vehicle's equipment identified in Step 2.
  4. **Do not rely only on the label.** If the physical part does not match the box label or catalog number, trust the physical inspection. Do not install a mismatched or old-design part on a 2026 MY vehicle. Set the part aside, notify the parts department, and reference Table A below for relabeling before it is returned to stock.

| <b>Picture 1 - OLD Design</b><br>No mounting holes on the inside of the vertical reinforcements. | <b>Picture 2 - NEW Design</b><br>Four (4) mounting holes on the inside of the vertical reinforcements (circled in red). |

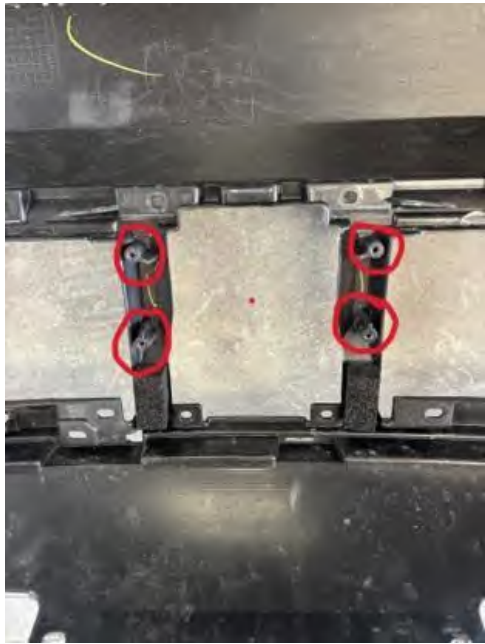
**New design** (four FCM mounting holes present) is approved for 2026 MY and 2025 MY vehicles. On 2025 MY vehicles the added holes are simply unused.

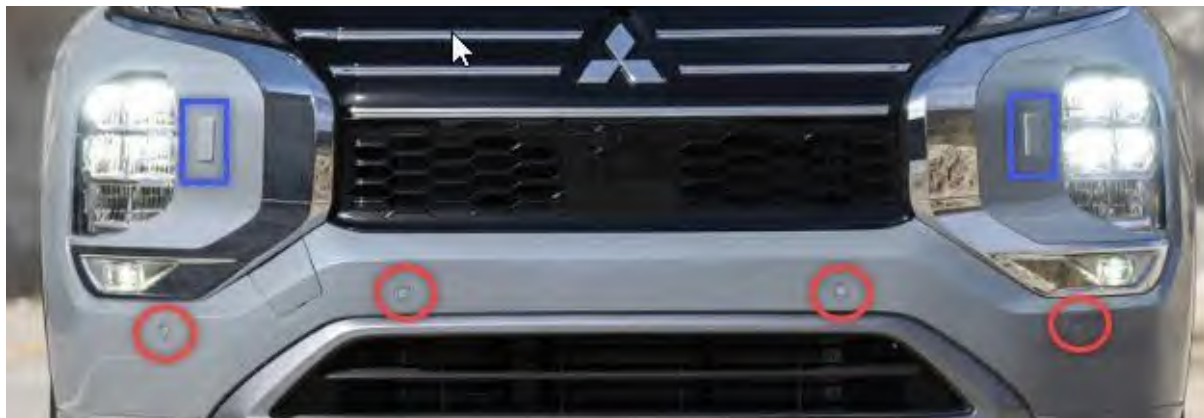
Match the openings in the part to the vehicle's equipment. In Figure 3, the **red circles** indicate front parking (assist) sensor holes and the **blue rectangles** indicate headlamp washer holes.

*Figure 3 - Front reference: parking assist holes (red) and headlamp washer holes (blue).*
