# Technical product information

| Topic | Service info: Paint Damage/Anomalies All Models |
| Transaction No. | 2078038/5 |

Service info: Paint Damage/Anomalies | All Models

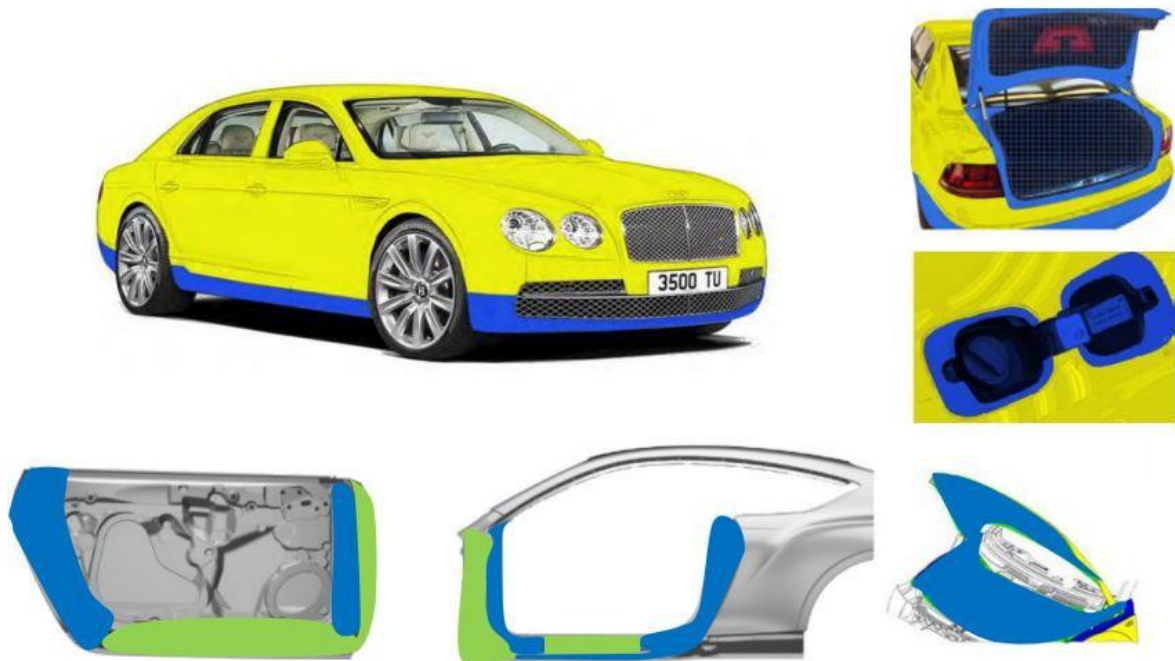
### Continental GT/GTC/Flying Spur

Zones to be considered:
