## Technical product information

| <b>Topic</b> | Windscreen replacement criteria whilst under manufacturers warranty |
| <b>Brand</b> | Bentley |
| <b>Transaction No.</b> | 2057841/5 |

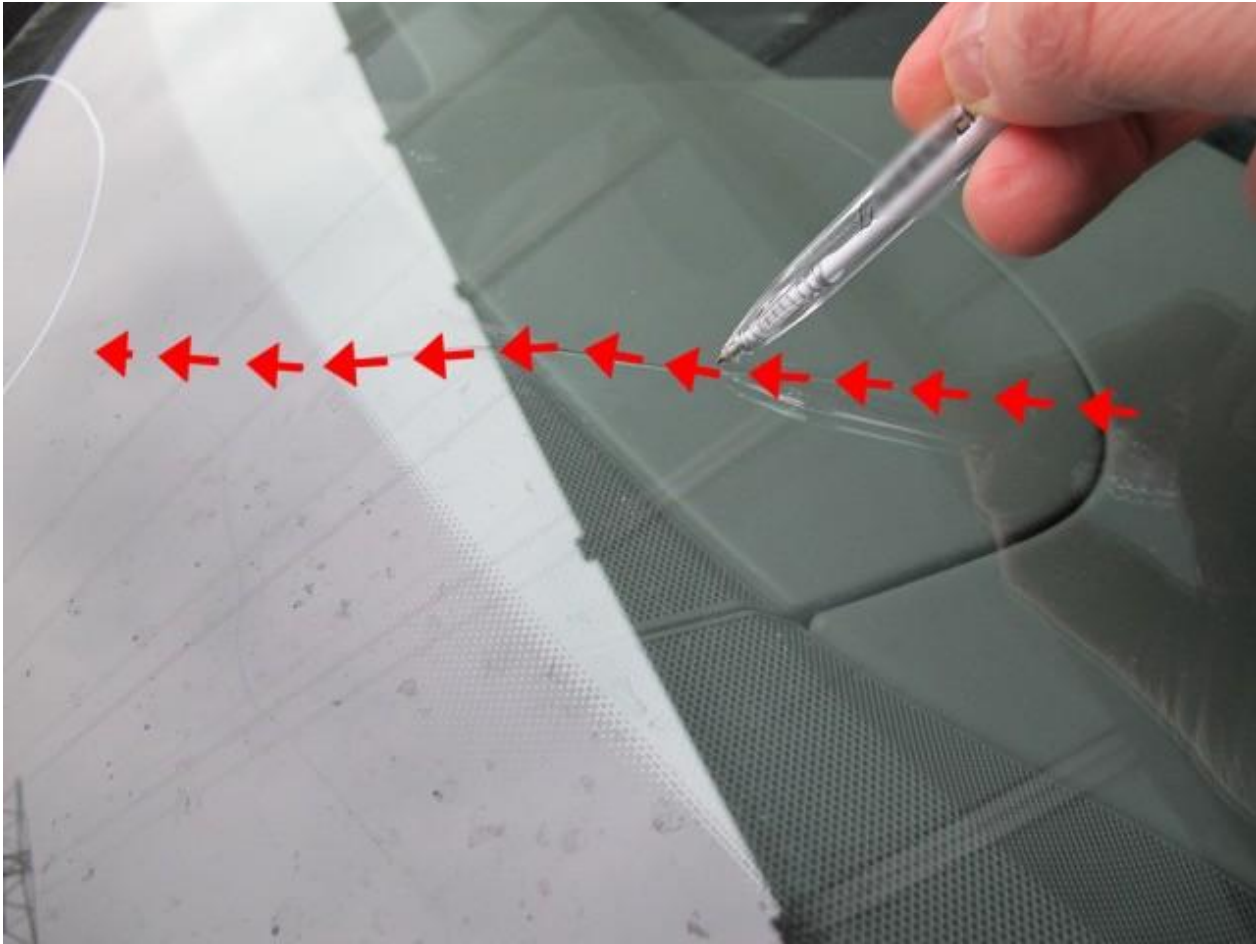
Figure 1

*TIP: A "pen test" can be used to determine if there is a stress crack evident, a ballpoint pen tip is run along the crack (Figure 1), in the event the tip of the pen dips at any point along the crack this MUST be classed as damage from external influences*

Should the pen not dip this can **possibly** be considered as a stress crack

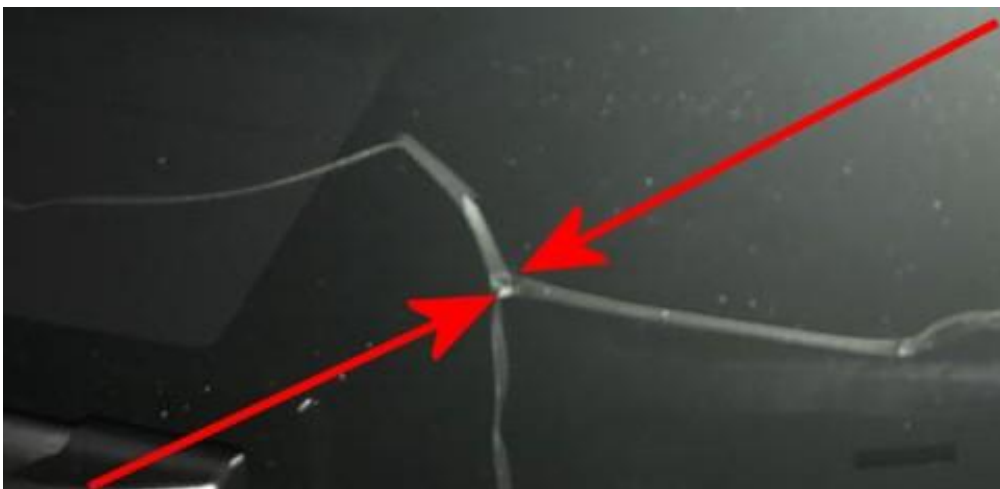
In the event that the windscreen has been identified as cracked/damaged through impact (See Figure 2 as an example), this would NOT be covered under the Bentley Motors Warranty policy, therefore the windscreen MUST be replaced, the cost of replacement would not be covered by Warranty

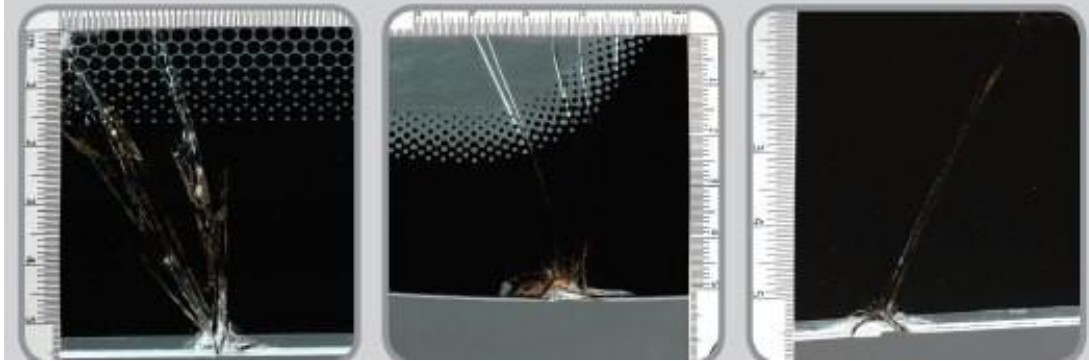
- Refer to the example shown in Figure 3 which details glass edge damage

Glass shelling / glass detached on glass edge. Depending on the force involved, there may be only a little, some or significant radial cracking of the glass from the edge damage, which may be difficult to see because of the black print on the glass.

Glass Edge.

Damaged during assembly to the vehicle. Impact to glass edge (exposed edges e.g. A-post, top of glass)

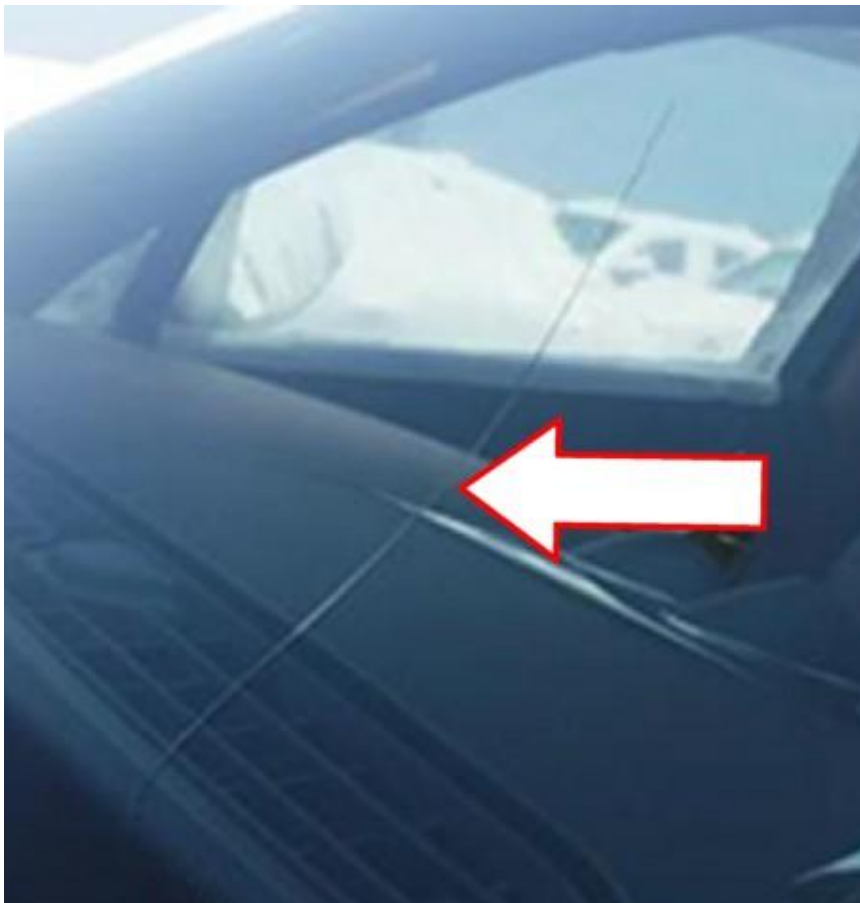
In the event the screen has been identified as cracked/damaged through a stress fracture (See Figure 4 as an example) and the vehicle is covered by manufacturers/extended warranty the retailer MUST carry out the following instructions

- Damaged windscreens MUST be reported as per the Mandatory DISS reporting policy
- A DISS query must be raised, the retailer MUST not carry out windscreen replacement or removal until permission has been granted through the open DISS query **NOTE: Product Support may request a Be. C.C call for further diagnosis.**
- The retailer must ensure that the following information is attached within the query:
- Clear photographs of the crack/damage
- Clear description of the location in which the crack/damage is emitting from for example: Right hand front corner
- Video to be attached to the DISS query clearly showing the tip of a ball point pen being run along the length of the suspected crack
- Clear photographs of the Glass ID number (See figure 5).
