# Abnormal noise from front seat cushion track

| YEAR(S) | MODEL(S) | ADDITIONAL INFORMATION |
|---|---|---|
| 2019 - 2024 | 4Runner | |

August 10, 2026 Rev1:

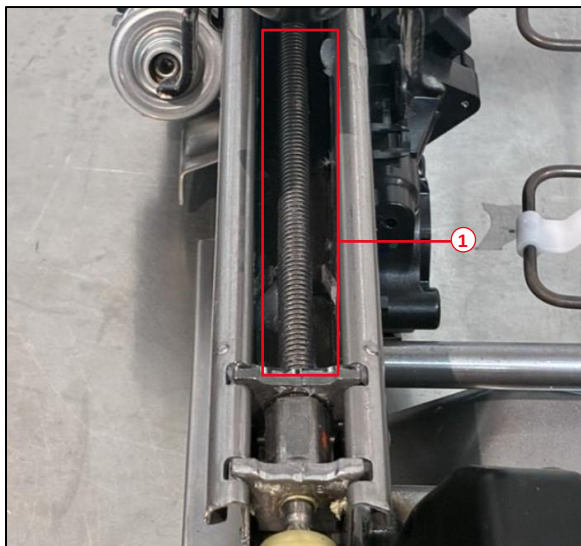
**Figure 2.**

| <b>1</b> | <b>Location to Add Grease</b> |

5. Apply grease to the border of the upper rail and rail screw shown in Figure 3.

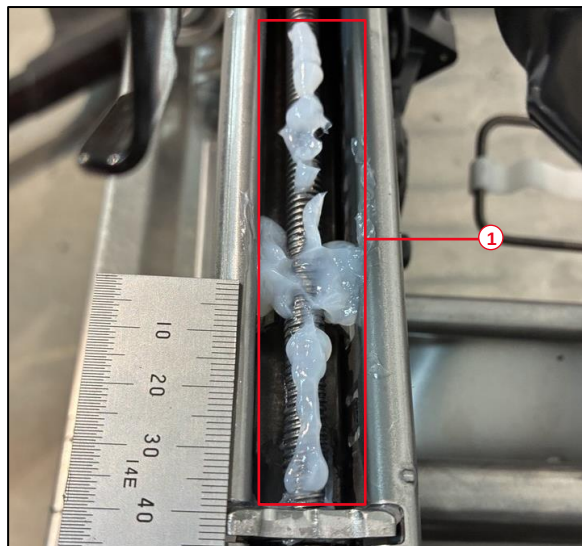
**Figure 3.**

| <b>1</b> | <b>Applied Grease</b> |
