# Vibration at Idle in Drive

**Service Category**   Engine/Hybrid System

| YEAR(S) | MODEL(S) | ADDITIONAL INFORMATION |
|---|---|---|
| 2024 - 2026 | GX550 | |

Some 2024 – 2026 model year GX 550 vehicles may exhibit a vibration at idle when in drive. The Engine Control Module (ECM) logic has been modified, in addition to improved exhaust hangers, to help improve this condition. Follow the Repair Procedure in this bulletin to address this condition.

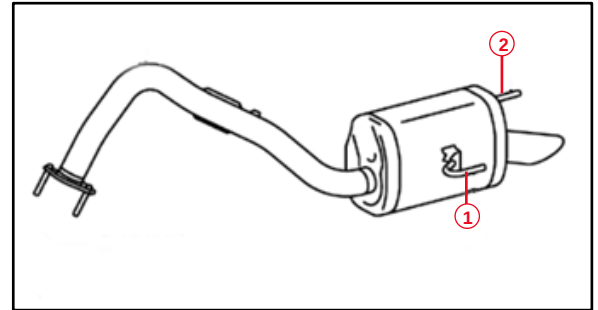
**Figure 1.**

| <b>1</b> | <b>Hanger 3</b> |
| <b>2</b> | <b>Hanger 4</b> |

4. Replace the exhaust supports on exhaust hangers three and four found in Figure 1.

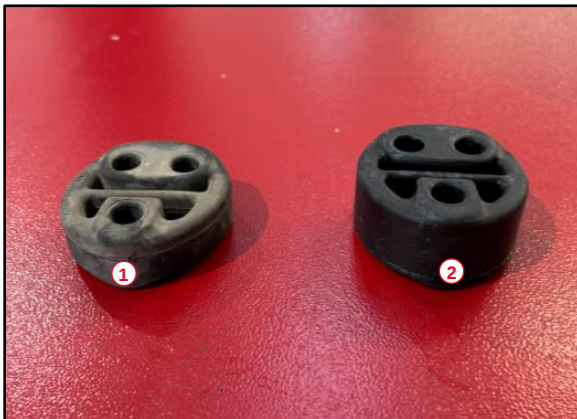
**Figure 2. Exhaust Support Hanger 3**

| <b>1</b> | <b>Original Exhaust Pipe Support (17565-74320)</b> |
| <b>2</b> | <b>Countermeasure Exhaust Pipe Support (17565-64180)</b> |

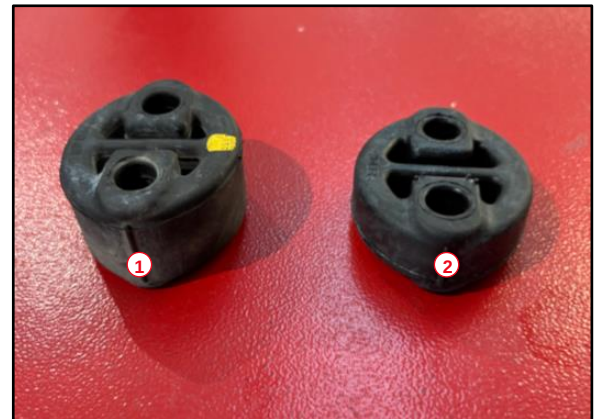
**Figure 3. Exhaust Support Hanger 4**

| <b>1</b> | <b>Original Exhaust Pipe Support (17565-22040)</b> |
| <b>2</b> | <b>Countermeasure Exhaust Pipe Support (17565-0P031)</b> |

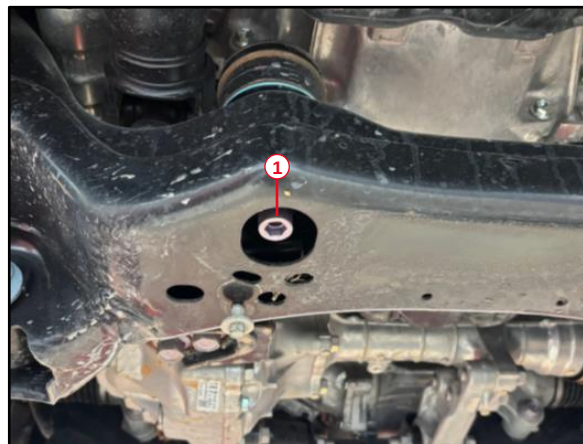
**Figure 4. Rear Mount**

| <b>1</b> | <b>Support Bolt</b> |

5. Loosen the front differential support points, as shown in Figure 4, Figure 5, and Figure 6.

6. Rotate/move the front differential to ensure proper settling, as shown in this [Example Video](#).
7. Re-torque differential support bolts using proper torque specifications found in Repair Manual.
  - [2024 – 2026](#) GX 550:  
*Drivetrain – Axle and Differential – Front Differential Carrier Assembly – Installation*
8. Confirm vibration at idle condition has improved.

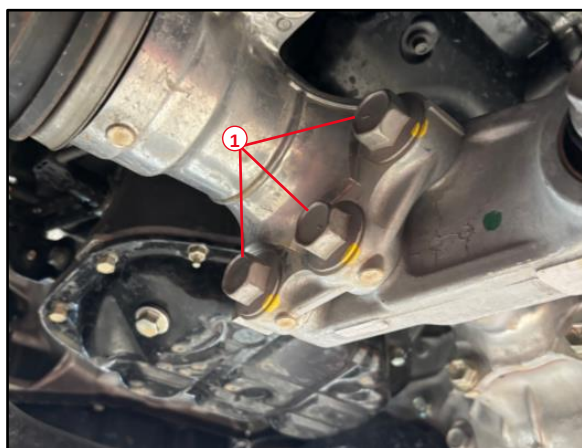
**Figure 5. Front Right-hand Mount**

| <b>1</b> | <b>Support Bolts</b> |

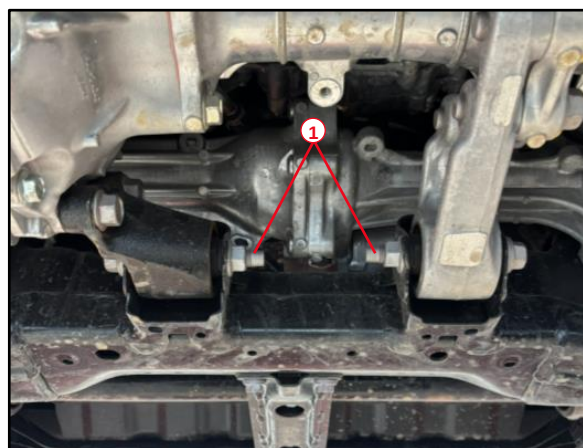
**Figure 6. Front Mount**

| <b>1</b> | <b>Support Bolts</b> |
