# HYUNDAI

## Technical Service Bulletin

| GROUP<br><b>CAMPAIGN</b> | NUMBER<br><b>26-01-071H</b> |

**SUBJECT:** HYBRID WARNING LIGHT ON – HPCU SOFTWARE UPDATE – DTC P0C381C (LIMITED COVERAGE CAMPAIGN LA39)

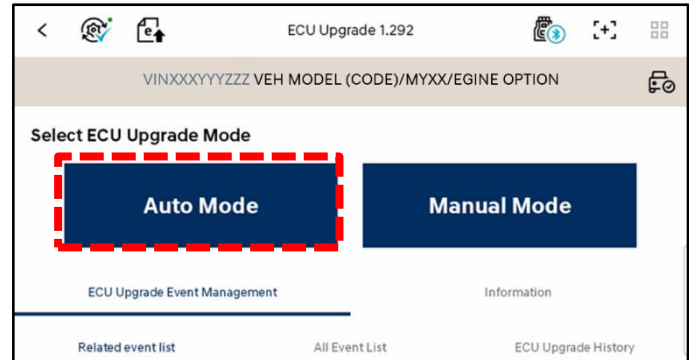
1. Perform the ECU update in **Auto Mode**.

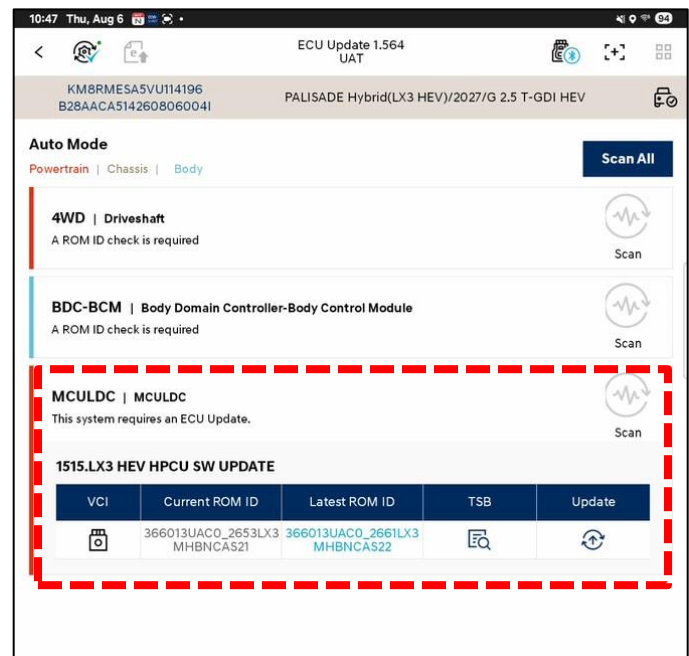
2. Verify the ROM ID by selecting the **MCULDC** system to scan the vehicle's current ROM ID.

Check the current ROM ID version and compare it to the ROM ID Information table before attempting to perform the software update.

If the update fails, remove the power connector from the in-cabin fuse box for at least **5 seconds**. Reassemble and retry the update.

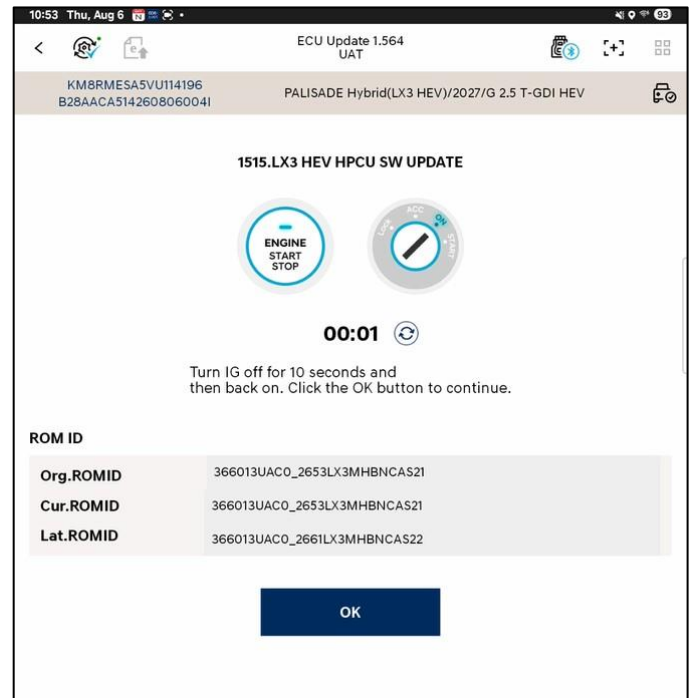
3. After the ECU update process shows 100% complete, follow the prompts on the screen to cycle the ignition **OFF** for at least **10 seconds** to reset the control unit.

Use the **Refresh** button to reset the timer.

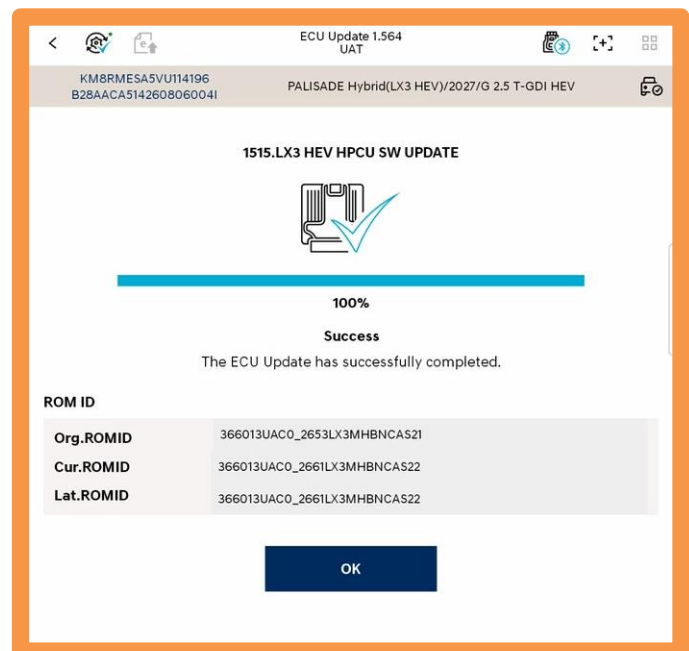
Using the tablet or GDS screen capture function, take a screenshot of the ECU Update "Success" result screen.

Upload the photo to STUI.

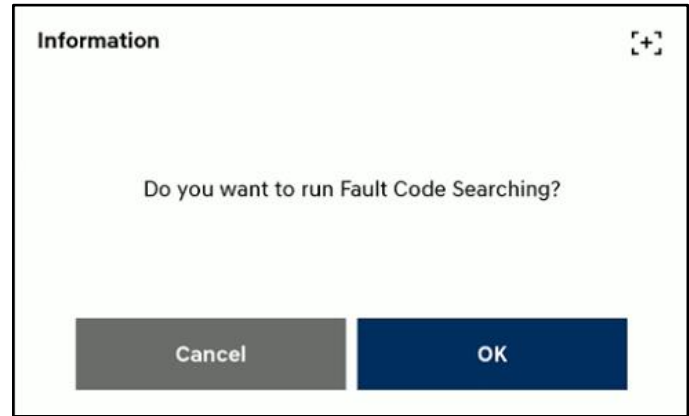
5. Perform an **All Systems Fault Code** search and erase DTC history that had incidentally occurred from the ECU update.

If some DTCs cannot be cleared, select **OBD-II** menu on the main GDS home screen to scan and clear the DTCs.
