GENERAL MOTORS  
DCS7572  
URGENT - DISTRIBUTE IMMEDIATELY

Subject: N262566020 - Service Update  
Water Intrusion Through Roof to Body Joint

Models: 2027 Chevrolet Bolt EV

### N262566020 Water Intrusion Through Roof to Body Joint

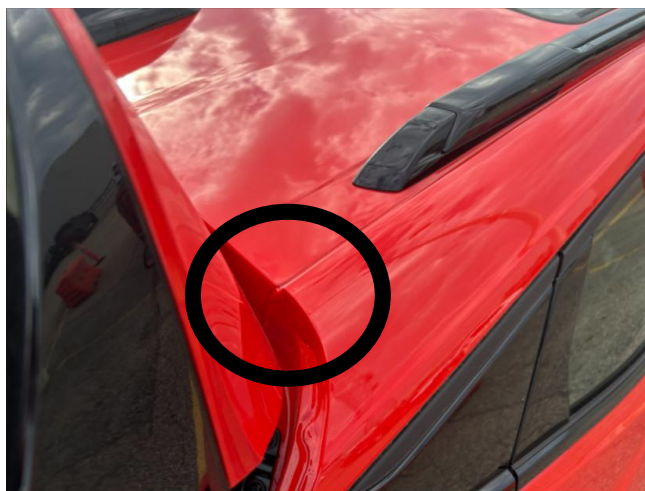
7214639

| <b>Condition</b> | Certain vehicles listed above may have a condition in which the roof to body side structure has a pinhole in it. |

2. Inspect the roof panel to quarter panel seam at the rear of the right side roof panel as indicated above.

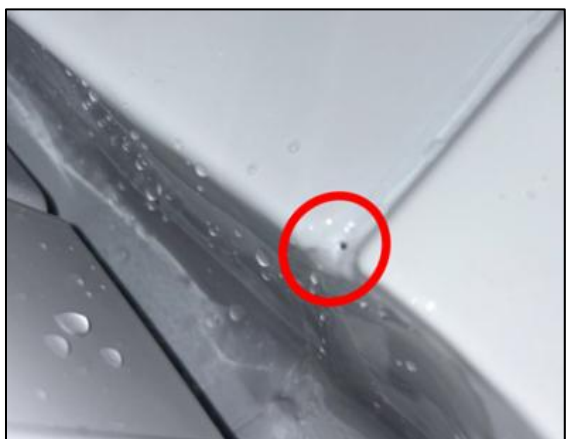
7214640

3. Inspect for a pinhole in the seam as shown above. If no pinhole is found, no further action is required.
4. If a pinhole is found, thoroughly clean the surrounding area. Blow out the pinhole and surrounding area with compressed air.
5. Apply CLEAR Kent High-Tech Seam Sealer or equivalent into and around the pinhole. Using an acid/flux brush or equivalent tool, brush sealer into the pinhole and surrounding seam ensuring it covers the entire area leaving no gaps or holes. Work the sealer into the pinhole. Ensure no sealer remains on the flat visible surfaces of the roof panel or quarter panel.
6. Allow the CLEAR Kent High-Tech Seam Sealer or equivalent to dry, and verify no gaps or holes are present, and that the pinhole is filled.

| <b>Correction</b> | Dealers are to inspect the right hand side of the roof-to-body joint for pinholes and, if necessary, reseal the area. |
