# Service Bulletin

Bulletin No.: PIT5801F

**Subject: Diagnostic Tip / Vehicle Sits Unlevel / Leans / Sags / Leveling Unavailable Message / Speed Limited Message / Service Air Suspension Message / DTC C1190 C1191 C1192 C1193 C1187 C1188 C1189 C118A C118B C118C C118E C118F**

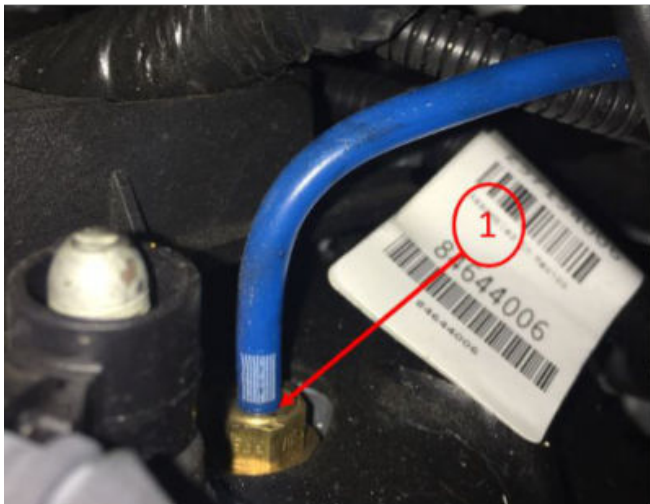
The air line must be inserted into the air fitting until it bottoms out AND the white marks are going into the top of the fitting. Below is a picture of an air line, at one of the air springs, which is NOT fully inserted (1). In this case, it is evident that the white markings are not actually going into the fitting. The second photo below shows the air line after it was fully inserted (2). You can see the white marks are now down into the top of the air line fitting (2) and the air line is bottomed out in the fitting.

**Note:** It is recommended to push the line into the fitting as far as it will go. At least part of the white marking MUST be into the top of the fitting. Remember, when inserting an air line into an air spring fitting, just because the white marks are in the fitting, does NOT always mean that the line is fully inserted and pushing the one way check valve open.

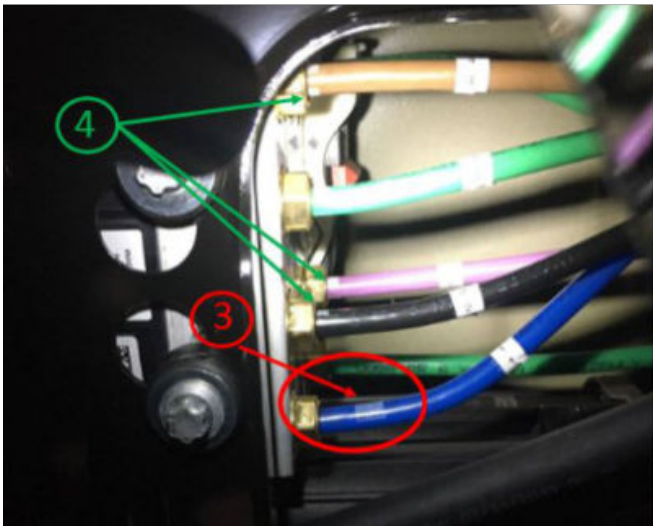
5675484

For additional examples, see the third photo below. This is a picture of the air lines at the air controller. In this example, there are several fully seated lines as shown in call out 4. Each of these lines is fully seated as indicated by the fact that the white lines are partially covered by the air line fitting itself. Call out 3 is an example of a line that is not fully seated. In call out 3 you can see the white marking is not into the air line fitting as it should be.

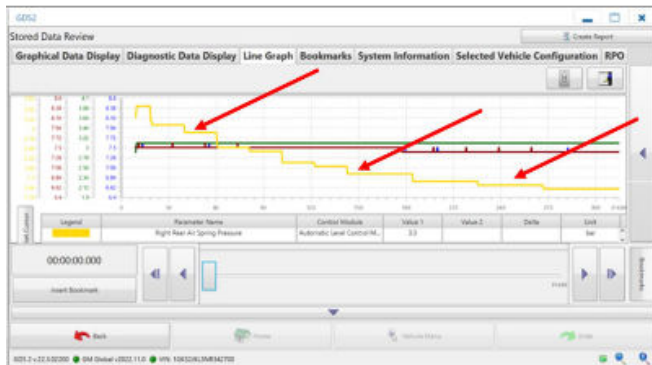
6374061

- Use GDS2 and go into Module Diagnostics> K5 Auto Level Control Module>Data Display>Pressure Data and view the pressure data for at least 5 minutes. During that 5 minutes GDS2 is polling each air spring and the reservoir tank for it's pressure reading. If an air line is not fully inserted into one of the air spring fittings, you will notice the air pressure for that corner will be slowly decreasing (yellow graph line, shown below) while the pressure for the other corners is holding steady.

- If the air pressure is slowly decreasing for a particular corner, as shown below, then suspect the air line at the air spring is not fully inserted. In some cases, if the air spring is full of air and under high pressure, it can be very difficult to push the air line into the air fitting. This is because the one way check valve is being pushed closed by the high pressure air inside the air spring. In these cases, try lifting the vehicle by the frame so the suspension is fully extended. Then while using extreme care, push the air line into the fitting with a suitable tool. If the air line gets kinked, pinched, or damaged, it will need to be replaced.
