## Technical Service Bulletin (TSB)

### Engine Overheat

| REFERENCE: | TSB: 07-006-26 REV. A<br>GROUP: 07 - Cooling | Date: | September 1, 2026 | REVISION: | 07-006-26 |
| VEHICLES AFFECTED: | 2026 - 2027 (DJ) RAM 2500 Pickup<br>2026 - 2027 (D2) 3500 Pickup<br>2026 - 2027 (DD) RAM 3500 Cab Chassis<br>2026 - 2027 (DP) RAM 4500/5500 Cab Chassis<br>This bulletin applies to vehicles built on or after **February 21, 2026 (MDH 0221XX) and on or before July 22, 2026 (MDH 0722XX)** equipped with 6.4L V8 Hemi Upgrade HD Engine (Sales Code ESL). | | | MARKET APPLICABILITY:<br><div><input checked="" type="checkbox"/> NA<input checked="" type="checkbox"/> MEA</div> <div><input type="checkbox"/> EE<input type="checkbox"/> IAP</div> <div><input checked="" type="checkbox"/> SA<input type="checkbox"/> CH</div><br>NOTE: This bulletin applies to the North America, South America and Middle East & Africa markets. | |

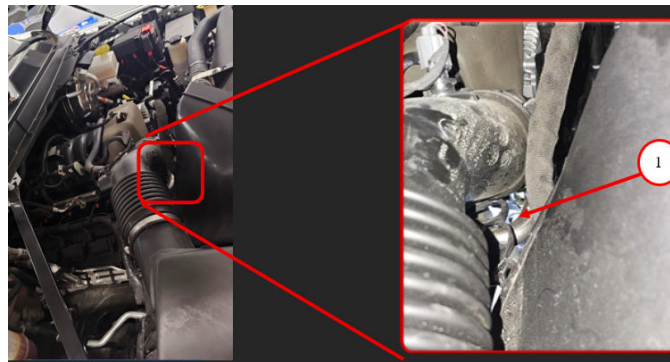
**Fig. 1**  
Thermostat Part Number Location

1. \*\*Check the thermostat date code using a borescope and take a picture of the date code [Fig. 1](#), [Fig. 2](#).

2. Does the thermostat have a date code of **3375** or **3365**?
  - YES>>> Proceed to [Step 3](#).
  - NO>>> This bulletin has been completed. Use Inspection LOP (07-40-01-95) to close the active RSU.
3. Replace the thermostat. Refer to the detailed service procedures available in DealerCONNECT/Service Library under: Service Info> 09 - Engine, 6.4L / Engine Cooling / Thermostat / Removal and Installation.\*\*
