## Technical Service Bulletin (TSB) Wrong Instrument Panel Cluster (IPC) Configuration

| REFERENCE: | TSB: 08-328-26<br>GROUP: 08 - Electrical | Date: | September 3, 2026 | REVISION: | — |
| VEHICLES AFFECTED: | 2026 (DT) RAM 1500 Pickup<br>This bulletin applies to vehicles built on or after September 24, 2025 (MDH 0924XX) and on or before September 25, 2025 (MDH 0925XX) equipped with a Cluster 7.0" TFT Color Display (Sales Code JAL) or a Cluster 3.5" TFT Color Display (Sales Code JAK). | | | MARKET APPLICABILITY:<br><div><input checked="" type="checkbox"/> NA<input type="checkbox"/> MEA</div> <div><input type="checkbox"/> SA<input type="checkbox"/> IAP</div> <div><input type="checkbox"/> EE<input type="checkbox"/> CH</div><br><b>NOTE:</b> This bulletin applies to North America markets. | |

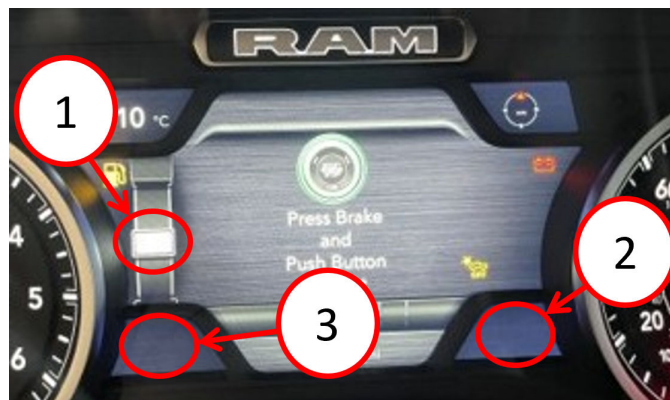
**Fig. 1**  
Missing/Blank IPC Information

| CUSTOMER SYMPTOM: | Customers may comment on one or more the following: <ul style="list-style-type: none"><li>Oil pressure gauge and battery life gauges are blank or missing from the IPC <a href="#">Fig. 1</a>.</li><li>The Trailer Brake radial slider movement will not move past one bar and is inaccurate <a href="#">Fig. 2</a>.</li></ul> <b>NOTE:</b> The Trailer Brake percentage does display correctly. | | | | |
| CAUSE: | IPC configuration | | | | |

- 1 - Missing IPC Cluster Screen Option Selections
- 2 - Missing Oil Temperature Gauge
- 3 - Missing Battery Gauge

This bulletin involves performing a reconfigure and Proxi alignment on the IPC.

1. Using wiTECH, perform a Restore Vehicle Configuration by navigating to the Guided Diagnostics tab on the left hand menu, selecting Restore Vehicle Configuration, and then following the on-screen prompts.
2. Cycle the ignition Off, then to the Run position (**do not crank the engine**) and leave the ignition in the Run position for a minimum of 60 seconds.
3. Cycle the ignition to the to the Off position.
4. Cycle the ignition from Off then to the Run position (**do not crank the engine**).
5. Clear DTCs.
6. Perform a PROXI Configuration Alignment under the Guided Diagnostics menu.
7. Clear all DTCs.
