**Technical Service Bulletin (TSB)**  
**Wrong Instrument Panel Cluster (IPC) Configuration**

| REFERENCE: | TSB: 08-328-26 REV. A<br>GROUP: 08 - Electrical | Date: | September 5, 2026 | REVISION: | 08-328-26 |
| VEHICLES AFFECTED: | 2026 (DT) RAM 1500 Pickup<br>This bulletin applies to vehicles built on or after September 24, 2025 (MDH 0924XX) and on or before September 25, 2025 (MDH 0925XX) equipped with a Cluster 7.0" TFT Color Display (Sales Code JAL) or a Cluster 3.5" TFT Color Display (Sales Code JAK). | | | MARKET APPLICABILITY:<br><div><input checked="" type="checkbox"/> NA<input type="checkbox"/> MEA<br/><input type="checkbox"/> SA<input type="checkbox"/> IAP<br/><input type="checkbox"/> EE<input type="checkbox"/> CH</div><br>NOTE: This bulletin applies to North America markets. | |

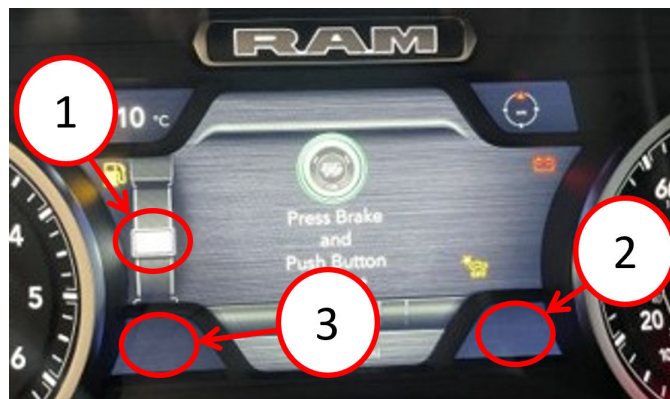
| CUSTOMER SYMPTOM: | Customers may comment on one or more the following: <ul style="list-style-type: none"><li>Oil pressure gauge and battery life gauges are blank or missing from the IPC <a href="#">Fig. 1</a>.</li><li>The Trailer Brake radial slider movement will not move past one bar and is inaccurate <a href="#">Fig. 2</a>.</li></ul><br>NOTE: The Trailer Brake percentage does display correctly. | | | | |
| CAUSE: | IPC configuration | | | | |

**Fig. 1**  
Missing/Blank IPC Information

- 1 - Missing IPC Cluster Screen Option Selections
- 2 - Missing Oil Temperature Gauge
- 3 - Missing Battery Gauge

This bulletin involves performing a reconfigure and PROXI alignment on the IPC.

1. Using wiTECH, perform a Restore Vehicle Configuration by navigating to the Guided Diagnostics tab on the left hand menu, selecting Restore Vehicle Configuration, and then following the on-screen prompts.
2. Cycle the ignition Off, then to the Run position (**do not crank the engine**) and leave the ignition in the Run position for a minimum of 60 seconds.
3. Cycle the ignition to the to the Off position.
4. Cycle the ignition from Off then to the Run position (**do not crank the engine**).
5. Clear DTCs.
6. Perform a PROXI Configuration Alignment under the Guided Diagnostics menu.
7. Clear all DTCs.

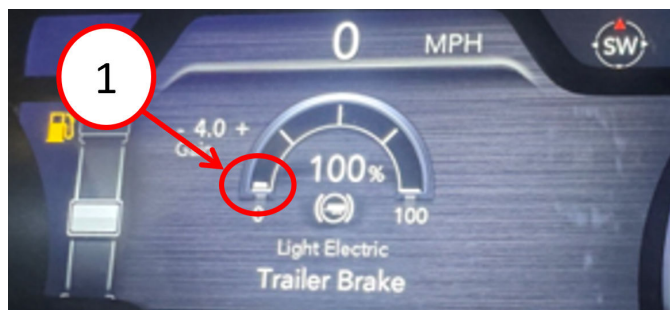
**Fig. 2**  
Trailer Brake IPC Gauge

1 - Trailer Brake Radial Slider Will Not Move Further Than This (Percentage Is Displaying Correctly)
