# Service Bulletin

Bulletin No.: PIC6629F

**Subject: Display Diagnostic Tips and Procedures**

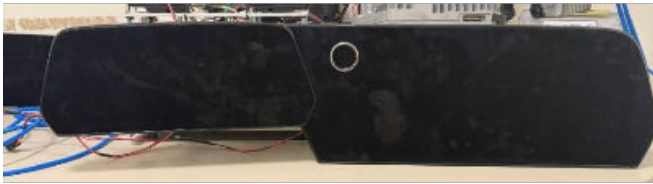
Examples of whole or both displays are blank or black

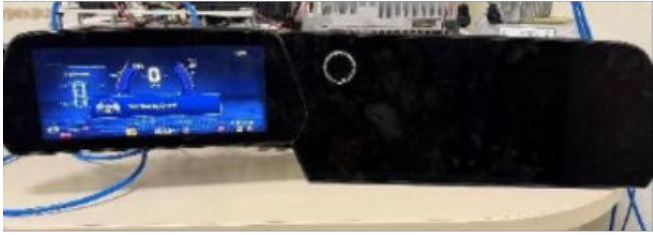
7019596

Below are examples of one, or portion of the display is blank
