GENERAL MOTORS  
DCS7590  
URGENT - DISTRIBUTE IMMEDIATELY

Subject: UPDATE: N262570770-02 – Service Update  
Radiator Thermal Break Tabs  
Updated Warranty Information and Service Procedure

Models: 2023 – 2025 Cadillac XT5  
2023 – 2025 Cadillac XT6  
2024 – 2025 Chevrolet Blazer

## N262570770 Radiator Thermal Break Tabs

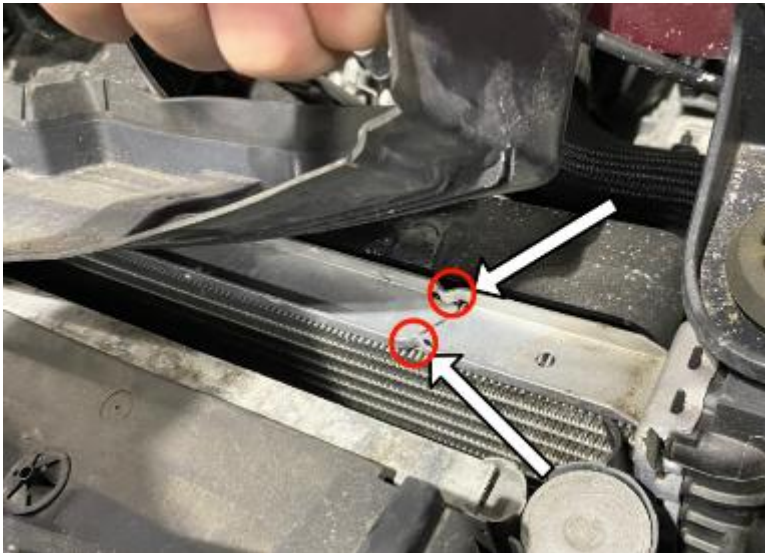
7213566

| <b>Condition</b> | Certain vehicles listed above may have a condition in which the thermal break tabs induce stress into the radiator causing a coolant leak. |

8. Carefully pull back the sides of the Radiator Air Upper Baffle and cut the thermal break tabs (4 in total) on both the left and right hand sides of the radiator with side cutters.
9. Reassemble in the opposite order of disassembly.
