## Technical Service Bulletin

**GROUP****CAMPAIGN****NUMBER****26-01-076G****DATE****SEPTEMBER 2026****MODEL(S)****GV60 (JW1 EV)****SUBJECT:**

INOPERATIVE FRONT SENSOR – ADAS PRK SOFTWARE UPDATE  
– DTC C137496 (LIMITED COVERAGE CAMPAIGN L10G)

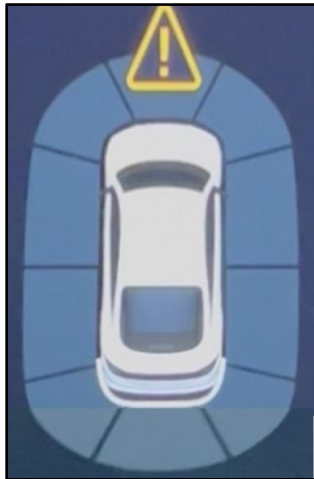
**Description:** Certain GV60 (JW1 EV) vehicles may display a warning message and store DTC C137496 due to an internal software logic error affecting the front inner left ultrasonic sensor. This condition may result in the sensor being recognized as inoperative. This bulletin provides the procedure to update the Advanced Driver Assistance System Parking (ADAS PRK) control module software to address this condition.
