SIB 01 08 26

## F33 F83 LOWER REAR SIDE PANEL WATER DRAIN REPAIRS EXTENDED COVERAGE 15/150 2026-09-03

This Service Information Bulletin (Revision 00) replaces SI B51 33 16 **dated June 2021**

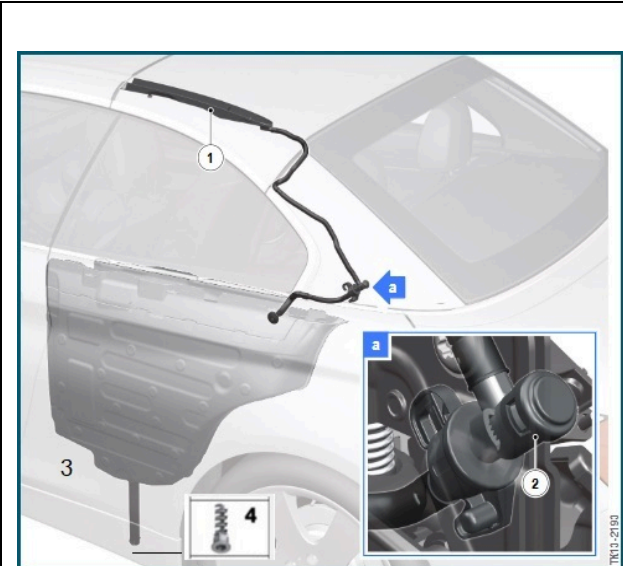
Specific to the F33 F83 convertible vehicle models with the retractable hardtop on both sides, accumulated water is collected by roof ducts (item #1), the shut-off valve (item #2) is open when the top is closed. The shut-off valves’ hoses/pipes system channels this water into the drain assemblies located in the mid to upper sections of rear side panels.

When the retractable hardtop is open, the shut-off valves close to help prevent any water, still in the roof duct systems, from flowing into the trunk/luggage compartment area.

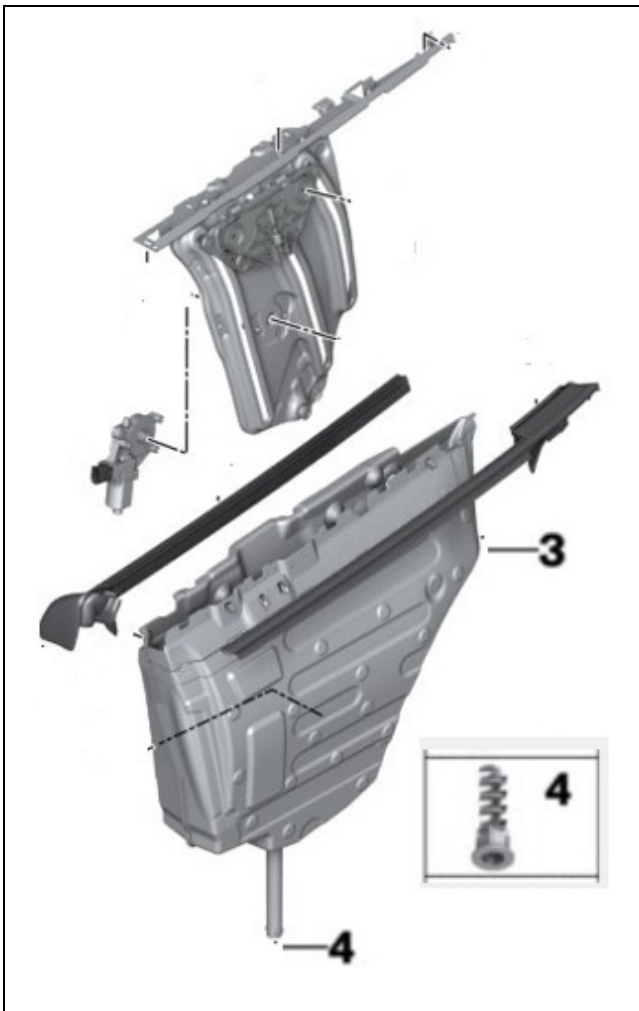
The vehicle's OEM installed lower side rocker panel trim, and its corresponding plastic underbody panel may be fitted too tightly against water outlet holes' blind plugs, restricting the flow, and causing insufficient drainage. This, together with a buildup of dirt, mud, and / or leaves can further prevent the normal release of this collected water.

Should the release flow significantly slow, or stop completely, the drain assemblies can overflow, spilling the captured water into the rear side panels' lower/bottom areas. Since this water still cannot drain out, a perceptible sloshing noise may eventually be heard coming from these areas while driving the vehicle.

Over time, the water sitting in this area can corrode the rear side panels' window regulator mechanisms and/or electric drive units to the point where they are can no longer function properly.

For both sides, perform the procedure to drain any accumulated water in the rear side panel bottom area by removing the water drain outlets' blind plugs, and cleaning out any built-up material residue in the drain holes to ensure they are clear going forward.
