SIB 51 11 25

UNABLE TO UNLOCK THE HOOD USING THE RELEASE LEVER

2026-09-21

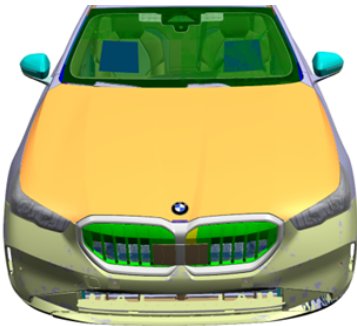
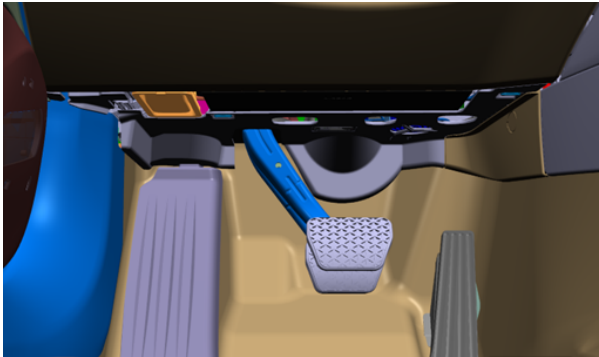
When pulling on the hood (**highlighted in orange in the top photo**) release lever (**highlighted in orange in the bottom photo**; driver’s footwell shown), there is a noticeable lack of cable tension; and the hood will not unlock.

- 1. Lower the Driver trim panel for the pedal assembly according to **REP 51 45 184** and replace Hood Bonnet lever.
- 2. Once repair is completed, reassess the operation of the Hood lever.

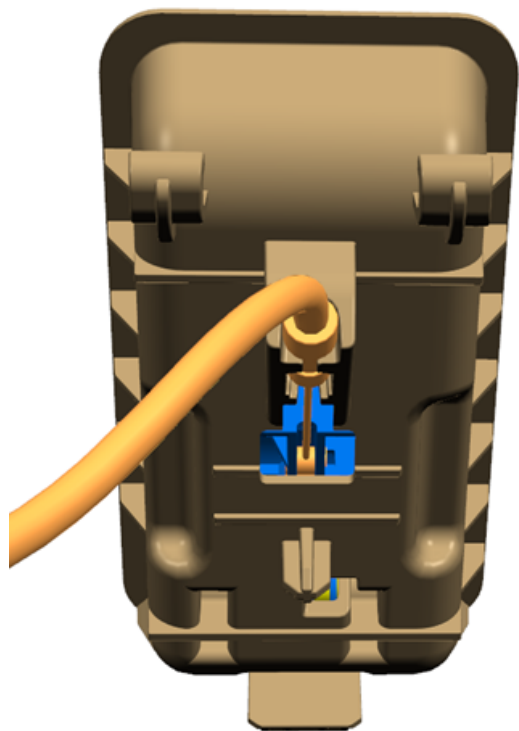
The Bowden cable (**highlighted in orange**) in the release lever becomes unclipped.

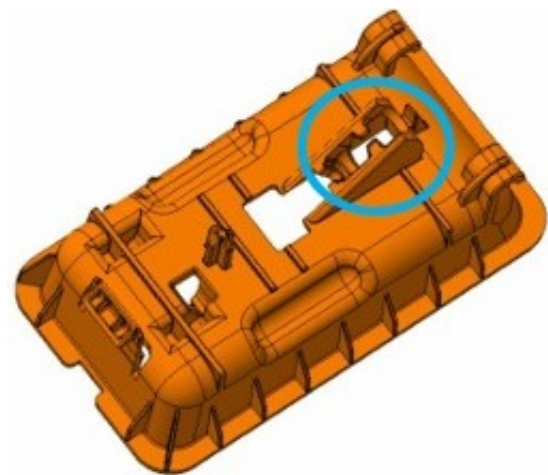
The updated component, part number **51 23 5 B89 DF8**, supersedes the previous version. The revisions are identified by the blue circles in the image.
