SIB 61 14 26

## SERVICE ACTION: WEATHERPROOF THE REAR FOG LIGHT CONNECTOR

2026-09-09

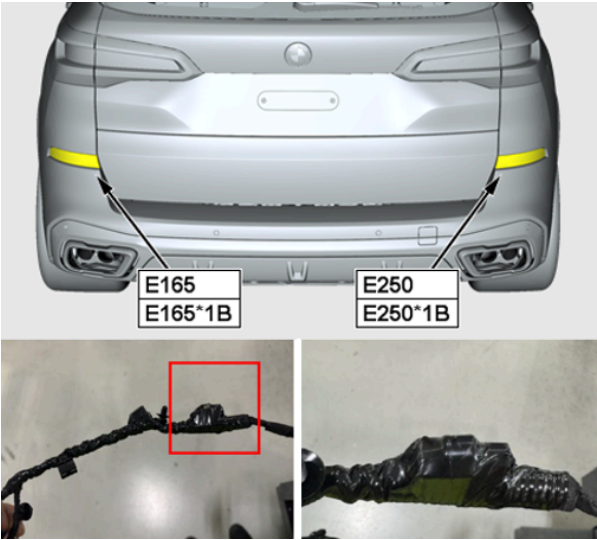
2. On the driver's side, remove the electrical tape from the rear fog light (E165\*1B) connector.

4. Remove the two pins from the fog light (E165\*1B) connector.
