# TECHNICAL SERVICE BULLETIN

## Horn Sounds When Turning The Steering Wheel

**26-2423**

| <b>Ford</b><br>2025-2027 Expedition |

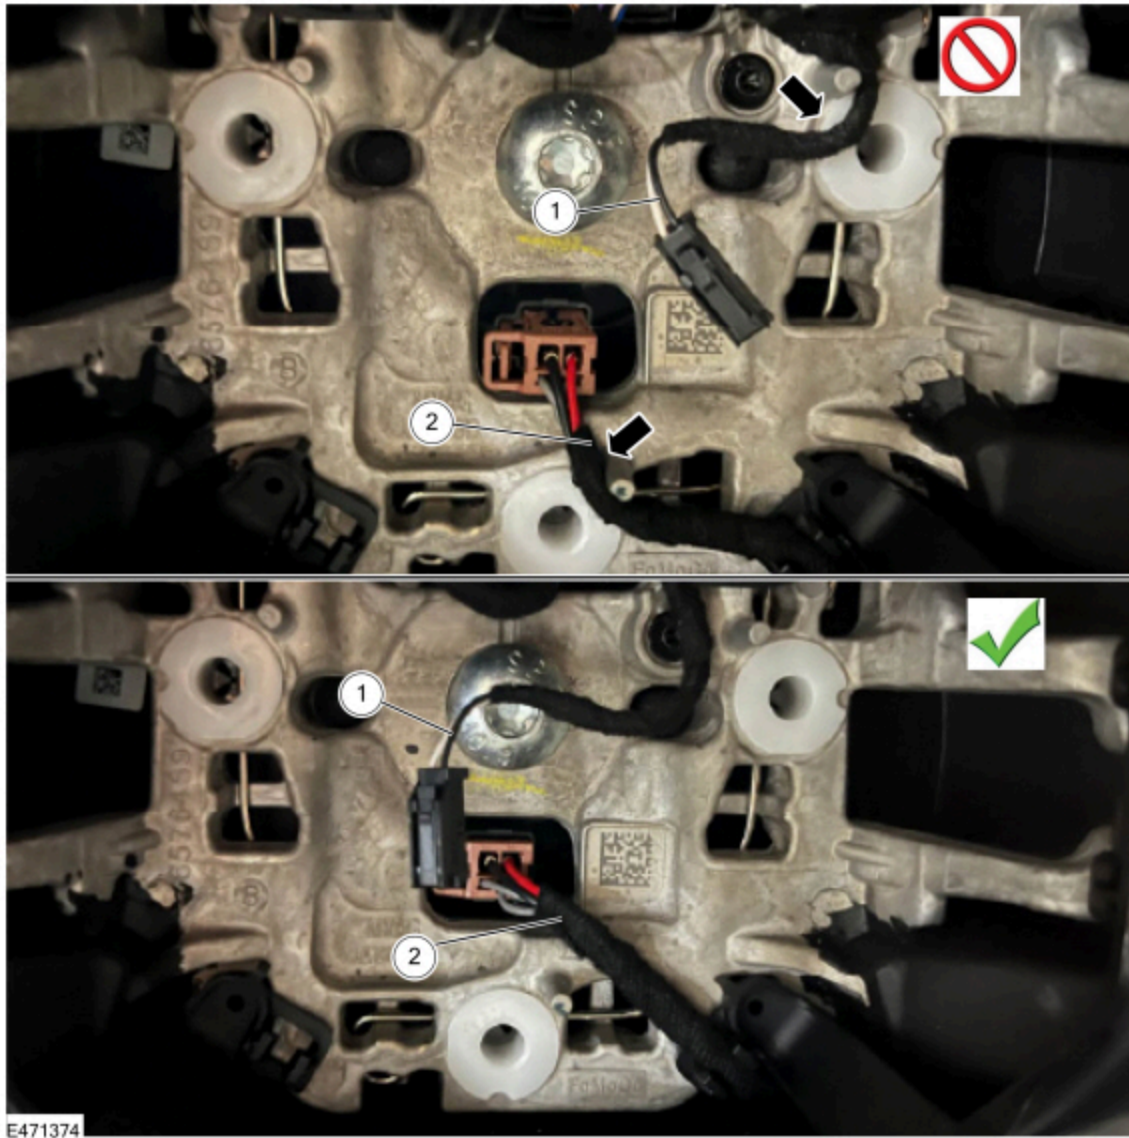
Figure 1

1. Remove the driver airbag. Refer to the WSM, Section 501-20B.
2. Carefully inspect for impressions on the horn wire harness (Figure 1 Callout 1) and heated steering wheel (if equipped) wire harness (Figure 1 Callout 2) that would indicate the harness was pinched under one of the airbag

mounting springs. Repair the harness if damaged. Refer to Wiring Diagram, Cell 005.

**NOTE: When routed correctly, the horn wire harness is routed to the left of the cast aluminum locator pin, and the heated steering wheel harness (if equipped) is routed to the right of the cast aluminum locator pin to keep the harnesses away from the airbag springs. (Figure 1)**

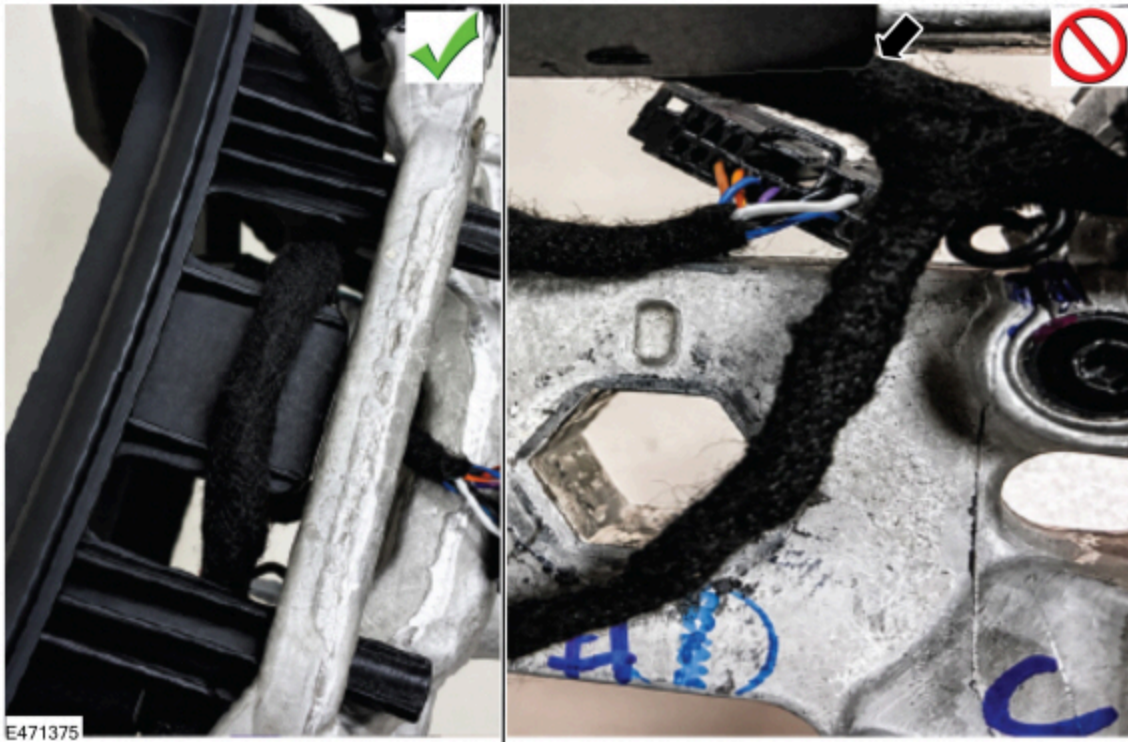
Figure 2 - Steering wheel cover removed for routing clarity, removal not required for inspection

3. Confirm that the upper main steering wheel harness is routed over the top of the plastic steering wheel flange. Make sure the harness is not pinched between the plastic flange and the cast aluminum frame of the steering wheel. Repair as needed. (Figure 2)

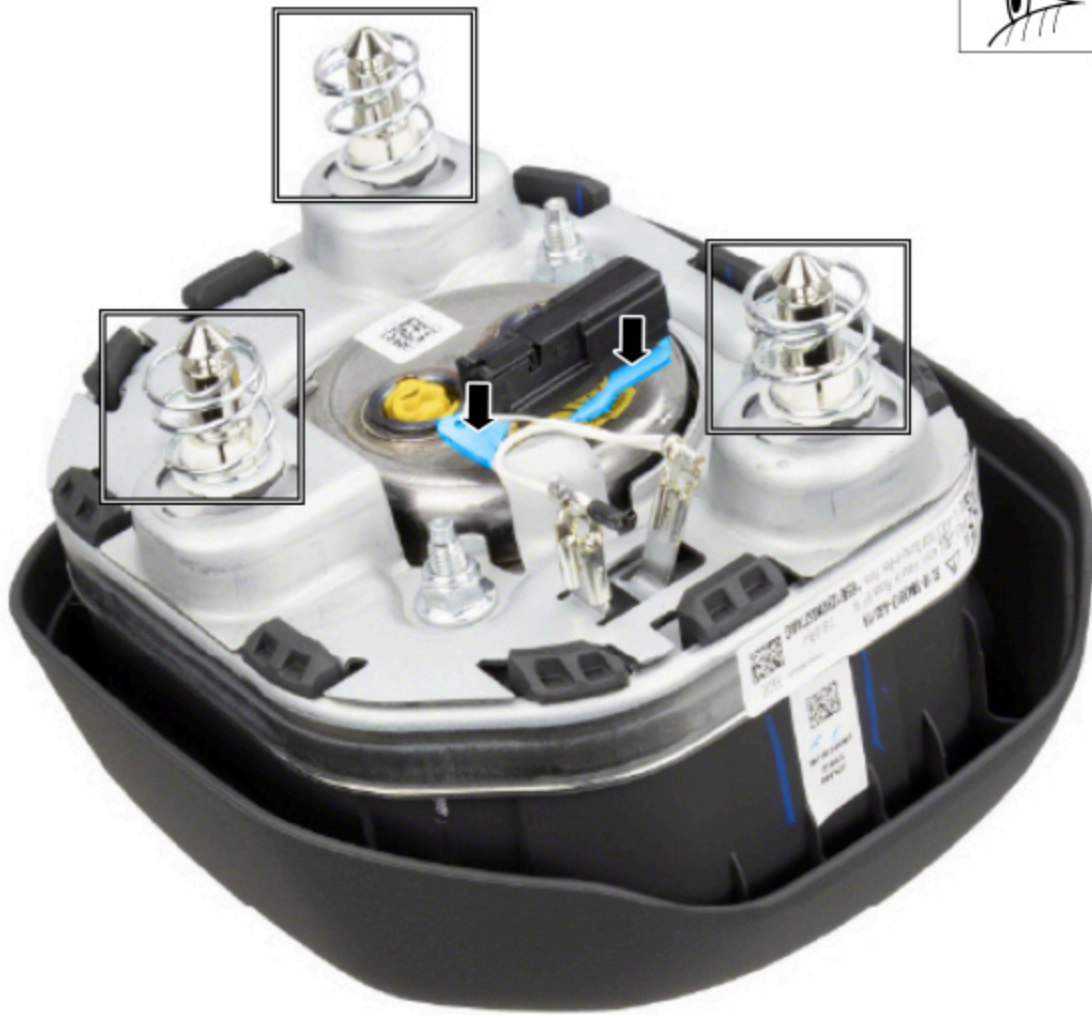
Figure 4

5. Confirm that the horn connector C217 is securely attached to the metal tab on the back of the driver airbag, and all 3 springs are present on the back of the driver airbag. Repair as necessary outside of this article. (Figure 4)

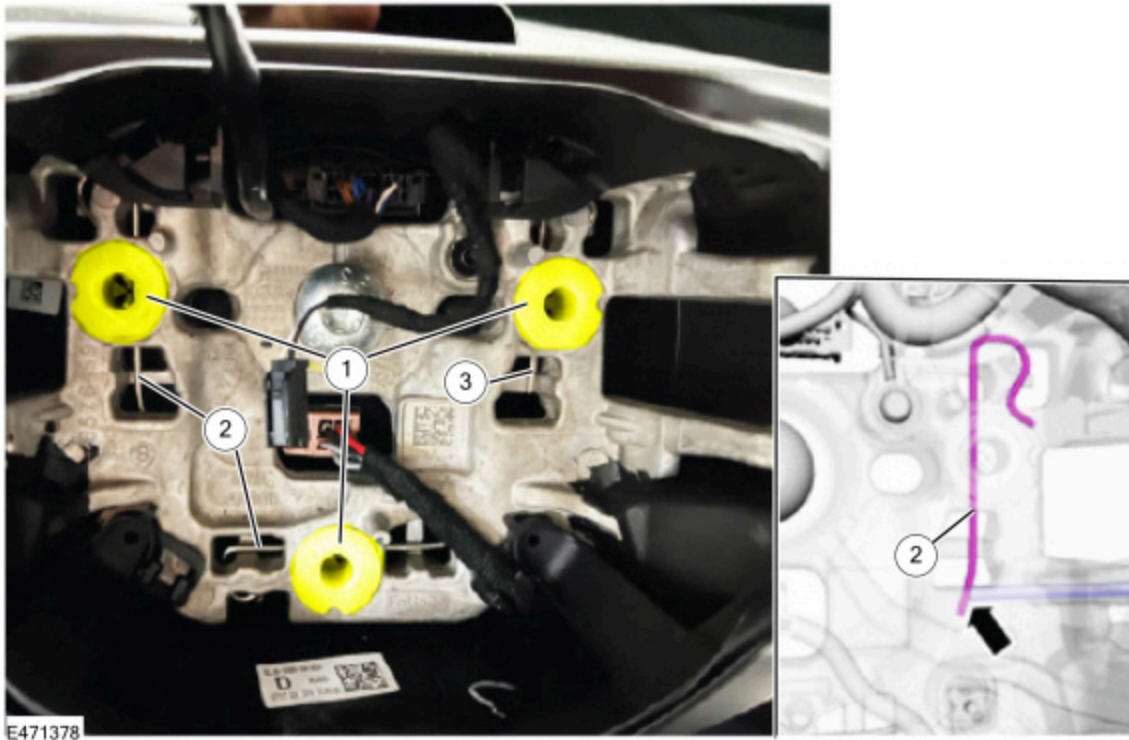
Figure 5

6. Inspect the 3 plastic guide bushings for any damage. Confirm the 3 spring clips are present, undamaged, and fully seated. Repair as necessary outside of this article. (Figure 5)
