**Technical Service Bulletin (TSB)**  
**Umbrella Valve Seal Missing From Cylinder Head Cover**

| REFERENCE: | TSB: 09-023-26<br>GROUP: 09 - Engine | Date: | September 25, 2026 | REVISION: | 09-020-26<br>09-017-26 REV A |
| VEHICLES AFFECTED: | 2026 - 2027 (WL) Jeep Grand Cherokee / Grand Cherokee L<br>This bulletin applies to vehicles built on or before **August 21, 2026 (MDH 0811XX)** equipped with a 2.0L Hurricane 4 Turbo W/ESS (Sales Code EC7). | | | MARKET APPLICABILITY:<br><div><input checked="" type="checkbox"/> NA<input checked="" type="checkbox"/> MEA</div> <div><input checked="" type="checkbox"/> EE<input checked="" type="checkbox"/> IAP</div> <div><input checked="" type="checkbox"/> SA<input type="checkbox"/> CH</div><br><b>NOTE:</b> This bulletin applies to North and South America, Enlarged Europe, Middle East & Africa, and India & Asia Pacific markets. | |

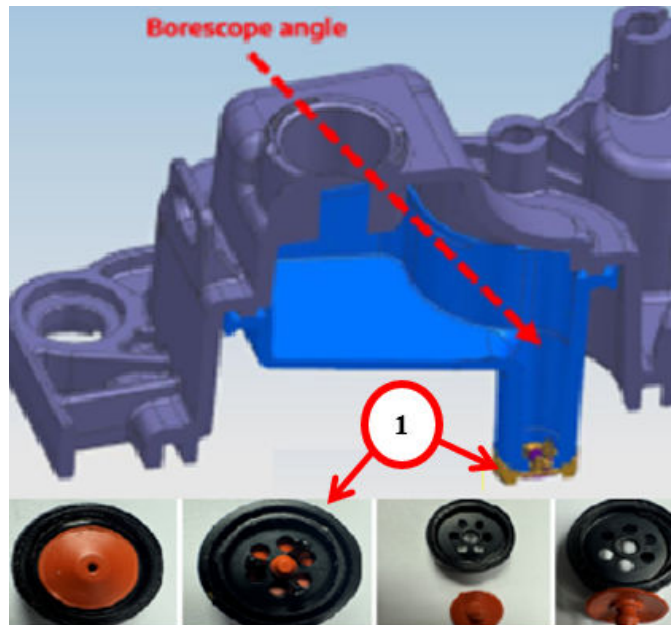
**Fig. 3**  
Borescope to PCV Valve Opening

2. **With the PCV valve removed**, insert a borescope into the PCV valve opening [Fig. 3](#) to inspect if the umbrella valve is missing or present [Fig. 4](#) [Fig. 5](#) [Fig. 6](#).

1 - Umbrella Valve Seal

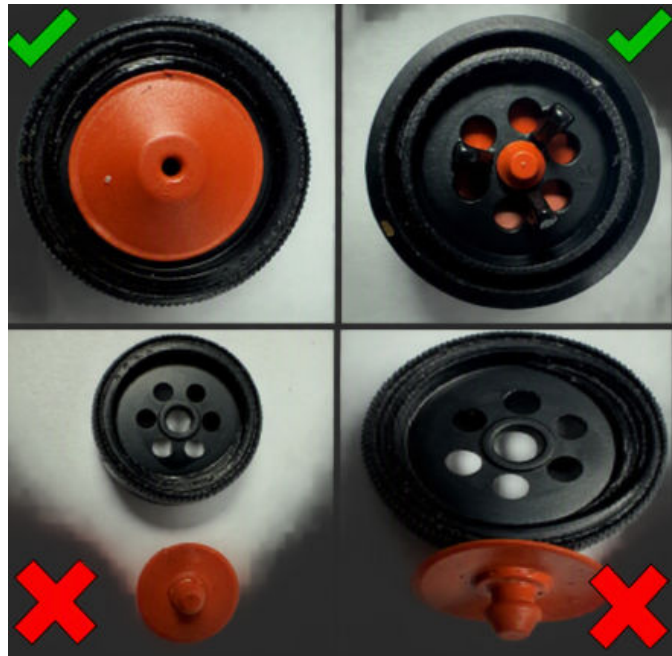
**Fig. 4**  
**\*\*Umbrella Seals - Present and Missing\*\***

| CAUSE: | Cover Cylinder Head Umbrella valve seal missing | | | | |

Green Check Mark - Umbrella Valve Seals - Present

Red X Mark - Umbrella Valve Seals Not Seated or Missing

3. Is the umbrella valve seal missing [Fig. 4](#)?
  - YES>>> Replace the cylinder head cover assembly. Refer to the detailed service procedures available in DealerCONNECT/Service Library under: Service Info> 09 - Engine, 2.0L / Cylinder Head / Cover(s), Cylinder Head / Removal and Installation and then proceed to [Step 4](#).
  - NO>>> This bulletin has been completed. Use Inspection LOP (09-35-20-98) to close the active RSU.
4. Ensure that the engine oil level is to proper specification.
5. Using wiTECH, perform the PCM Reset ECU routine. Navigate to **Guided Diagnostics > Reset ECU**, select **PCM**, and follow the on-screen instructions to complete the procedure.
6. Clear DTCs.
