## Technical Service Bulletin (TSB)

### Transmission Rattle

| REFERENCE: | TSB: 21-062-26<br>GROUP: 21 - Transmission and Transfer Case | Date: | September 25, 2026 | REVISION: | — |
| VEHICLES AFFECTED: | 2026 (DT) RAM 1500 Pickup<br>This bulletin applies to vehicles built on or after April 01, 2026 (MDH 0401XX) and on or before July 10, 2026 (MDH 0710XX). | | | MARKET APPLICABILITY:<br><div><input checked="" type="checkbox"/> NA<input type="checkbox"/> MEA<br/><input type="checkbox"/> EE<input type="checkbox"/> IAP<br/><input checked="" type="checkbox"/> SA<input type="checkbox"/> CH</div><br><b>NOTE:</b> This bulletin applies to the North America and South America markets. | |

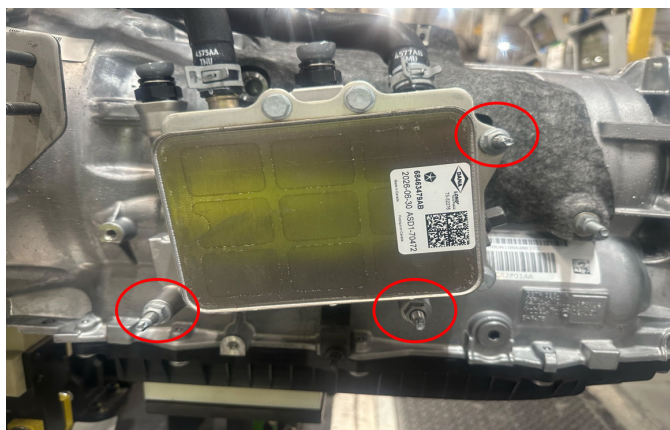
**Fig. 1**  
Transmission Oil Cooler Mounting Nuts

| CAUSE: | Transmission oil heater mounting nuts are under torqued | | | | |

1. Is the vehicle on the RSU VIN list?
  - YES >>> Proceed to [Step 2](#).
  - NO >>> This bulletin does not apply. Perform further diagnostics.
2. Raise and support the vehicle. Refer to the detailed service procedures available in DealerCONNECT/Service Library under: Service Info> 04 - Vehicle Quick Reference / Hoisting / Standard Procedure.
3. Torque the transmission oil heater mounting nuts to proper specification [Fig. 1](#). For torque specification refer to the Torque Specifications - Transmission Oil Cooler And Heater table available in DealerCONNECT/Service Library under: Service Info> 21 - Transmission and Transfer Case / Automatic - 8HP75 / Heater, Transmission / Removal and Installation.

**NOTE: If nuts are found to be loose and there is evidence of transmission fluid leaking, follow standard warranty processes to repair and claim.**
