## Technical Service Bulletin (TSB)

### Multi-function Tailgate Requires High Closing Effort

| REFERENCE: | TSB: 23-048-26<br>GROUP: 23 - Body | Date: | September 26, 2026 | REVISION: | — |
| VEHICLES AFFECTED: | 2026 - 2027 (DT) RAM 1500 Pickup<br>This bulletin applies to vehicles built on or after March 31, 2026 (MDH 0331XX) and on or before July 31, 2026 (MDH 0731XX) equipped with Multi-function Tailgate (Sales Code MWK) and RamBox Cargo Management System (Sales Code XB9). | | | MARKET APPLICABILITY:<br><div><input checked="" type="checkbox"/> NA<input type="checkbox"/> CH<br/><input type="checkbox"/> EE<input type="checkbox"/> IAP<br/><input type="checkbox"/> SA<input checked="" type="checkbox"/> MEA</div><br>NOTE: This bulletin applies to the North America and Middle East & Africa markets. | |

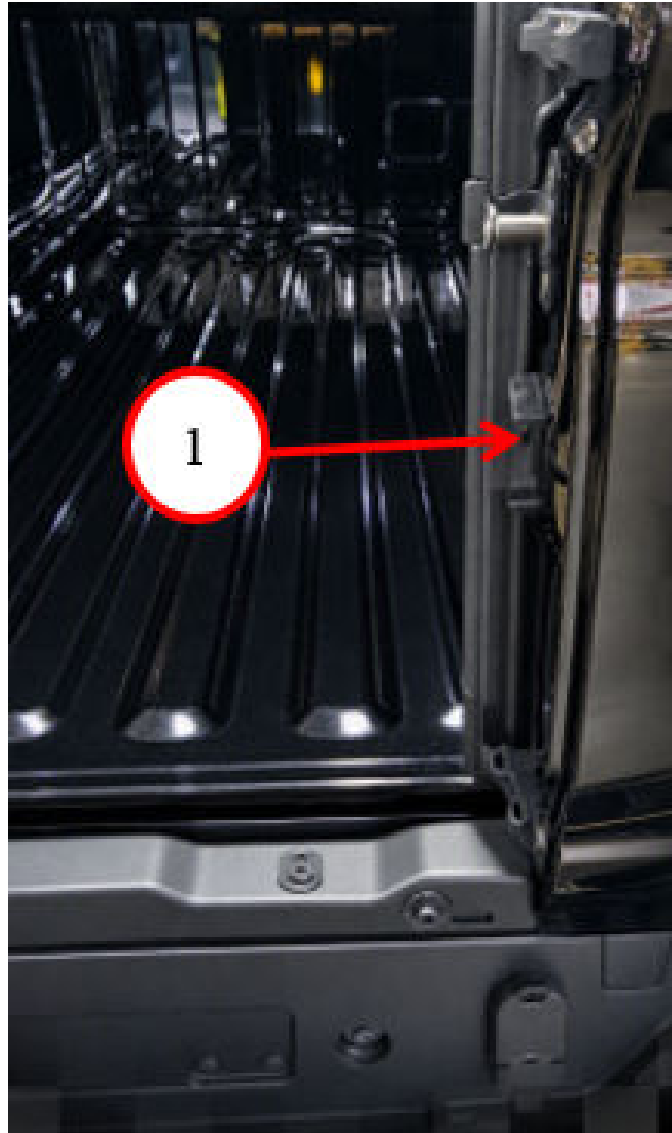
**Fig. 1**  
JK Stabilizer

1 - JK Stabilizer

**NOTE: A loose or unstable stabilizer can create false closing-effort symptoms and may reduce repeatability during striker adjustment.**

1. Cycle the Multi-function Tailgate through a complete open and close sequence.
2. Is excessive force required when closing the right hand Multi-function Tailgate?
  - YES>>> Proceed to [Step 3](#).
  - NO>>> This bulletin has been completed. Use Inspect LOP (23-00-25-92) to close this active RSU.
3. Tighten the JK stabilizer using a ratchet. Confirm stabilizer is secure before moving to striker adjustments [Fig. 1](#).

4. Cycle the 40% door and full gate. Confirm there is no abnormal movement or looseness at the stabilizer interface.

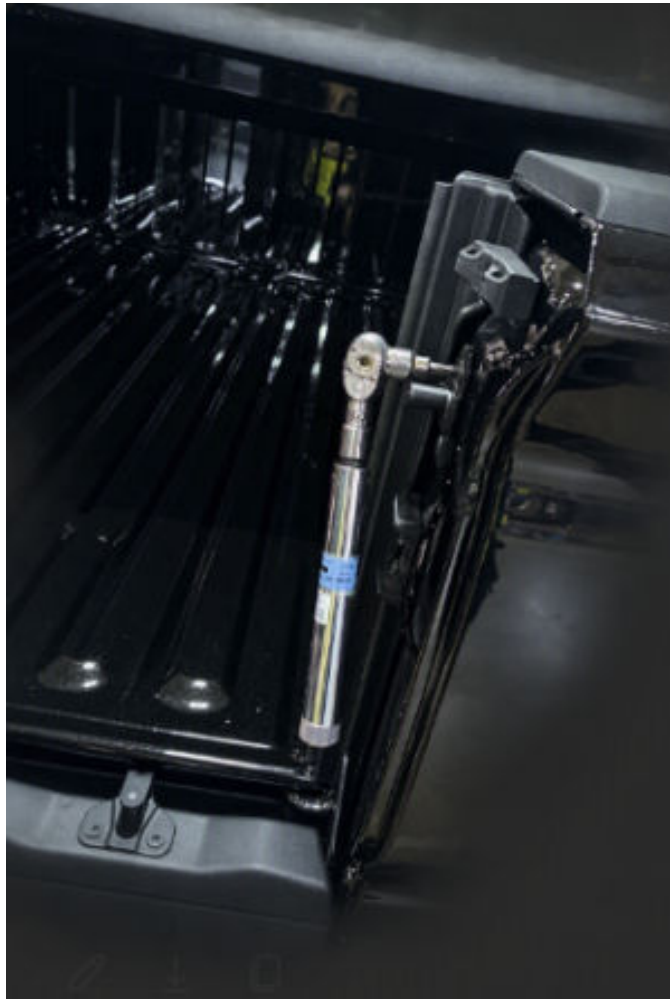
**Fig. 2**  
40% Door Striker

Torquing Striker Fastener

**NOTE: Rearward striker movement improves latch capture and can reduce the force required to close the 40% door.**

5. Loosen the 40% door striker fasteners. Shift the striker rearward in small increments, then retorque to approved specification. Refer to the detailed service procedures available in DealerCONNECT/Service Library under: Service Info> 23 - Body / Technical Specifications>**TORQUE SPECIFICATIONS** [Fig. 2](#).

6. Close the 40% door several times. Confirm latch engagement, flush condition, and no secondary interference.

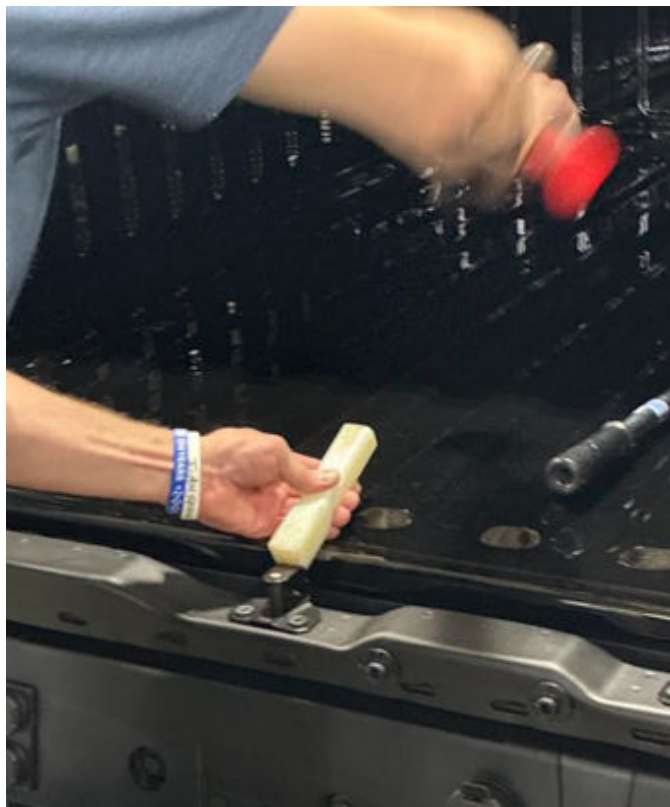
**Fig. 3**  
Bottom Striker

**NOTE: Bottom striker position affects door pull-in and final seated condition. Small movement can improve latch engagement.**

7. Using a soft-face hammer, move the bottom striker rearward as required. Avoid aggressive impact or paint/contact damage [Fig. 3](#).

8. After adjustment, cycle both barn doors and confirm the full gate closes without elevated RH closing effort.

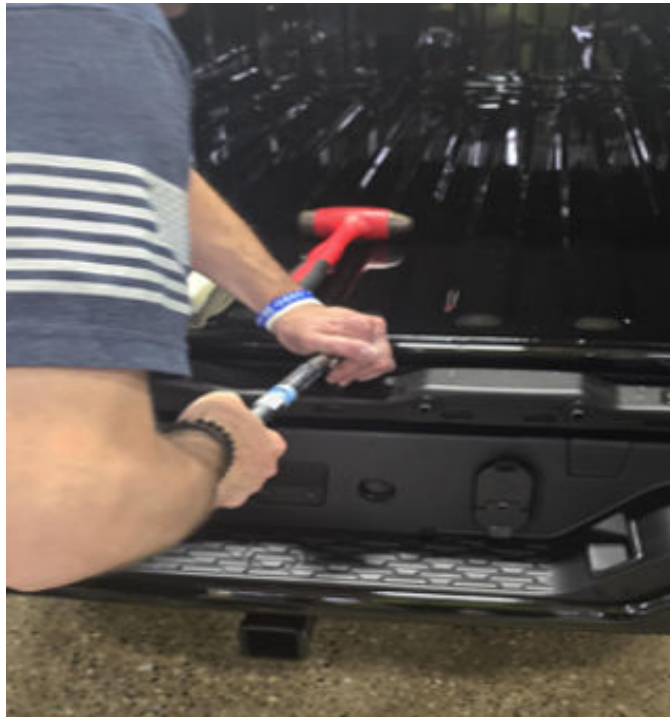
**Fig. 4**

Bottom Striker Torquing

**NOTE: Do Not Over-Adjust. Excessive rearward movement can create latch imbalance, overflush, or inconsistent secondary latch engagement.**

9. Retorque the bottom striker after rearward adjustment. Confirm the striker did not walk during torque. Refer to the detailed service procedures available in DealerCONNECT/Service Library under: Service Info> 23 - Body / Technical Specifications>**TORQUE SPECIFICATIONS** [Fig. 4](#).

10. Verify striker position, latch engagement, 40% door flush, and full-gate closing effort before proceeding.

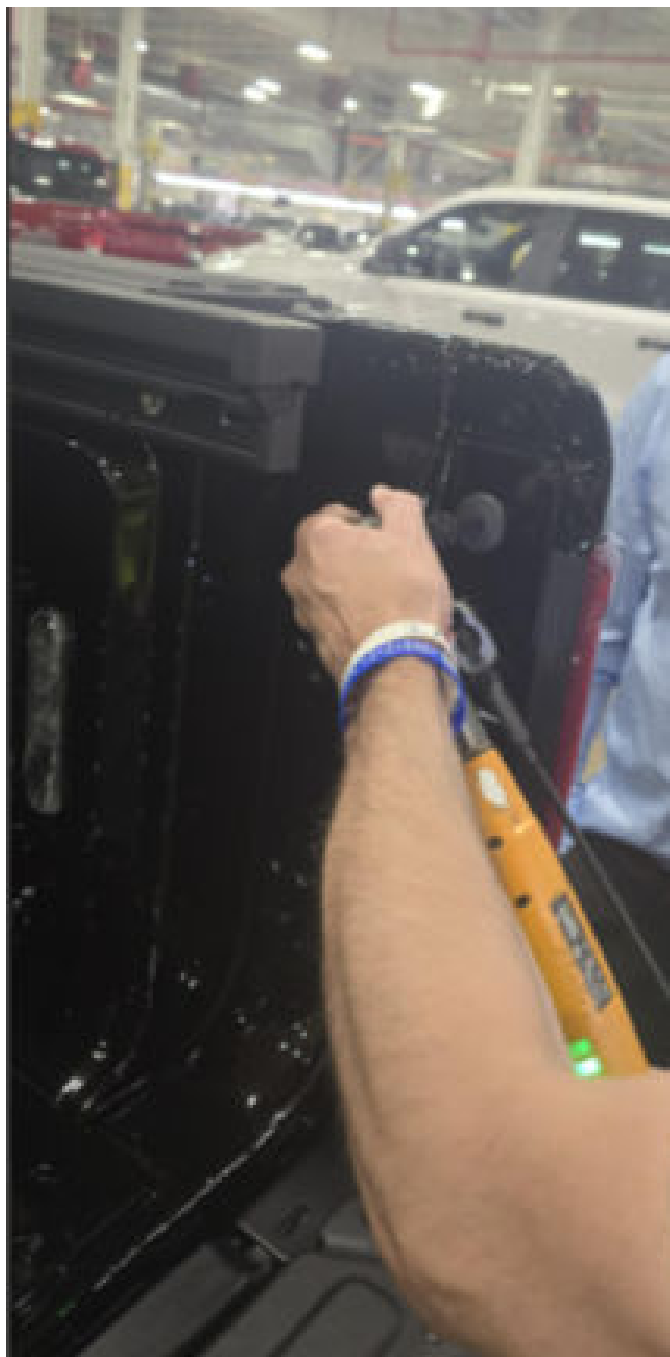
**Fig. 5**  
Body-Side Striker

12. Body-side striker position influences final full-gate pull-in and can reduce elevated closing effort when tuned correctly.

**NOTE: Confirm full-gate close, 40% door close, 60% door close, gap/flush, and no rattle or abnormal binding.**

11. Adjust the body-side striker rearward to optimize the full-gate latch engagement and closing effort [Fig. 5](#).
