| REFERENCE: | TSB: 08-221-26 REV. B<br>GROUP: 08 - Electrical | Date: | September 23, 2026 | REVISION: | 08-221-26 REV. A |
| VEHICLES AFFECTED: | 2021 - 2025 (WL) Jeep Grand Cherokee / Grand Cherokee L<br>2022 - 2025 (WS) Grand Wagoneer / Wagoneer<br>This bulletin applies to vehicles equipped with one of the following radios: <ul style="list-style-type: none"><li>Uconnect 5 w 8.4" Display (USA) (Sales Code UBF).</li><li>Uconnect 5 w 8.4" Display (CAN) (Sales Code UEF).</li><li>Uconnect 5 Nav w 8.4" Display (USA) (Sales Code UBL).</li><li>Uconnect 5 Nav w 8.4" Display (CAN) (Sales Code UEL).</li><li>Uconnect 5 Nav w 10.1" Display (USA) (Sales Code UBN).</li><li>Uconnect 5 Nav w 10.1" Display (CAN) (Sales Code UEN).</li><li>Uconnect 5 Nav w 12.0" Display (USA) (Sales Code UBQ).</li><li>Uconnect 5 Nav w 12.0" Display (CAN) (Sales Code UEQ).</li><li>Uconnect 5 w 8.4" Display (MEX) (Sales Code UFF).</li><li>Uconnect 5 Nav w 8.4" Display (MEX) (Sales Code UFL).</li><li>Uconnect 5 Nav w 10.1" Display (MEX) (Sales Code UFN).</li><li>Uconnect 5 Nav w 12.0" Display (MEX) (Sales Code UFQ).</li></ul> | | | MARKET APPLICABILITY:<br><div><input checked="" type="checkbox"/> NA<input type="check

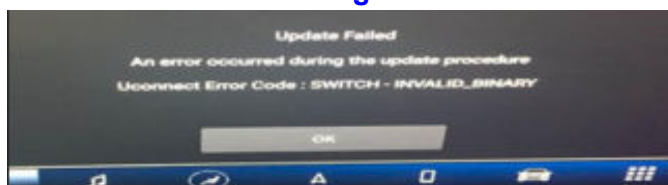
**Fig. 5**  
**Switch-Invalid\_Binary Error**

**NOTE:** Sometimes the radio throws an error pop up "Switch-Invalid\_Binary" after successful radio update. Please ignore this error and click ok [Fig. 5](#).
