**Technical Service Bulletin (TSB)**  
**R1H Radio Update to U41.17 - Dealer Option**

| REFERENCE: | TSB: 08-287-26 REV. B<br>GROUP: 08 - Electrical | Date: | September 23, 2026 | REVISION: | 08-287-26 REV. A |
| VEHICLES AFFECTED: | 2026 (H1) Jeep Commander<br>2026 (M1) Jeep Compass<br>2026 (N4) RAM Rampage<br>This bulletin applies to vehicles built on or after June 09, 2025 (MDH 0609XX) and on or before July 10, 2026 (MDH 0710XX). | | | MARKET APPLICABILITY:<br><div><input type="checkbox"/> NA<input type="checkbox"/> MEA</div> <div><input checked="" type="checkbox"/> SA<input type="checkbox"/> IAP</div> <div><input type="checkbox"/> EE<input type="checkbox"/> CH</div><br>NOTE: This bulletin applies to the **South America** market. | |

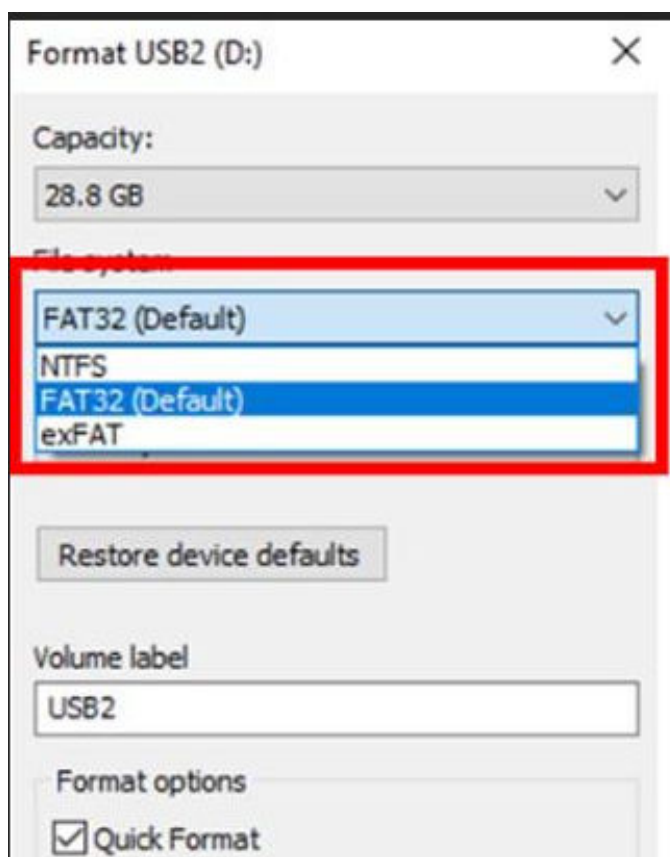
**Fig. 1**  
Format Screen

7. Choose the "NTFS" or "FAT32" option, according to [Fig. 1](#).

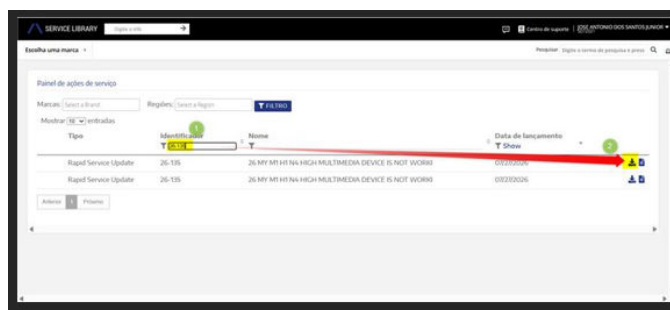
**Fig. 2**  
Download File

8. Select "Start" to proceed with the formatting.
9. Then download the update file - File available in the Service Library [Fig. 2](#):

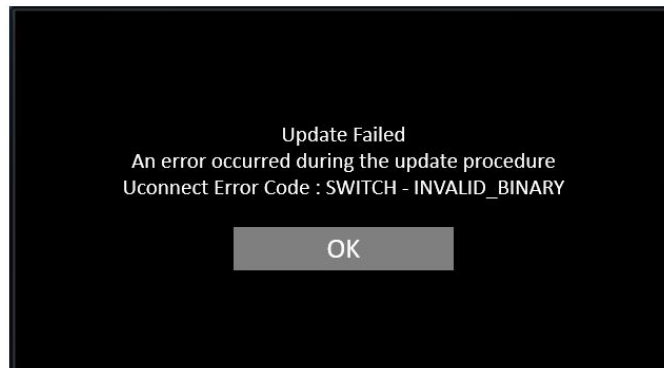
**Fig. 4**  
Update Failed

14. Wait a few seconds.
15. A window will appear on the vehicle's multimedia screen.
16. Click "Continue" to start the update.
17. Wait until the update is complete.\*\*
18. If the radio displays an error pop up " SWITCH-INVALID\_BINARY" after successful radio update, ignore this error message and press "OK" to continue [Fig. 4](#).

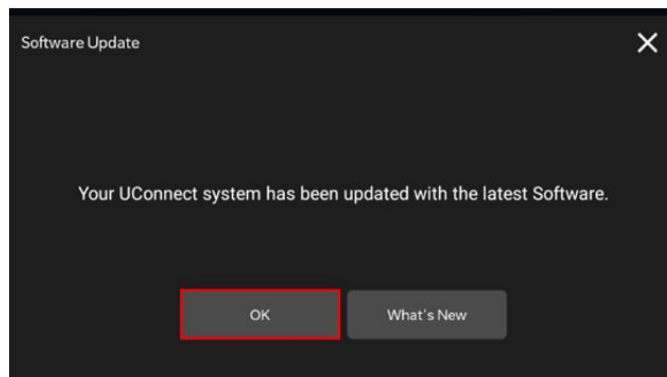
**Fig. 5**  
Completed Update

19. Press "OK" to continue [Fig. 5](#).
