## Technical Service Bulletin (TSB)

### Heads Up Display (HUD) Dimming Too Low

| REFERENCE: | TSB: 08-341-26<br>GROUP: 08 - Electrical | Date: | September 24, 2026 | REVISION: | |
| VEHICLES AFFECTED: | 2026 (WS) Jeep Wagoneer / Grand Wagoneer<br>This bulletin applies to vehicles built on or after November 18, 2025 (MDH 1118XX) and on or before March 18, 2026 (MDH 0318XX) equipped with Augmented HUD (Sales Code LBK). | | | MARKET APPLICABILITY:<br><div><input checked="" type="checkbox"/> NA<input type="checkbox"/> MEA<br/><input type="checkbox"/> SA<input type="checkbox"/> IAP<br/><input type="checkbox"/> EE<input type="checkbox"/> CH</div><br>NOTE: This bulletin applies to North America markets. | |

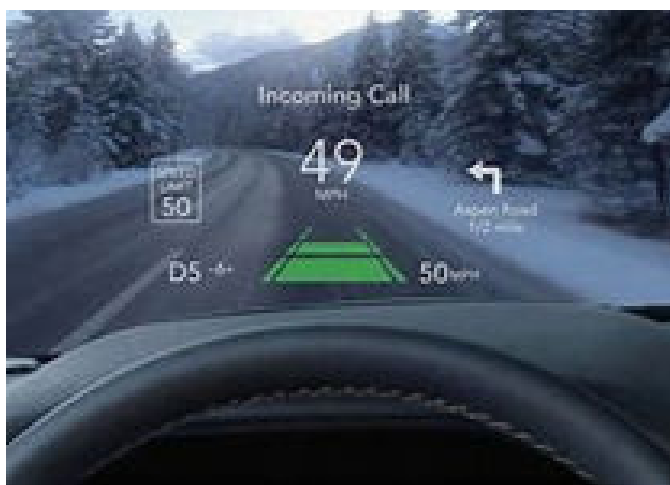
**Fig. 1**  
HUD

1. Is the vehicle on the RSU VIN list?
  - YES >>> Proceed to [Step 2](#).
  - NO >>> This bulletin does not apply.
2. Verify that the HUD is turned on and brightness is set to max.
3. Is the HUD legible and easily visible to the driver? Refer to [Fig.1](#).

- YES>>> Use Inspection LOP (08-19-1Q-90) to close the active RSU.
  - NO>>> Proceed to [Step 4](#).
4. Replace the HUD module. Refer to the detailed service procedures available in DealerCONNECT/Service Library under: Service Info> 08 - Electrical / 8J - Instrument Cluster / Display, Heads Up / Removal and Installation.
