## STAR ONLINE PUBLICATION

**Case Number: S2623000055**

**Models Affected:**  
**2026 – 2027 Dodge Charger (LB)**

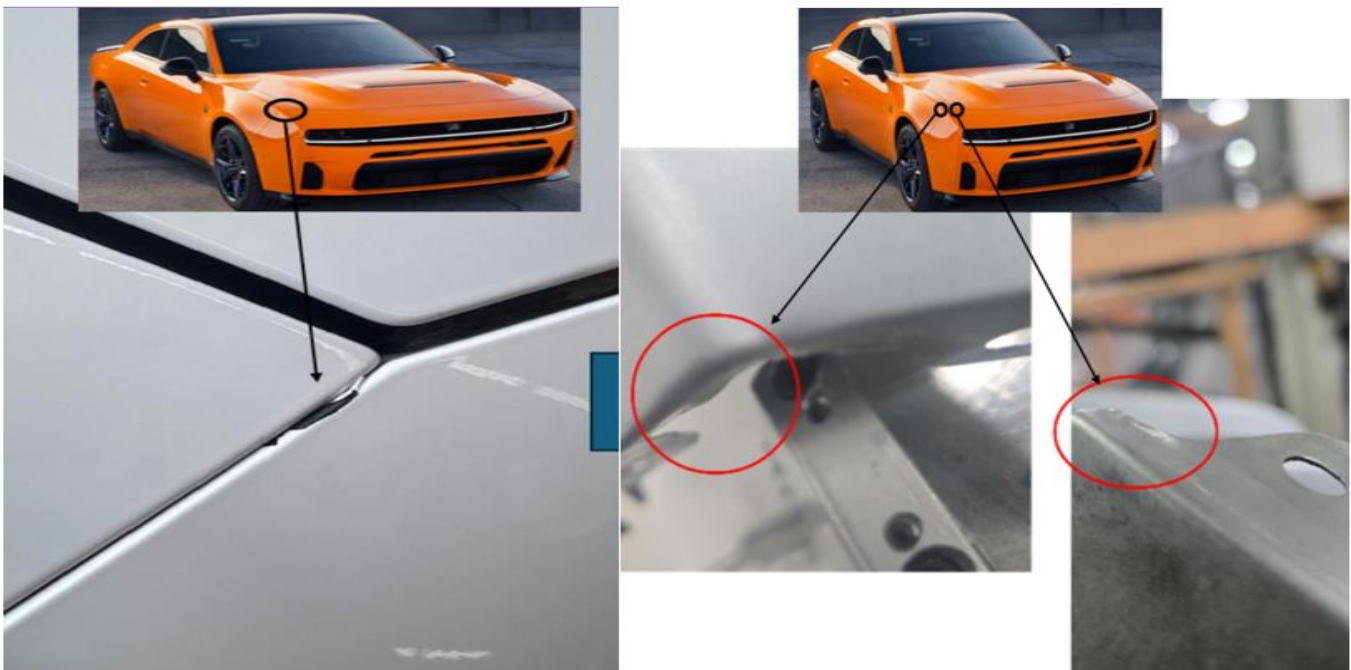
Fig 1

**Symptom/Vehicle Issue:** Front Fascia Paint Peeling at Interface to Fender. Caused When There is no Gap Between Fender And Fascia, And the Fender Has a Metal Deformation on it.

**Discussion/Repair Procedure:** Remove the front fascia. Sand/repaint the affected area (see Fig 1). Properly repair any metal deformations that align with where the paint is peeling. Reinstall all components following proper procedures outlined in Service Library.
