# Service Alert

INFOTAINMENT CENTER DISPLAY AND CONNECTED VEHICLE  
IMPROPER OPERATION

Service Alert No.: SA-015/26

2026 CX-5

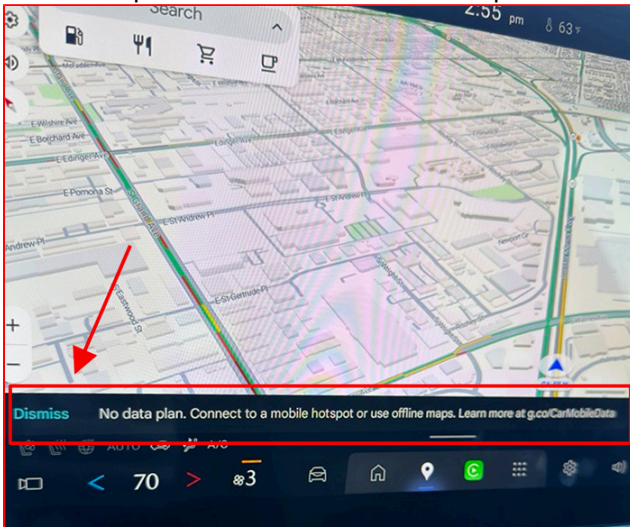
5. No data plan. Connect to a mobile hotspot or use offline maps. Learn more at [g.co/CarMobileData](https://g.co/CarMobileData) message.

- This message is incorrect.
- It does not affect system operation.
- Dismissing the message may temporarily clear it.
- Please ignore this message at this time.
- This condition is related to Item 1 above. Advise the customer that Mazda is aware of the condition and is currently working on a resolution. As soon as a resolution becomes available, this Service Alert will be promptly updated and re-released.

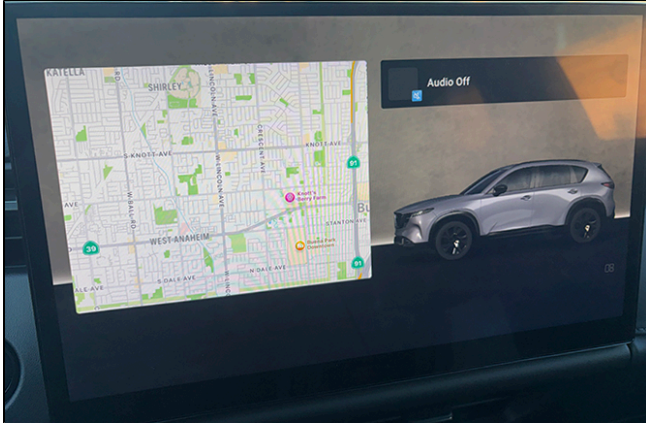
## 8. Infotainment Center Display Home Screen Partial Boot Up.

- Top icons are not displayed.
- Bottom climate controls are not displayed.
- Google Voice is inoperative.

Confirm that the Cockpit Domain Controller (CDC) is updated to the latest software version.

Navigate to MGSS → Mazda Connect/Connected Vehicle → MAZDA CONNECT Updates → [MAZDA CONNECT 3](#).

- Software update is available: Update the software, then confirm the repair.
- Software update is not available: Proceed with standard MGSS troubleshooting.

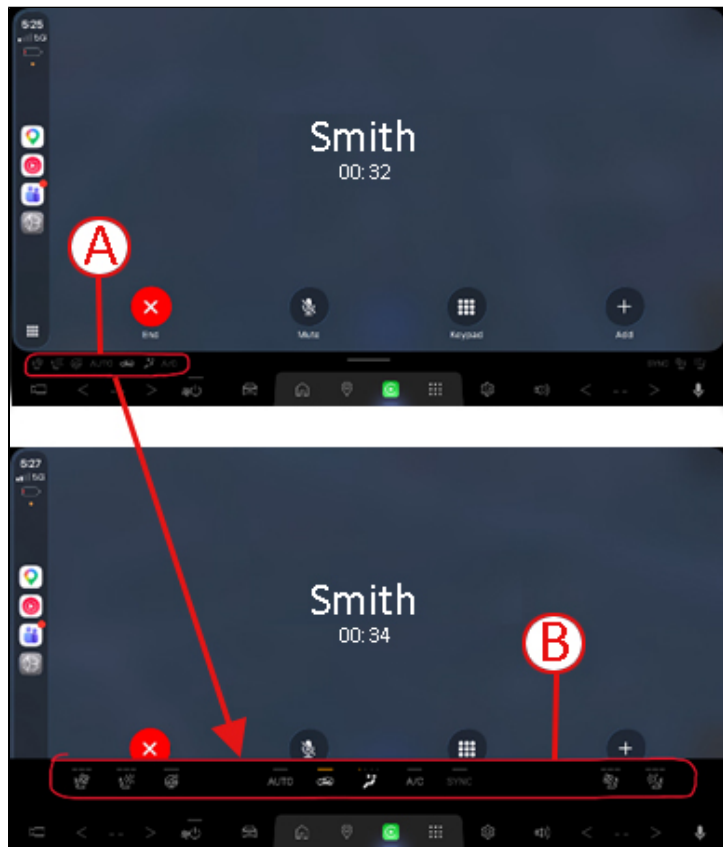
11. During an Apple CarPlay phone call, the Climate Control full-screen menu cannot be accessed. This is normal system operation.

- The Climate Control is available during a Apple Carplay phone call by selecting the area above the menu bar (A), then the Climate Control quick menu (B) will be displayed.

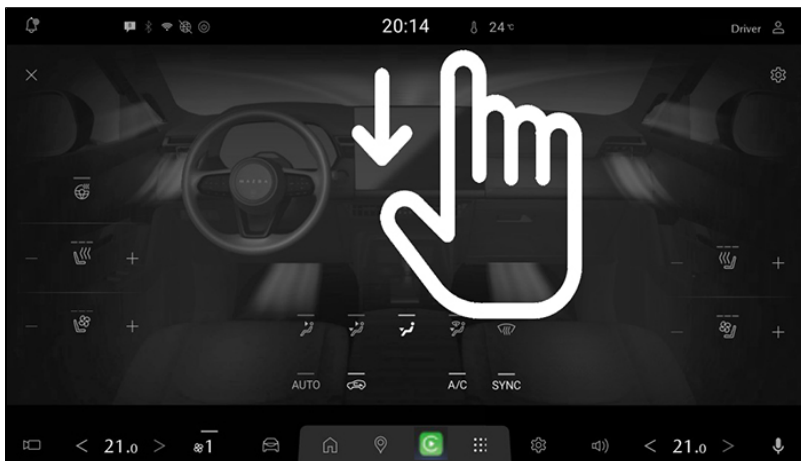
12. While the Climate Control screen is displayed in full screen, tapping the Apple CarPlay icon (A) does not launch Apple CarPlay.

- Because the screen priority is set to "Climate Control screen," it is not possible to switch directly to the CarPlay screen from the navigation bar.
- Use one of the following methods to return to the CarPlay screen:
  - Tap the "x" button (B) in the upper-left corner of the screen.
  - Tap the HOME button (C) on the navigation bar, then tap the CarPlay button on the navigation bar.

- Swipe downward on the screen.

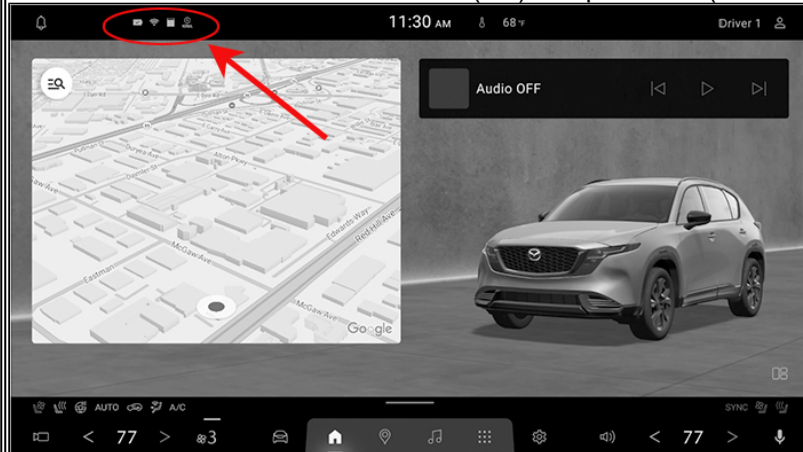
Wait for the normal Connected Vehicle (CV) reception icon (takes approx. 90 seconds).

Is the normal CV reception icon above displayed?

- Yes - Retry Mazda Connect 3 function or Connected Vehicle function.
- No - Repeat from Step 1.
