September 25, 2026

Version 1

## Warranty Extension: 2015–20 TLX Fuel Smell from Fuel Fill Pipe

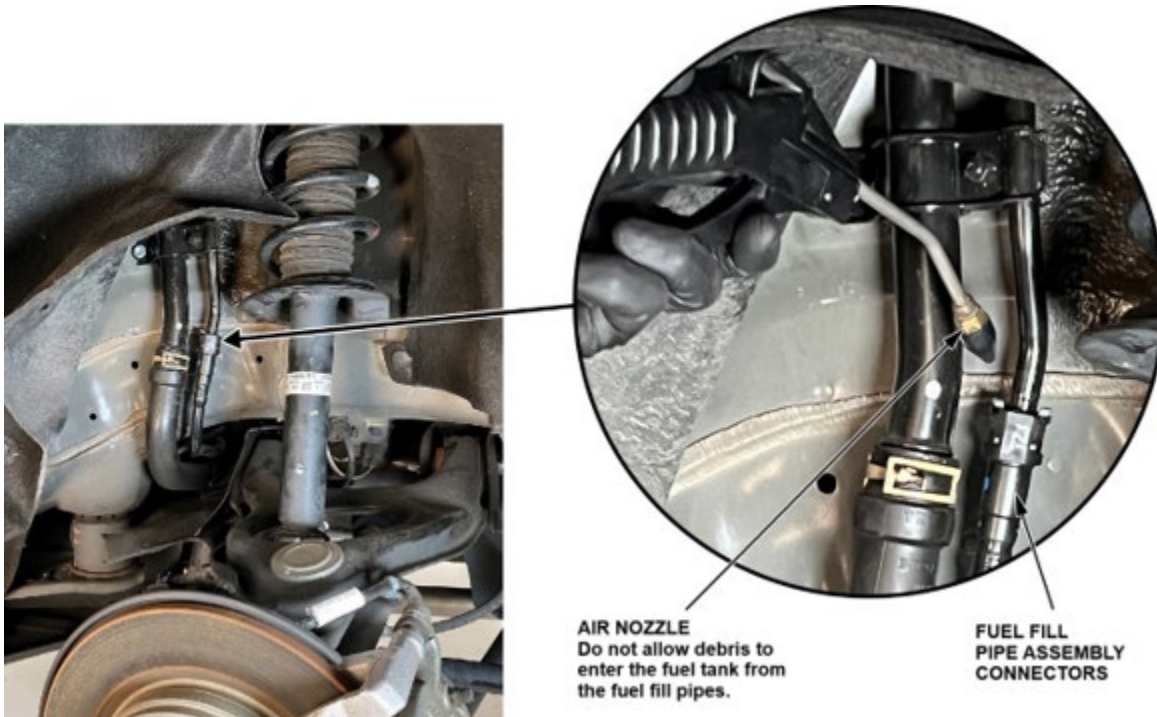
Before disconnecting the fuel fill pipe assembly, use compressed air and a clean shop towel to remove dirt and debris from the area around the fuel fill pipe connectors.

**Do not** allow debris to enter the fuel tank from the fuel fill pipe assembly. Debris may damage the fuel system.
