September 25, 2026

Version 1

## Warranty Extension: 2015-17 TLX Fuel Smell from Fuel Fill Pipe (6 Months) - Expires May 31, 2027

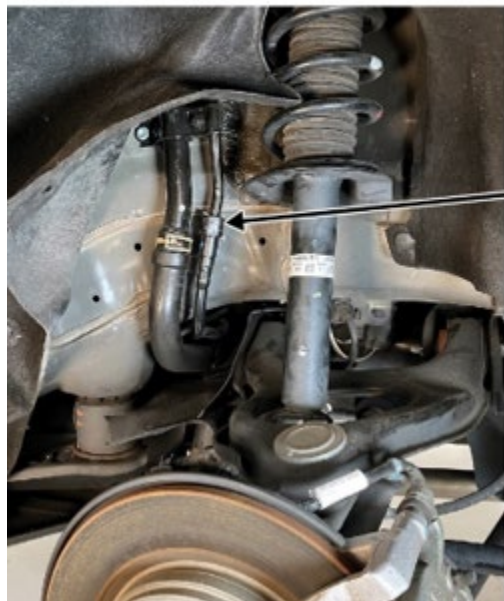
FUEL FILL  
PIPE ASSEMBLY  
CONNECTORS

AIR NOZZLE  
Do not allow debris to  
enter the fuel tank from  
the fuel fill pipes.

Before disconnecting the fuel fill pipe assembly, use compressed air and a clean shop towel to remove dirt and debris from the area around the fuel fill pipe connectors.
