KA-02042

# McLaren Artura Drive Motor 'A' Position Diagnosis Guide

**Topic:** Hybrid Warning displayed due to Drive Motor A faults

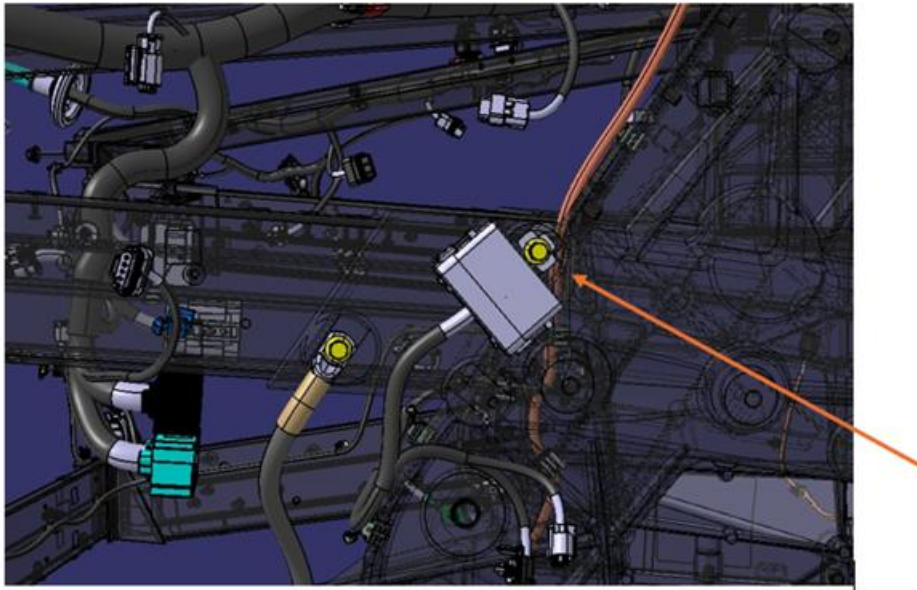
1. Inspect CGRND2 located to the rear left of the chassis frame. Remove the bolt and the casing to ensure the ground is clean and was correctly torqued. Gently remove the ground cap and inspect all ground pins are tight and free from corrosion or contamination.

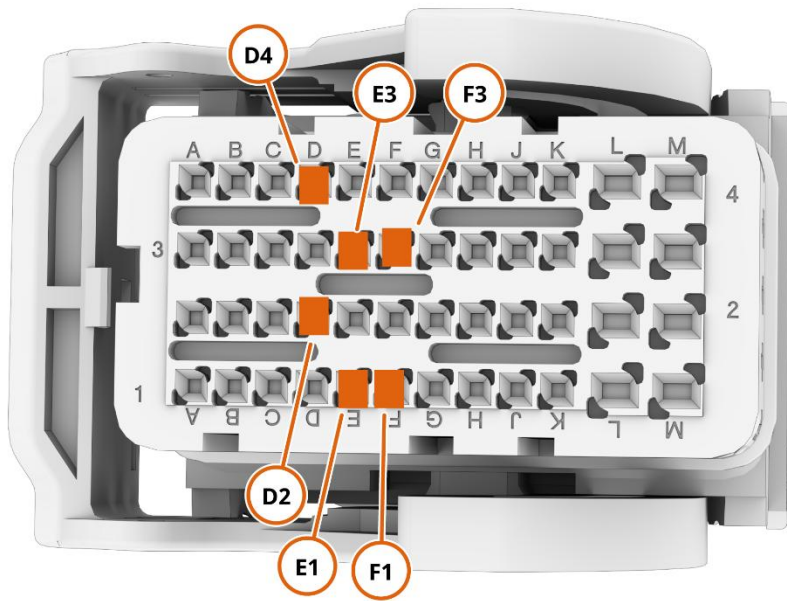
MCU Connector MBC027

2. Remove the HV Battery and Fuel Tank following MSP instructions and carry out resistance checks for the Rotor Position wiring from the MCU connector to the HTM harness at the front of the transmission. Checking for excess pin drag, contamination and corrosion.
3. Carry out resistance checks for the MCU ground from connector MBC027 to CGRND2.
4. Carry out resistance checks for the MCU power to Fuse 14, located in the Electric City fusebox.
5. Inspect the MCU casing ground. Ensure the ground is clean and was correctly torqued.

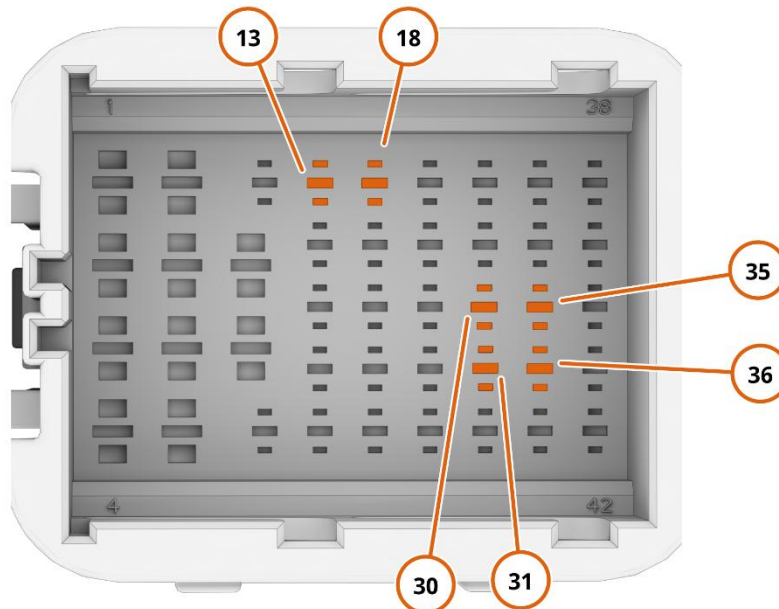
## Engine Bay inline connector I\_MBC\_TRE1-F

6. If high resistance is found in the wiring between the MCU and HTM connectors, inspect the Engine Bay inline connector I\_MBC\_TRE1-F I\_MBC\_TRE1-M. Checking for excess pin drag, contamination and corrosion. If concerns are found with this connector, capture images before cleaning.

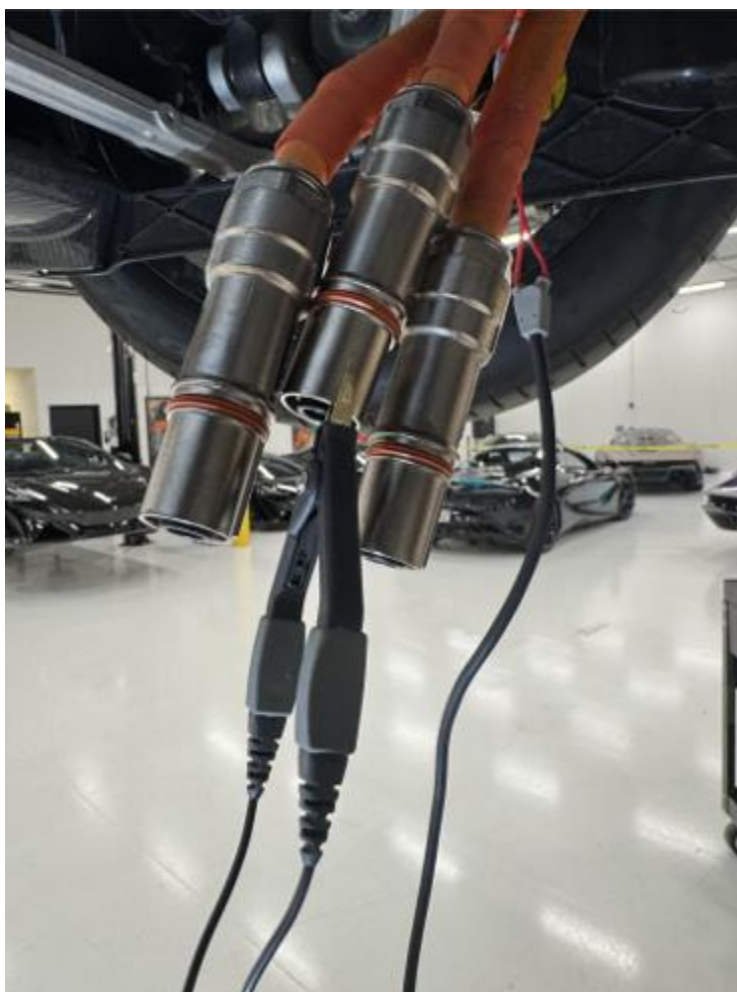
8. Carry out resistance checks between each of the 3 eMotor phase cables to the rear subframe. This reading should be in milli ohms ( $m\Omega$ ).
