| <b>Subject:</b><br><br><b>ELECTRICAL CONCERN AND/OR MULTIPLE DTC'S DUE TO AFTERMARKET DEVICE</b> | <b>Service Alert No.: SA-041/26</b> |
| | <b>Last Issued : 09/10/2026</b> |

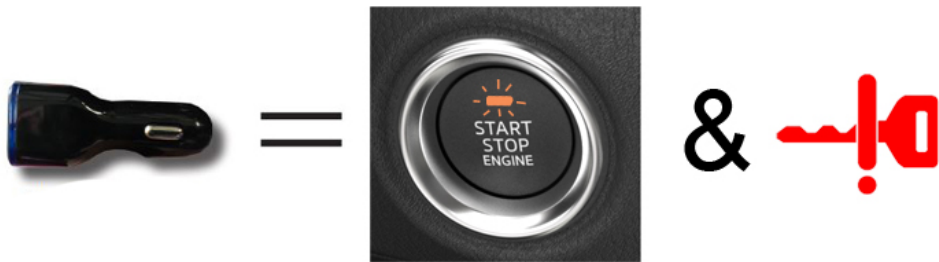
- Intermittent engine no start or unable to turn off
- Instrument cluster red security indicator light ON
- Engine Start/Start Button Amber indicator light flashing
- Battery discharge
- Electrical relay buzzing noise
- DTC B13D3:94 stored (Communication error with remote transmitter)
- DTC P1260:00 stored (Immobilizer system problem)
- Rear View Monitor Display is Blurry

| Aftermarket Cell Phone Charger/Accessory<br>connected to 12V outlet | Engine Start/Stop Button<br>Amber Indicator Light Flashing | Key Warning Light<br>(red) |

For concerns where the vehicle power supply cannot be controlled adequately, such as an engine no start condition or the engine cannot be turned off, explain to the customer as follows: Due to the reverse power supply from electronic devices with internal batteries connected through the vehicle's accessory socket, the vehicle system may not be able to determine the vehicle electronic status. As a result, the vehicle power supply control fails. To overcome this situation, remove the electronic device with internal batteries from the accessory socket.

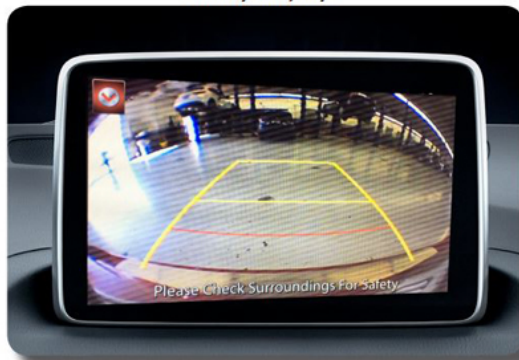
Blurry Display

With aftermarket cell  
phone charger connected  
to 12V outlet

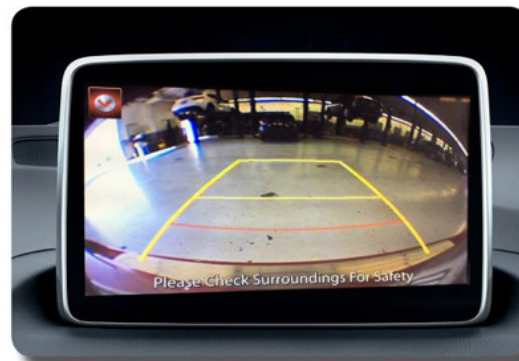
OK

Without aftermarket cell  
phone charger

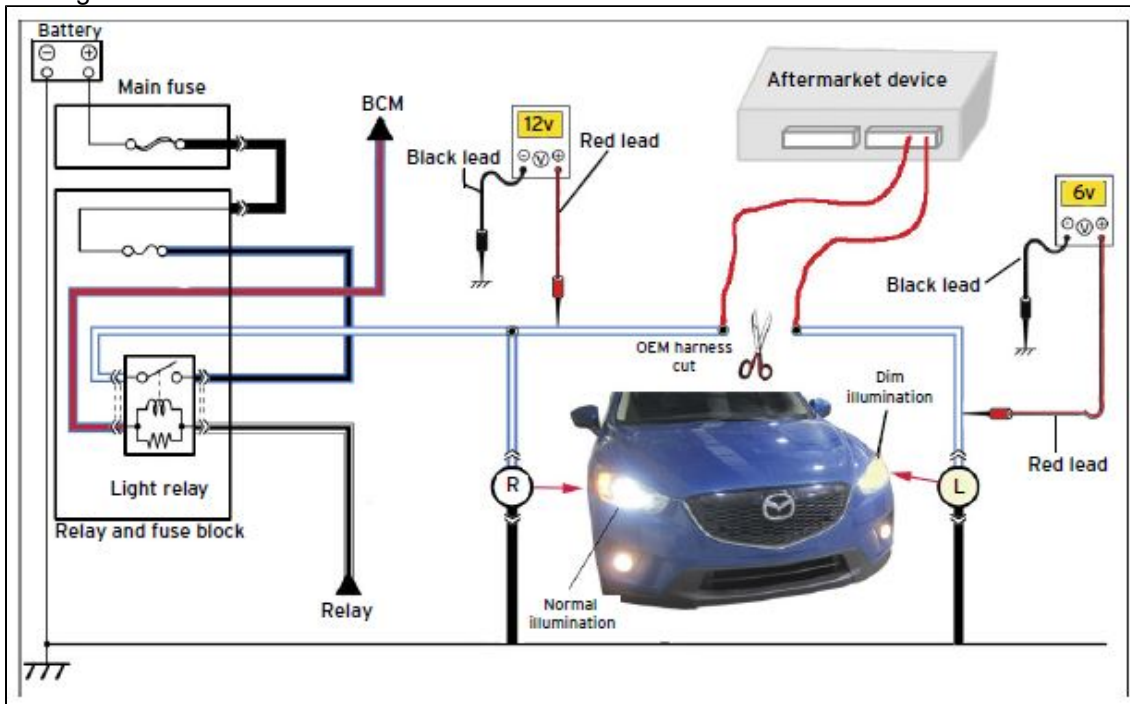
Below is an example of a dim headlight. The aftermarket device changed the headlight circuit resistance, causing a dim headlight.

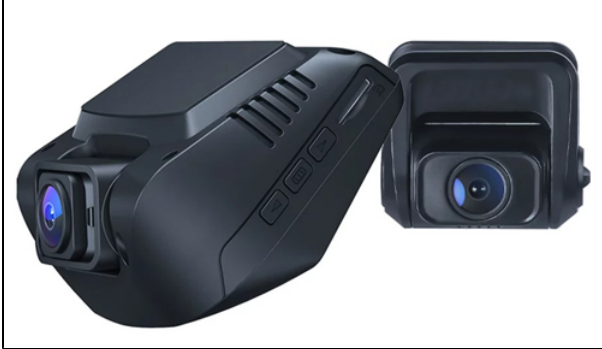
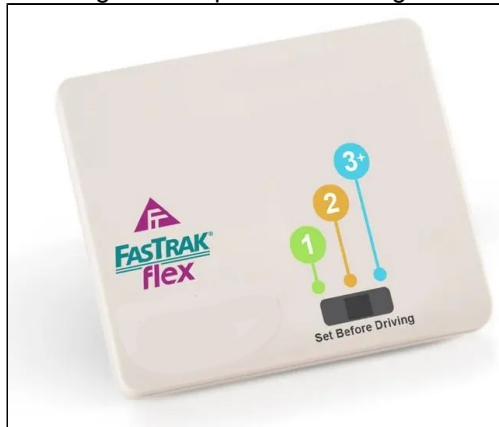
DTC B119F:01 (TEL antenna No.1 malfunction) stored. This may be caused by an aftermarket dash cam, radar detector and/or FasTrak device.

The aftermarket device may cause electrical noise disturbing the reception of GPS signals.

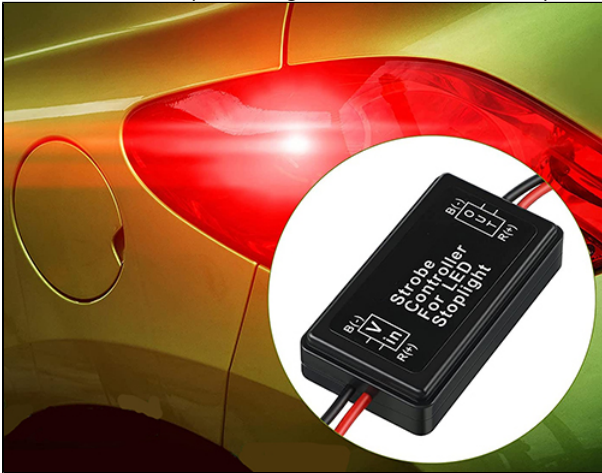
DTC C0023:14 (Brake light circuit malfunction) stored. This may be caused by an aftermarket brake light flasher.

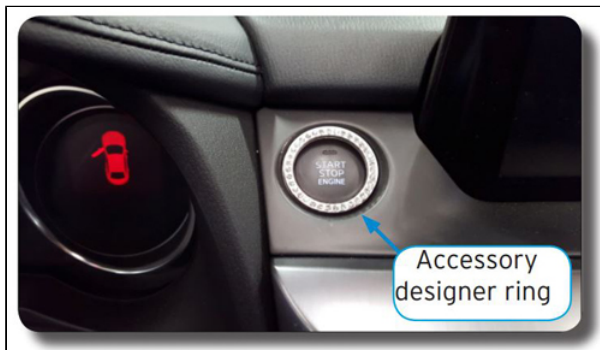
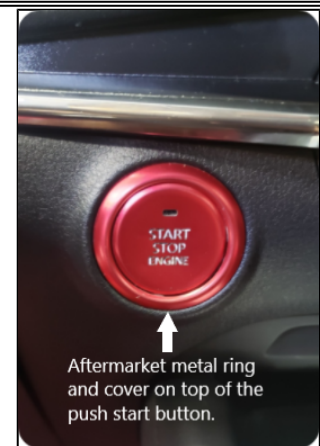
When programming a key or installing a Genuine Mazda Accessory Remote Engine Start system, you may encounter programming difficulty. This may be caused by a customer installed aftermarket decorative trim and/or cover on the START/STOP ENGINE button. The aftermarket accessory may create electrical interference, which may interfere with programming.

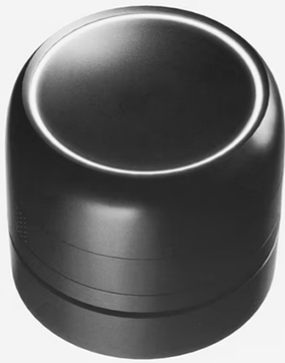
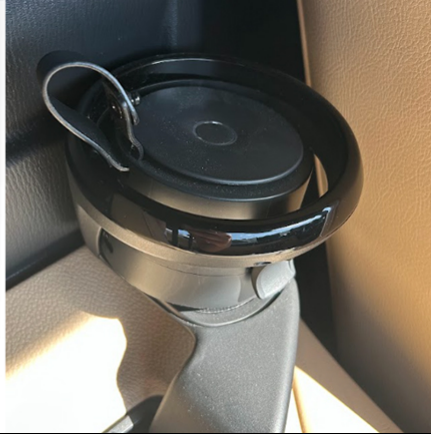
## Car Fragrance Diffuser

DTC B1182:06 Tire position not detected. This may be caused by an aftermarket electric car fragrance diffuser (electric air freshener).

The aftermarket device may cause electrical noise.
