L636-  
A.08.26

**Campaign code:**  
L636-A.08.26

**Campaign name:**  
BL Update for windows short-drop fix

**Model:**  
URUS SE

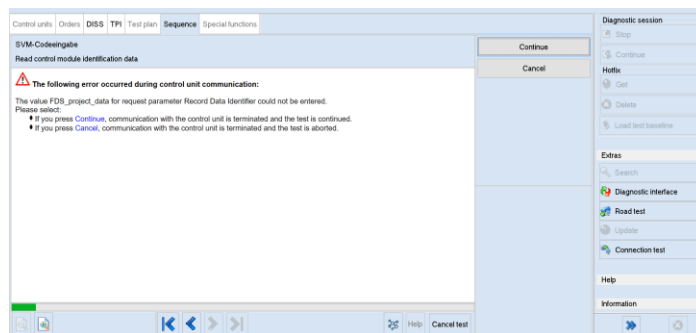
5. If the following error screen is displayed, the error does not indicate an issue, please press “Continue” and continue with the campaign.

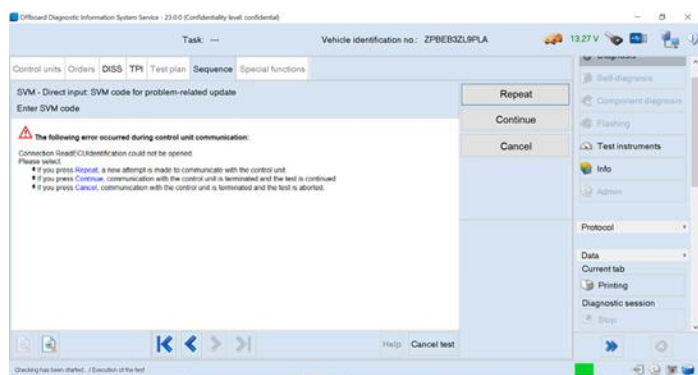
- A. If the following error screen is displayed, abort the guided function by clicking on “Cancel Test” and contact Technical Support.

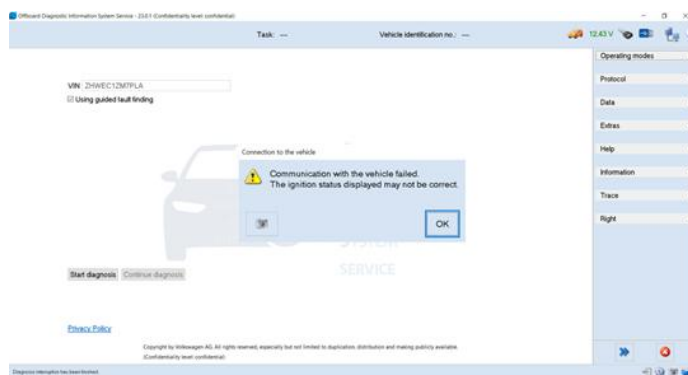
- B. If an error is displayed that regards the hardware interface, and the "connection to vehicle" and "key state" icons appear as shown in the figure below:

- Click “Cancel”
- Repeat installation of the interface 6154/6154A/6154B for the instructions in procedure (\*) “Checking the VAS 6154”, selecting the right-hand “Extras” menu in O.D.I.S. and clicking on the “Diagnostic interface” button.

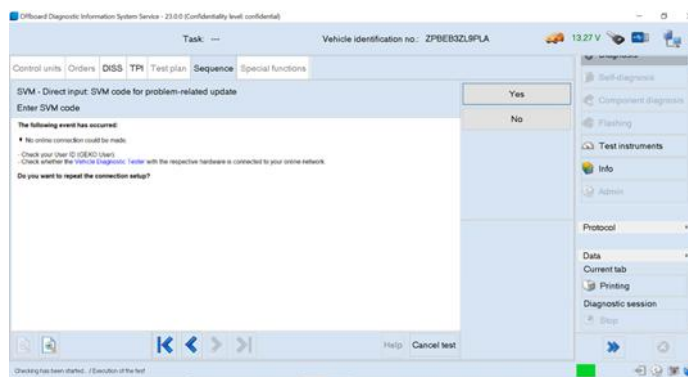
- C. If the following connection error is displayed like in the following example screenshots:

- It is not possible to connect to the central server; check that your laptop is correctly connected to the Internet and retry by clicking on “Yes” or “Done/continue”, as appropriate.

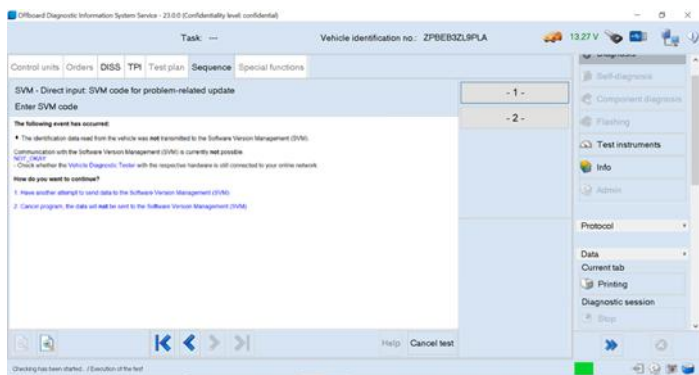
- D. If the connection is dropped during the target/actual comparison during the SVM procedure:

- It is not possible to connect to the central server; check that your laptop is correctly connected to the Internet and retry by clicking on “I”.
