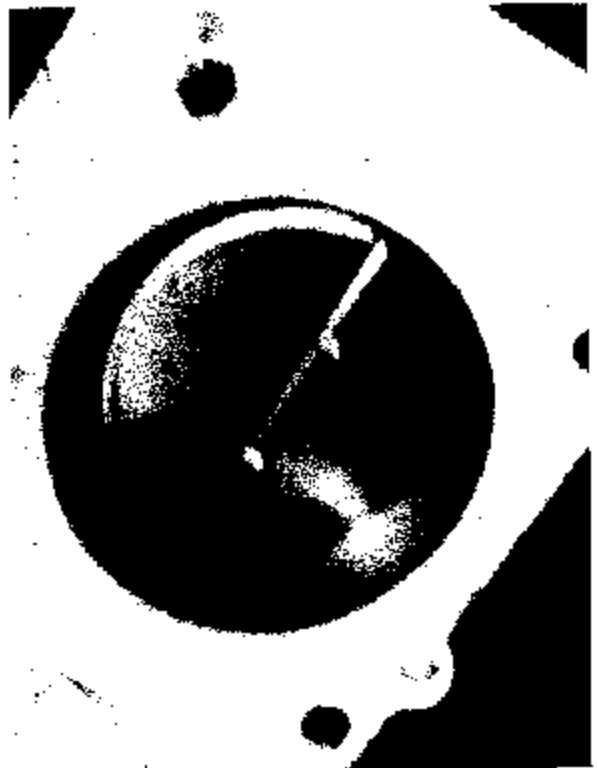
I discovered at Volvo of Fairfield that codes had not been run over a long period of time (see attached printouts), the mass air flow had not been cleaned, possibly ever (see attached photos taken on my cell phone showing before and after cleaning), and other issues of non- or inadequate-service.

BEFORE CLEANING

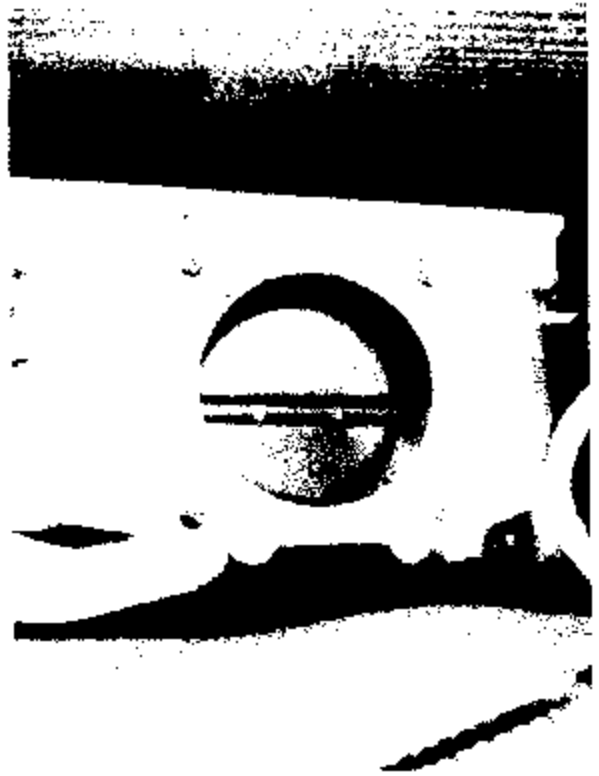
AFTER CLEANING
